# TEST REPORT

No. : XMIN191002621CCM

Sample Name : DOWNLIGHT  
Client Ref. Info. : Sample A: V50 Fixed Downlight, Type No.: JC1001  
Sample B: V50 Tilt Downlight, Type No.: JC1002  
Sample C: FG2 IP65 Downlight, Type No.: JC94110  
Sample D: FG2 Fixed Downlight, Type No.: JC94113  
Sample E: FG2 Tilt Downlight, Type No.: JC94114

To determine the fire resistance of a timber floor assembly protected by a plasterboard ceiling designed to provide 31 minutes fire resistance, incorporating five DOWNLIGHT fittings, when tested in accordance with Clause 7 of BS 476-21:1987 "Fire tests on building materials and structures – Part 21: Methods for determination of the fire resistance of loadbearing elements of construction".

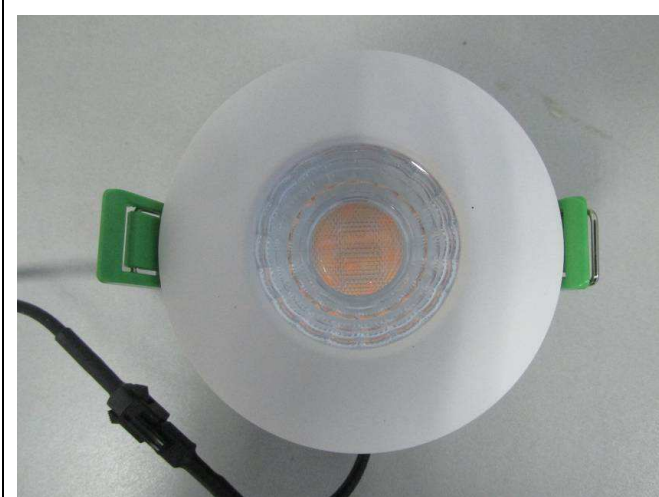
Photo 1: Front view of specimen 'A'

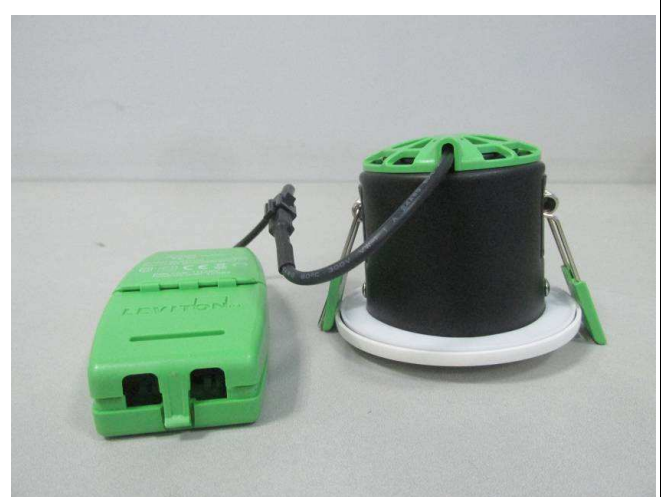
Photo 2: Side view of specimen 'A'

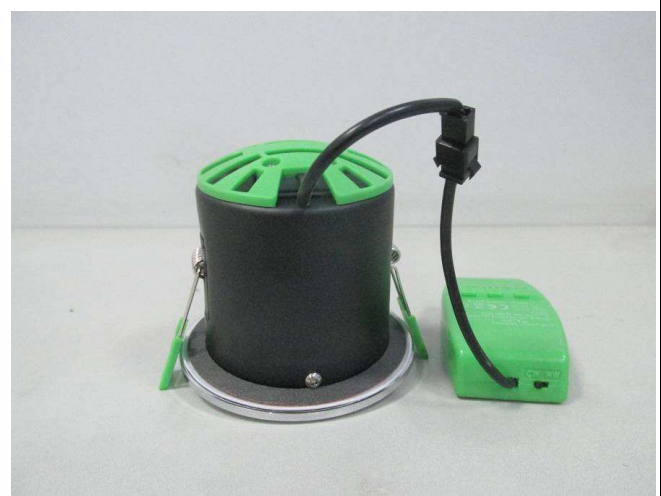
Photo 4: Side view of specimen 'B'

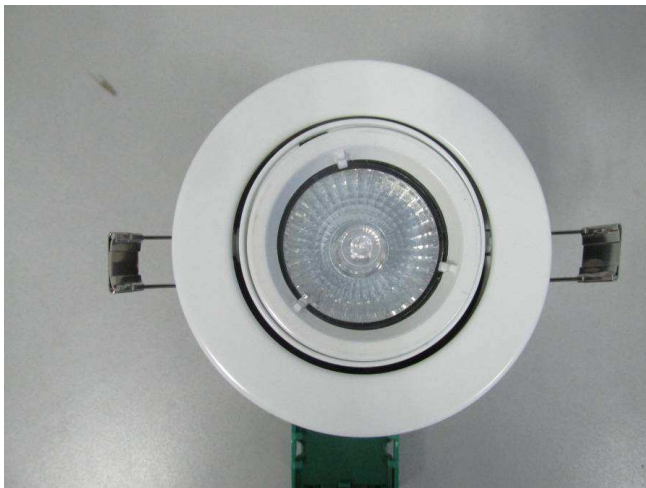
Photo 9 : Front view of specimen 'E'

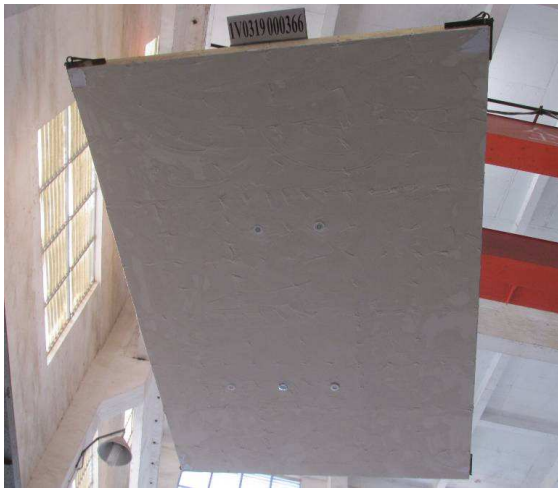
Photo 11: The exposed surface of the specimen before the test

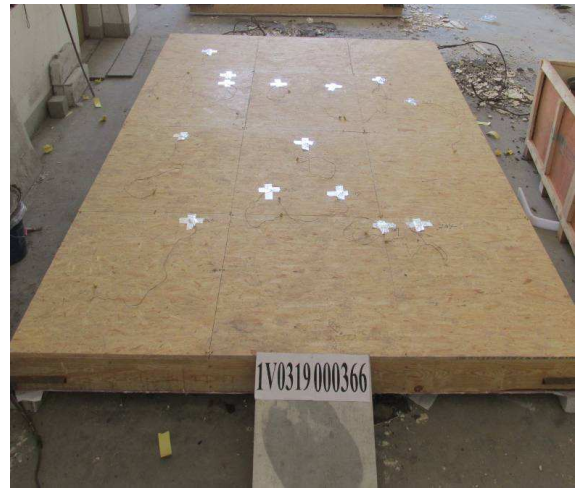
Photo 12: The unexposed surface of the specimen before the test.

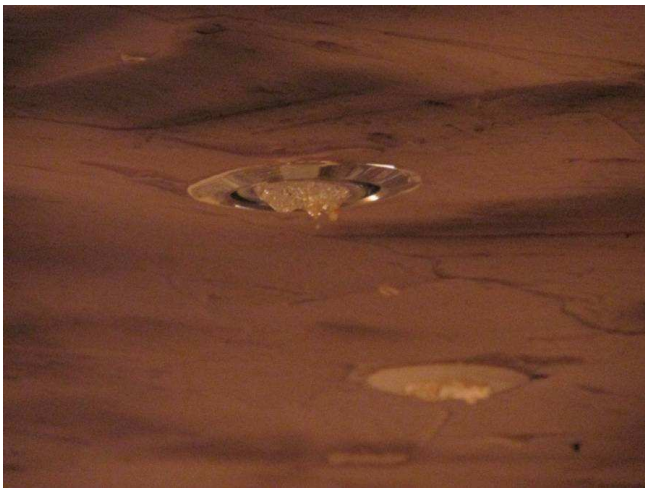
Photo 13: The exposed surface of the specimen after test duration of 3 minutes, showing the lens of specimen was fusing.

Time (min)	Observation (All observations are from the exposed face unless noted otherwise)
0	Test started.
3	The lens of specimens 'B' fused.
4	The lens of specimens 'A' fused.
10	Smoke released from the perimeter of the specimen.
13	Coating of the plasterboard ceiling fell away.
15	The faceplate of specimens 'A','C' and 'E' already fell away.
22	The lamp cup of specimen 'E' fell out from the light can.
25	Some cracks appeared on the plasterboard ceiling.
27	The faceplate of specimens 'B' already fell away.
31	Test terminated at sponsor's request.

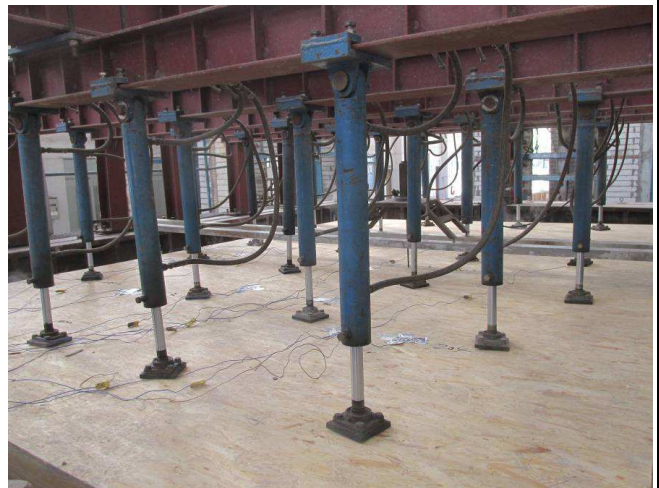
Photo 14: The unexposed surface of the specimen after test duration of 15 minutes.

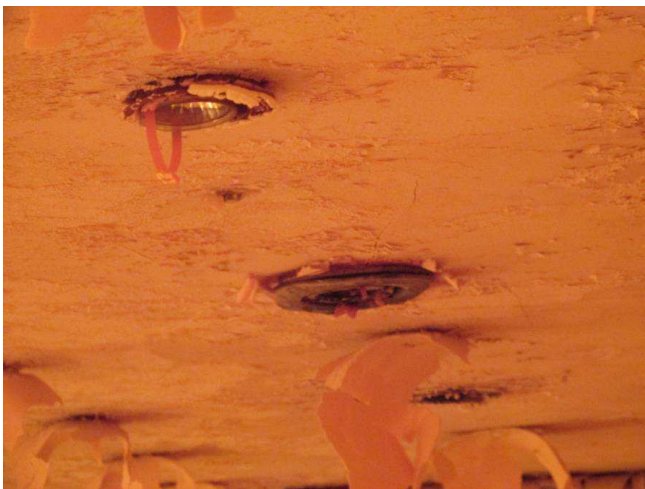
Photo 15: The exposed surface of the specimen after test duration of 16 minutes, showing the bezel of specimen fused

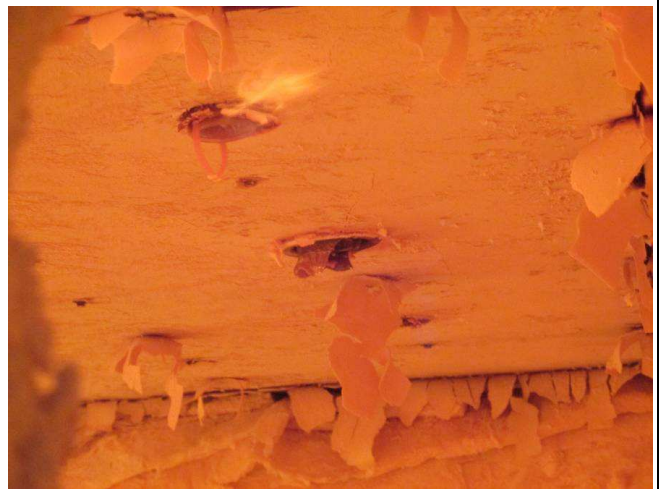
Photo 16: The exposed surface of the specimen after test duration of 22 minutes, showing the lamp cup of specimen fell out from the light can

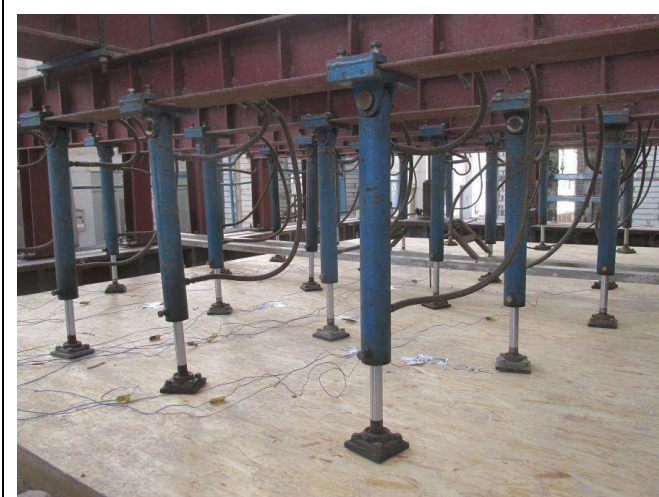
Photo 17: The unexposed surface of the specimen after test duration of 30 minutes

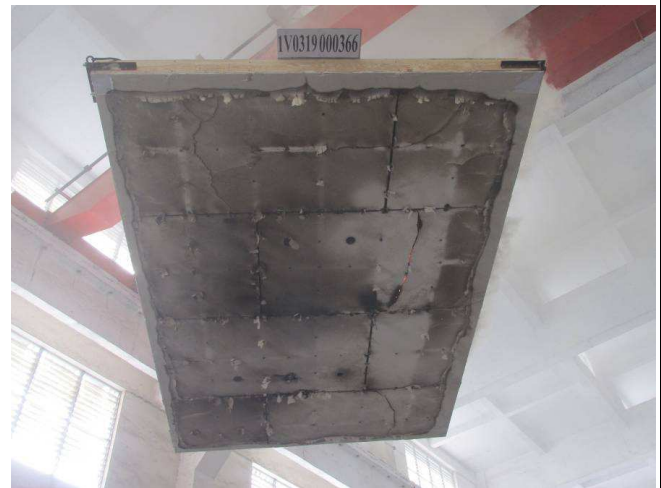
Photo 18: The exposed surface of the specimen after the test.

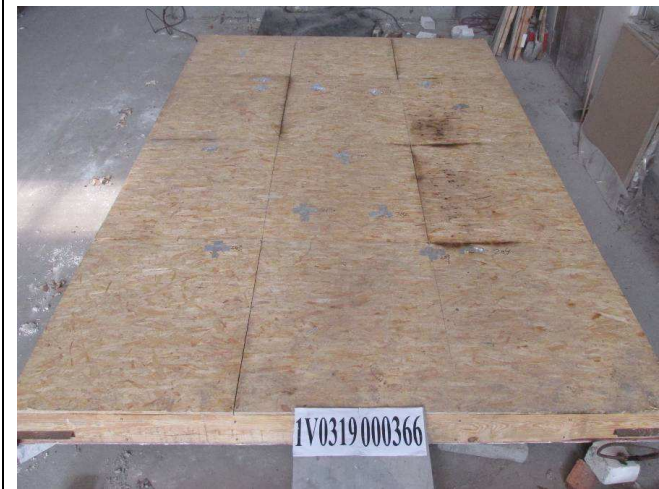
Photo 19: The unexposed surface of the specimen after the test
