TEST REPORT

No. : XMIN191002619CCM

Sample Name : DOWNLIGHT
Client Ref. Info. : Sample A: V50 Fixed Downlight, Type No.: JC1001
Sample B: V50 Tilt Downlight, Type No.: JC1002
Sample C: FG2 IP65 Downlight, Type No.: JC94110
Sample D: FG2 Fixed Downlight, Type No.: JC94113
Sample E: FG2 Tilt Downlight, Type No.: JC94114

To determine the fire resistance of a timber floor assembly protected by a plasterboard ceiling designed to provide 91 minutes fire resistance, incorporating five DOWNLIGHT fittings, when tested in accordance with Clause 7 of BS 476-21:1987 "Fire tests on building materials and structures – Part 21: Methods for determination of the fire resistance of loadbearing elements of construction".

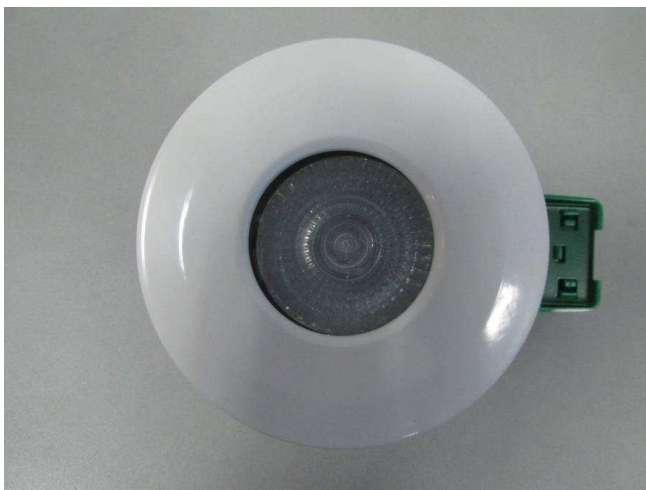
Photo 5: Front view of specimen 'C'

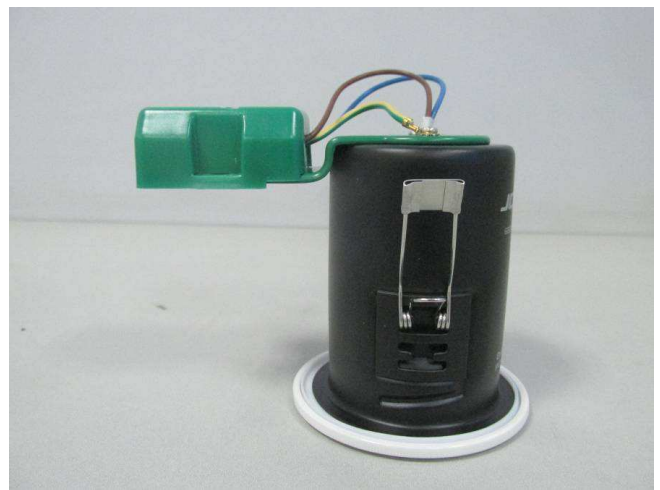
Photo 6: Side view of specimen 'C'

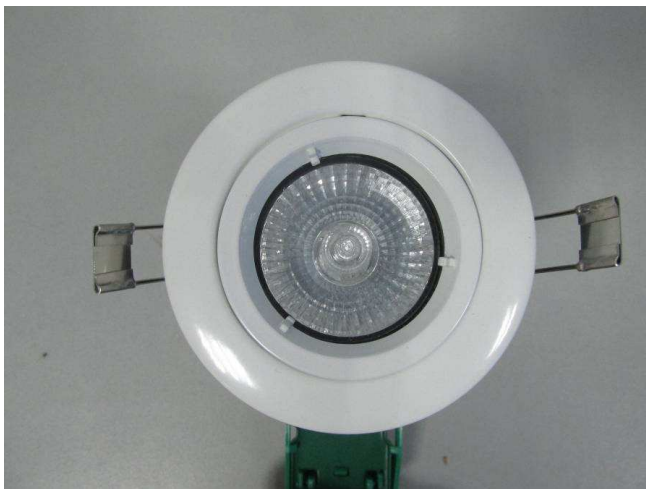
Photo 7: Front view of specimen 'D'

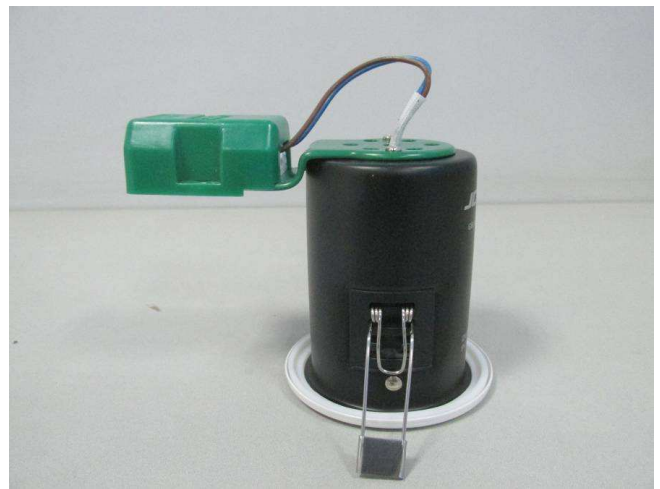
Photo 8: Side view of specimen 'D'

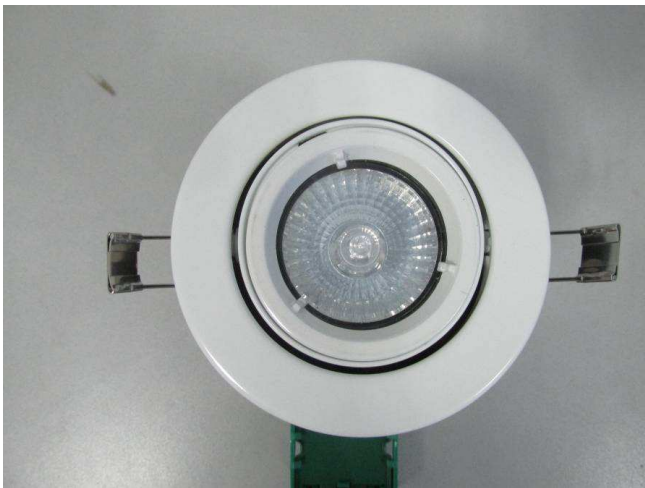
Photo 9 : Front view of specimen 'E'

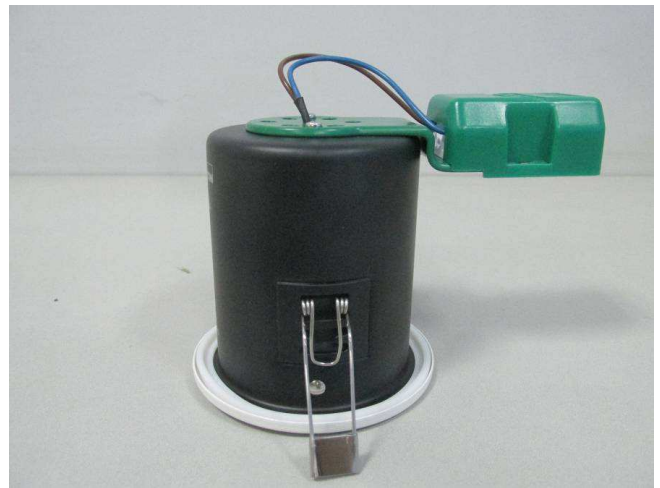
Photo 10: Side view of specimen 'E'

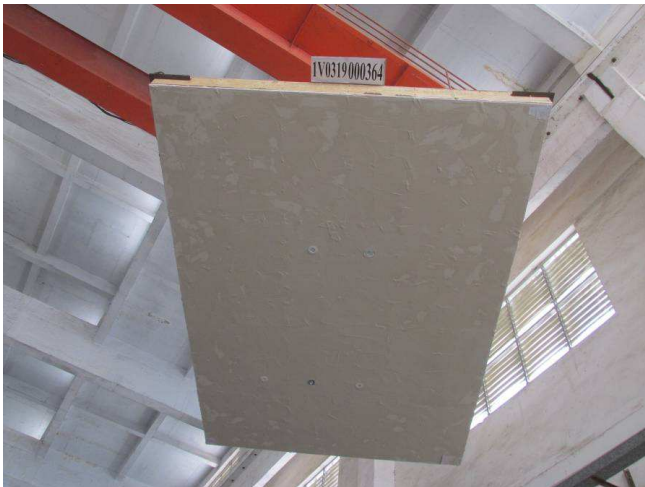
Photo 11: The exposed surface of the specimen before the test

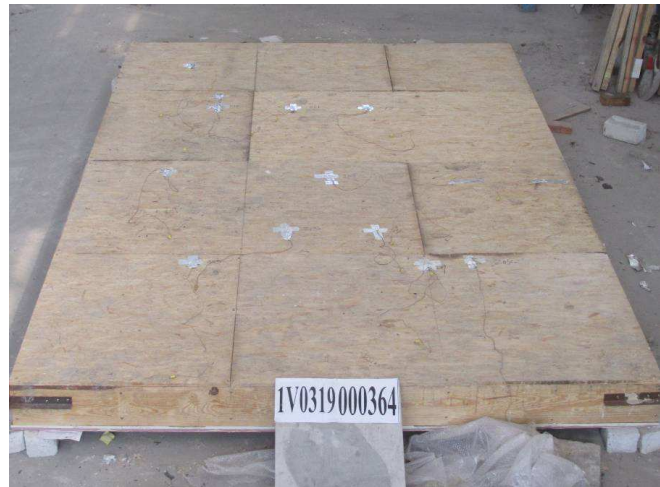
Photo 12: The unexposed surface of the specimen before the test

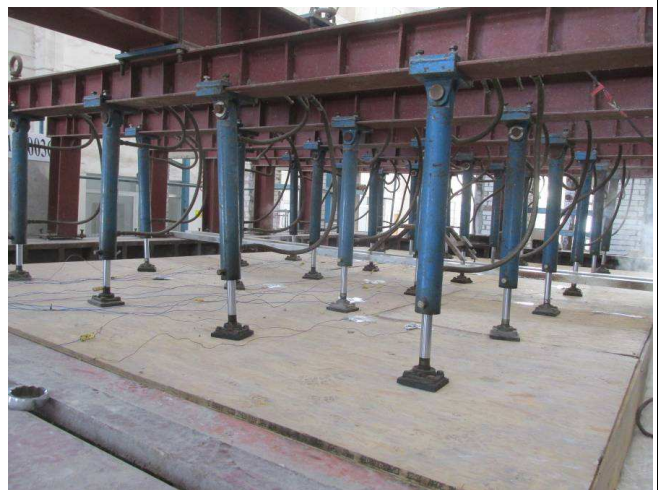
Photo 14: The unexposed surface of the specimen after test duration of 15 minutes

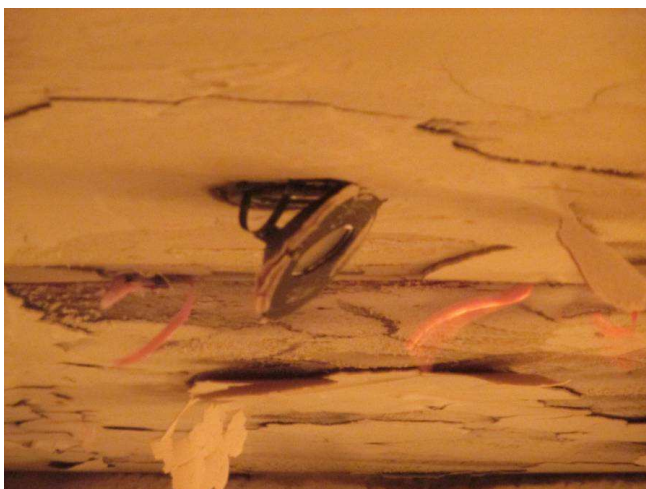
Photo 15: The exposed surface of the specimen after test duration of 16 minutes, showing the faceplate of specimen was falling away.

Time (min)	Observation (All observations are from the exposed face unless noted otherwise)
0	Test started.
4	The lens of specimens 'A' and 'B' fused.
8	Smoke released from the perimeter of the specimen.
14	Coating of the plasterboard ceiling already fell away.
15	The faceplate and lens of the specimens 'C' fell away together.
16	The faceplate and lens of the specimens 'E' fell away together, and the lamp cup of specimen fell out from the light can.
19	The faceplate of the specimens 'D' fell away and the lamp cup of specimen fell out from the light can.
25	The faceplate and of the specimens 'A' fell away.
30	The faceplate and of the specimens 'B' fell away.
45	The first layer plasterboard ceiling started to sag slightly and joints began to open.
62	Part of first layer plasterboard ceiling fell into the furnace.
67	Most of the first layer of plasterboard ceiling fell away.
68	The second layer plasterboard ceiling started to sag and joints began to open.

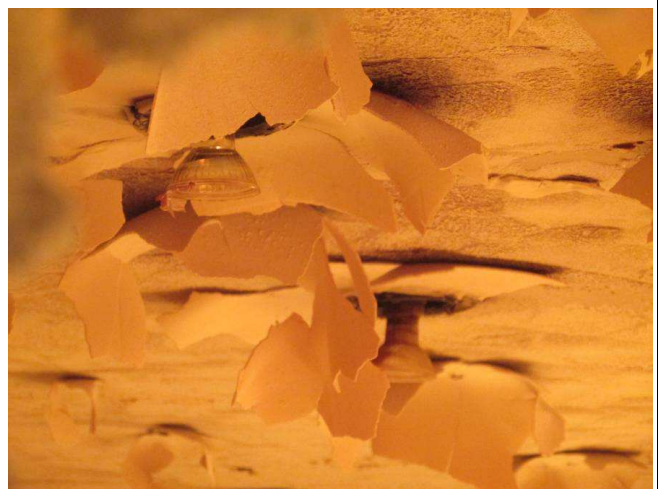
Photo 16: The exposed surface of the specimen after test duration of 19 minutes, showing the lamp cup of specimens fell out from the light can

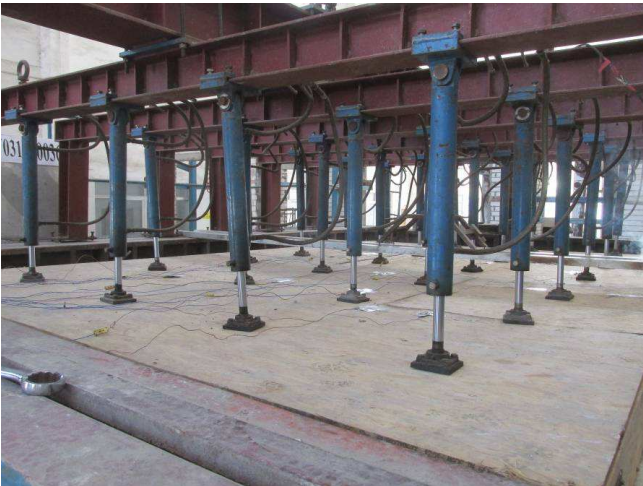
Photo 17: The unexposed surface of the specimen after test duration of 30 minutes

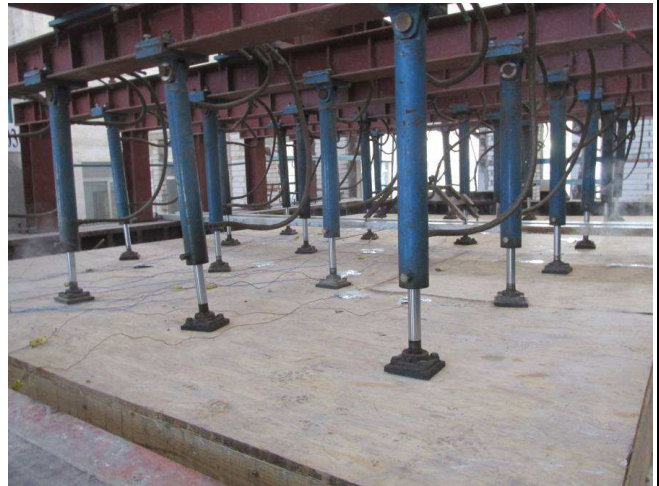
Photo 18: The unexposed surface of the specimen after test duration of 45 minutes

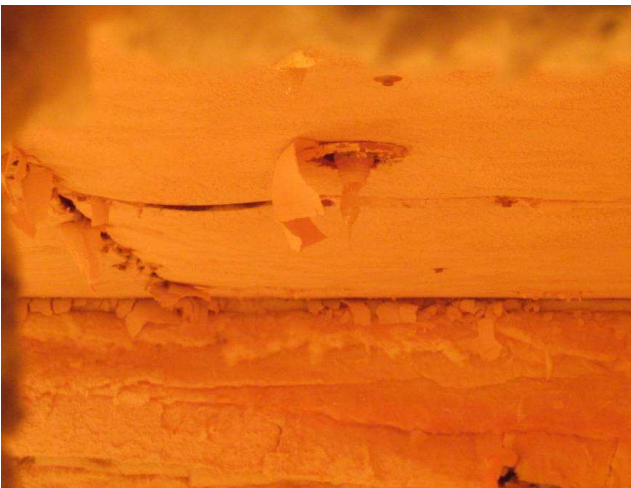
Photo 19: The exposed surface of the specimen after test duration of 45 minutes, showing the first layer plasterboard ceiling started to sag slightly and joints began to open

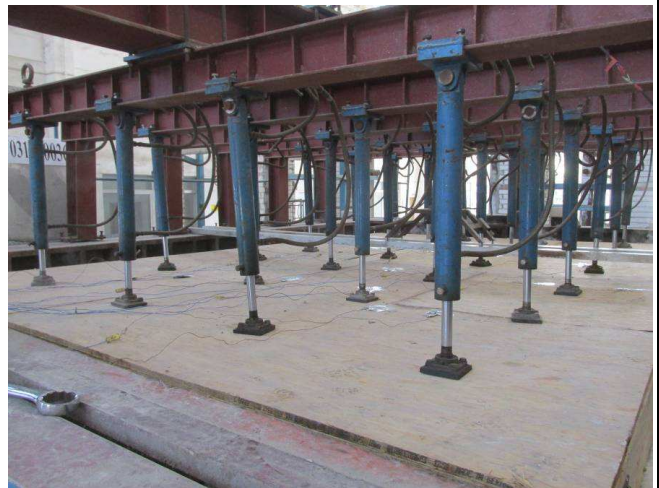
Photo 20: The unexposed surface of the specimen after test duration of 60 minutes

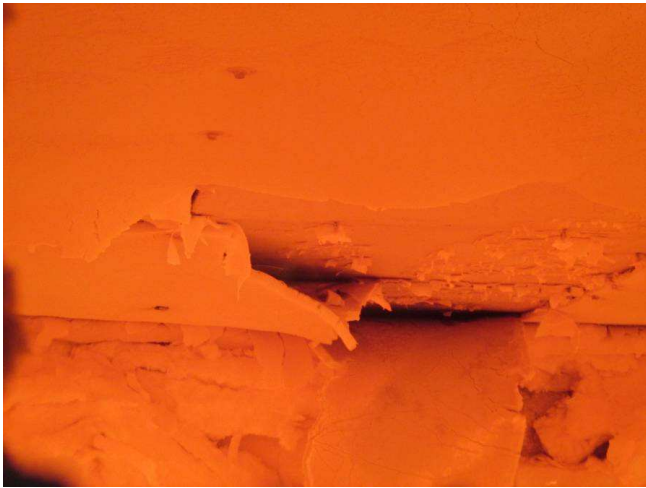
Photo 21: The exposed surface of the specimen after test duration of 62 minutes, showing part of first layer plasterboard ceiling was falling into the furnace

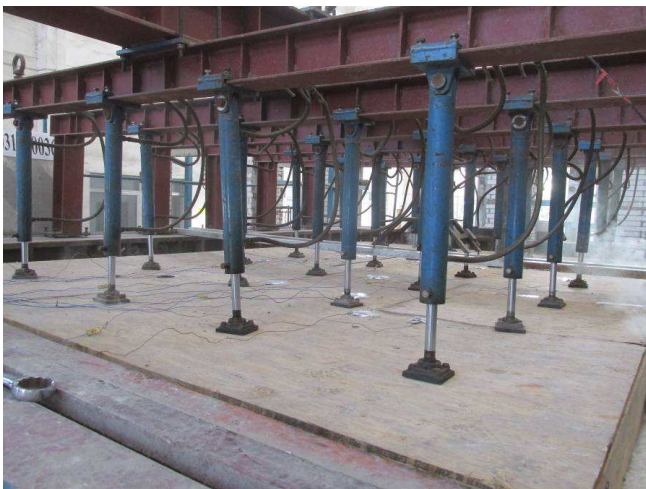
Photo 23: The unexposed surface of the specimen after test duration of 75 minutes.

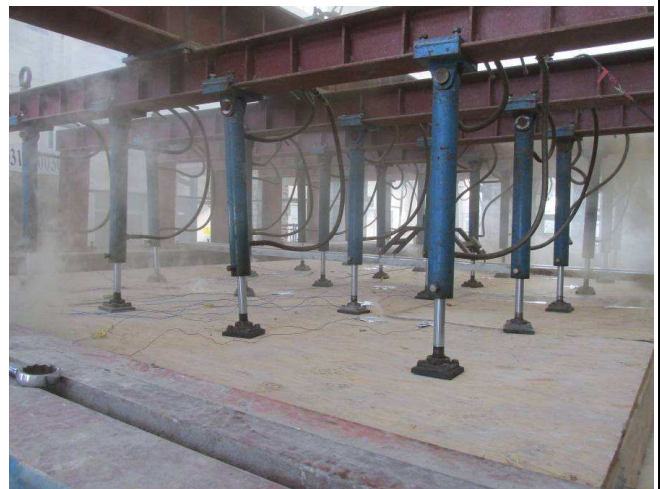
Photo 24: The unexposed surface of the specimen after test duration of 90 minutes

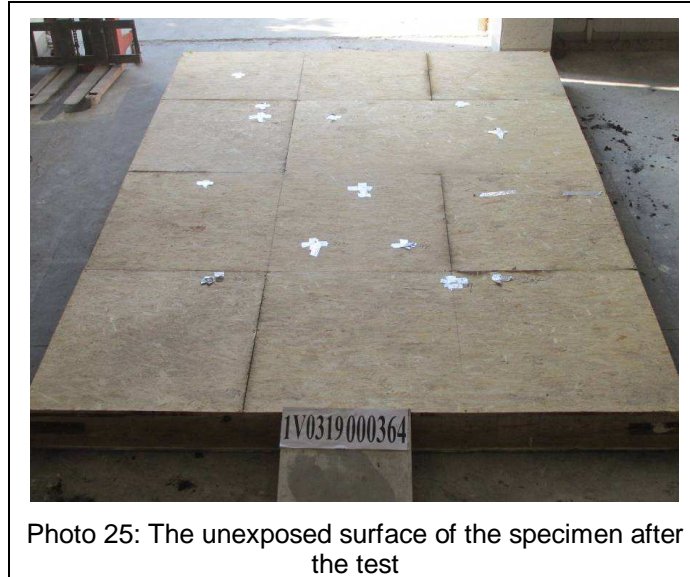
Photo 25: The unexposed surface of the specimen after the test
