FLOOR ASSEMBLY FIRE TEST REPORT

Sponsor: JCC LIGHTING PRODUCTS

Test Report No.: V03-20000055(E)

To determine the fire resistance of a timber floor assembly protected by a plasterboard ceiling designed to provide 31 minutes fire resistance, incorporating eight downlight fittings, when tested in accordance with Clause 7 of BS 476-21:1987 "Fire tests on building materials and structures – Part 21: Methods for determination of the fire resistance of loadbearing elements of construction".

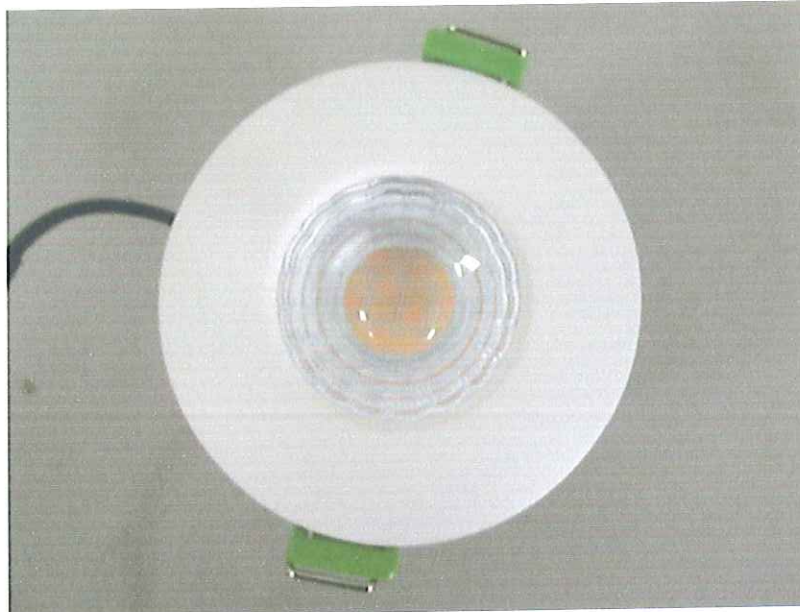
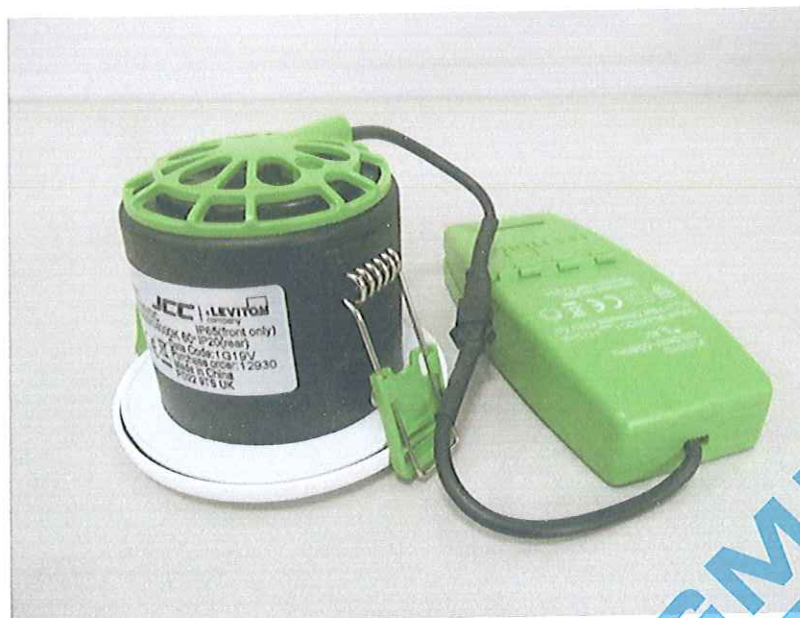
Photo 1: Front view of specimen 'A'
Photo 2: Side view of specimen 'A'

Product Name	: V50 Fixed Downlight
Reference	: JC1001 V50 Fixed Downlight
Manufacturer	: JCC Lighting
Type	: Recessed Downlight
Overall dimensions and construction	: See figure 4
Hole size in ceiling boards	: 70 mm diameter
Materials	i: Casing: Mild Steel ii: Cover: Polycarbonate iii: Spring clip: Steel iv: Connection block: Polycarbonate Housing Approx. weight: 0.29 Kg
Details of fireproof material	i: Manufacturer: JCC Lighting Products ii: Type: Mild Steel 'Can' iii: Thickness: 0.8mm
Details of Expanding material	i. Manufacturer: Tai-G ii. Type: SM43.5-1.0mm iii. Material: Fire Reactive Expandable Graphite iv. Thickness: 1.0mm v. Location: Top of 'Can'

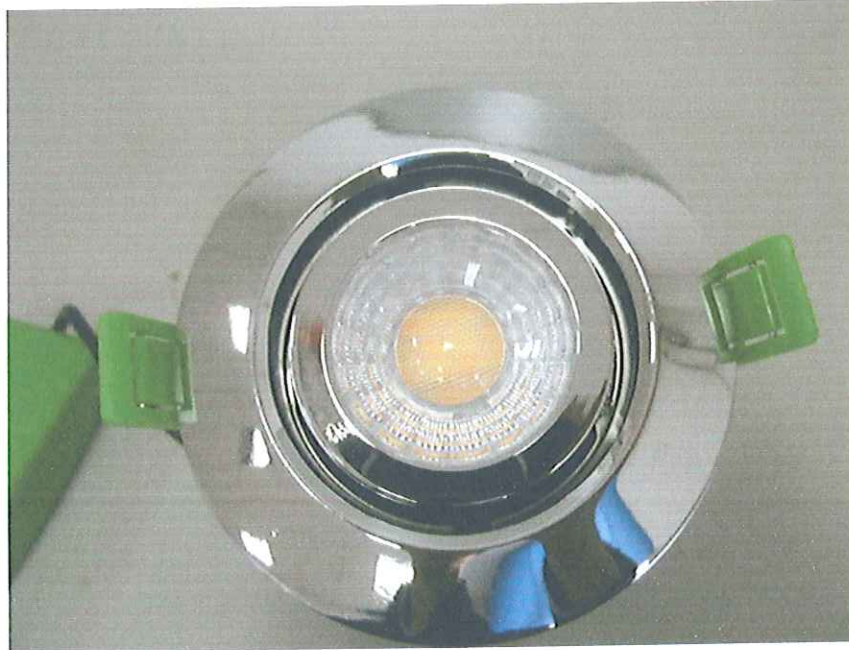
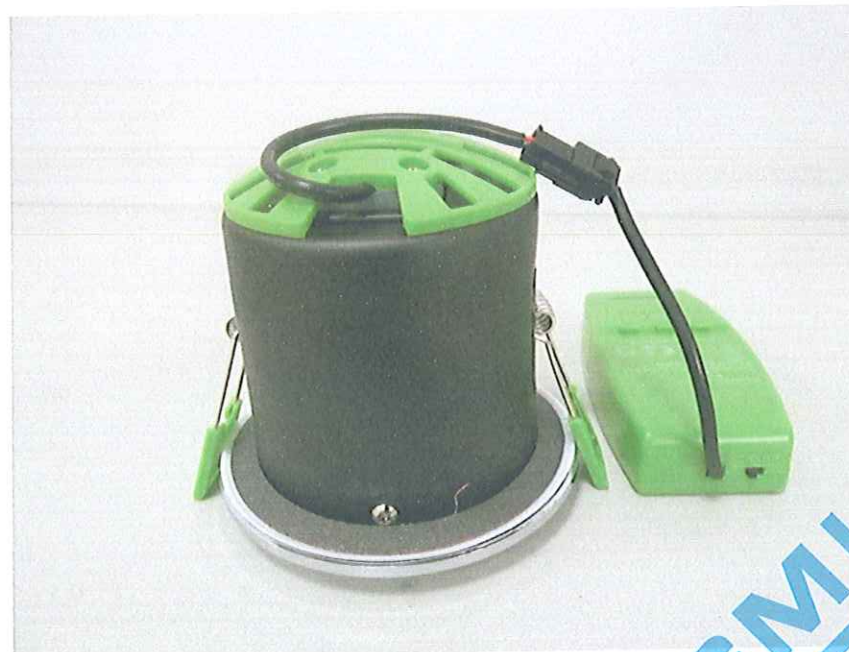
Photo 3: Front view of specimen 'B'
Photo 4: Side view of specimen 'B'

Type	: Recessed Downlight
Overall dimensions and construction	: See figure 5
Hole size in ceiling boards	: 85 mm diameter
Materials	<ul style="list-style-type: none"> i: Casing: Mild Steel ii: Cover: Polycarbonate iii: Spring clip: Steel iv: Connection block: Polycarbonate Housing Approx. weight: 0.46 Kg
Details of fireproof material	<ul style="list-style-type: none"> i: Manufacturer: JCC Lighting Products ii: Type: Mild Steel 'Can' iii: Thickness: 0.8mm
Details of Expanding material	<ul style="list-style-type: none"> i. Manufacturer: Tai-G ii. Type: SM43.5-1.0mm iii. Material: Fire Reactive Expandable Graphite iv. Thickness: 1.0mm v. Location: Top of 'Can'

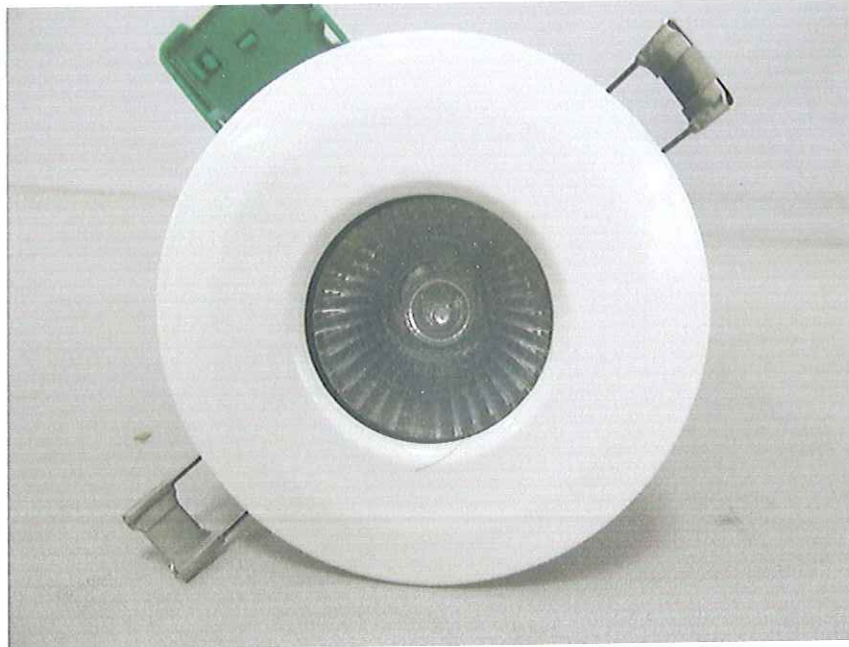
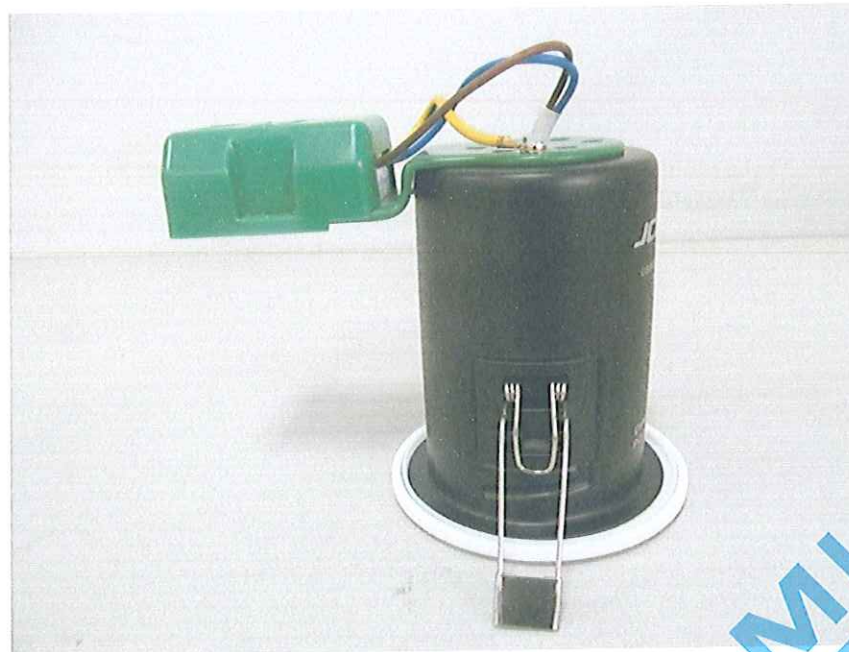
Photo 5: Front view of specimen 'C'
Photo 6: Side view of specimen 'C'

Product Name	: FG2 IP65 Downlight
Reference	: JC94110 FG2 IP65 Downlight
Manufacturer	: JCC Lighting
Type	: Recessed Downlight
Overall dimensions and construction	: See figure 6
Hole size in ceiling boards	: 74 mm diameter
Materials	<ul style="list-style-type: none"> i: Casing: Mild Steel ii: Cover: Mild Steel iii: Spring clip: Steel iv: Connection block: Polycarbonate Housing Approx. weight:0.27 Kg
Details of fireproof material	<ul style="list-style-type: none"> i: Manufacturer: JCC Lighting Products ii: Type: Mild Steel 'Can'

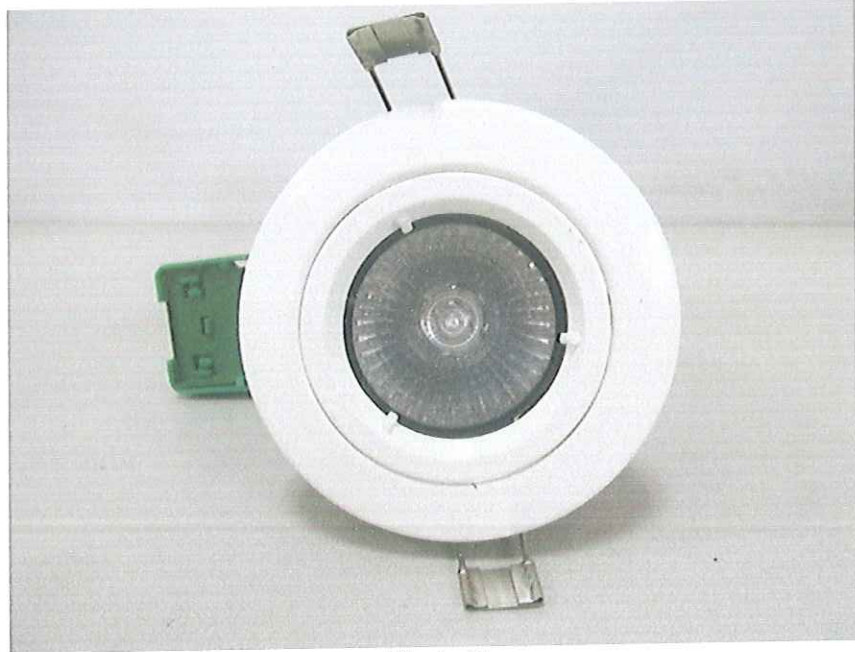
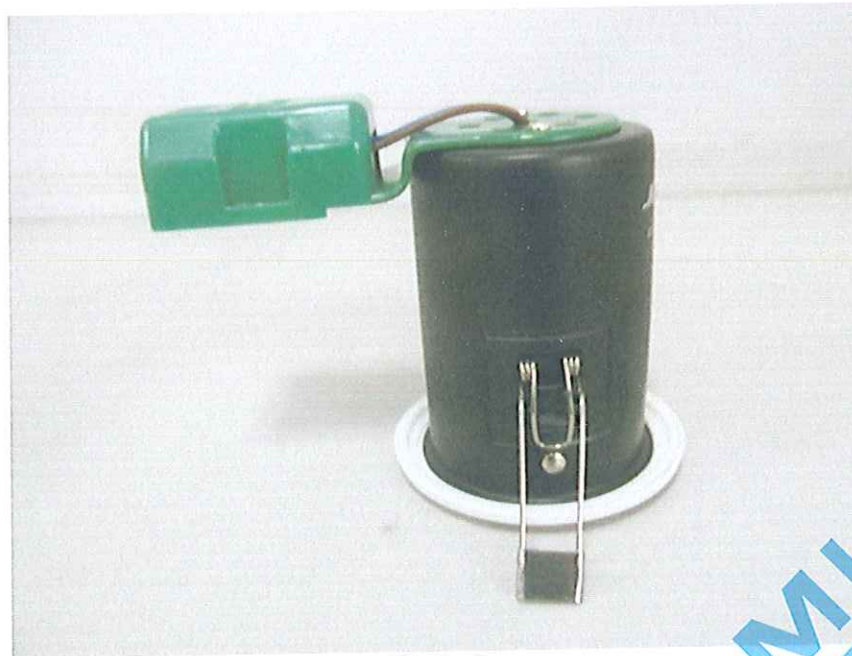
Photo 7: Front view of specimen 'D'
Photo 8: Side view of specimen 'D'

Product Name : FG2 Fixed Downlight
Reference : JC94113 FG2 Fixed Downlight
Manufacturer : JCC Lighting
Type : Recessed Downlight
Overall dimensions and construction : See figure 7
Hole size in ceiling boards : 74 mm diameter
Materials
i: Casing: Mild Steel
ii: Cover: Mild Steel
iii: Spring clip: Steel
iv: Connection block: Polycarbonate Housing
Approx. weight:0.25 Kg

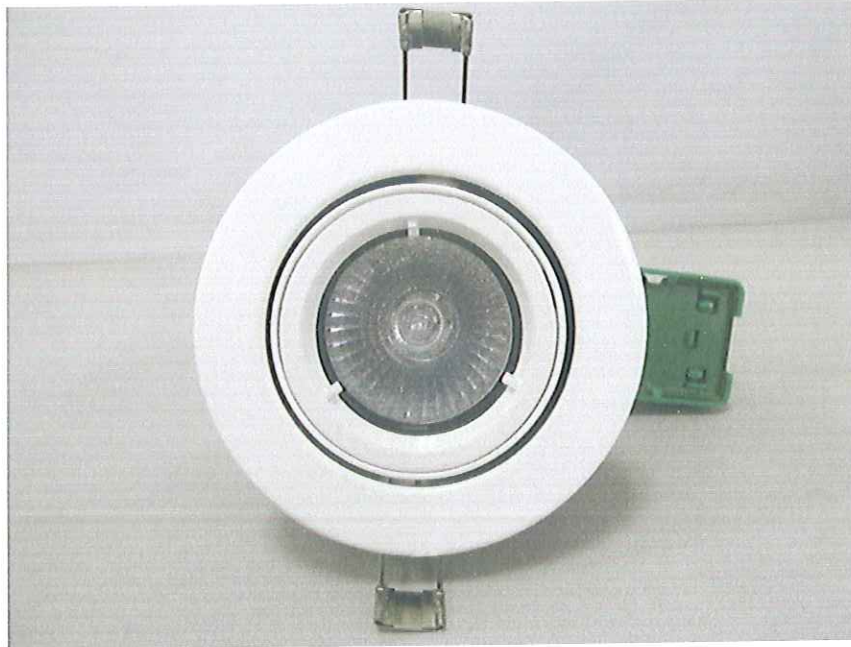
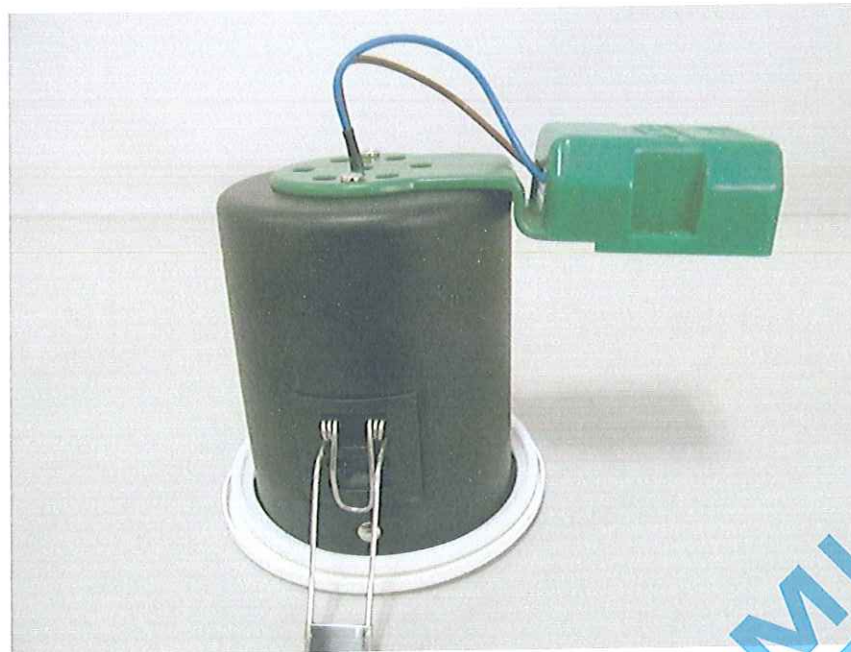
Photo 9: Front view of specimen 'E'
Photo 10: Side view of specimen 'E'

Type	: Recessed Downlight
Overall dimensions and construction	: See figure 8
Hole size in ceiling boards	: 85 mm diameter
Materials	i: Casing: Mild Steel ii: Cover: Mild Steel iii: Spring clip: Steel iv: Connection block: Polycarbonate Housing Approx. weight:0.32 Kg
Details of fireproof material	i: Manufacturer: JCC Lighting Products ii: Type: Mild Steel 'Can' iii: Thickness: 0.8mm
Details of Expanding material	i. Manufacturer: Tai-G ii. Type: SM43.5-1.0mm iii. Material: Fire Reactive Expandable Graphite iv. Thickness: 1.0mm v. Location: Top of 'Can'

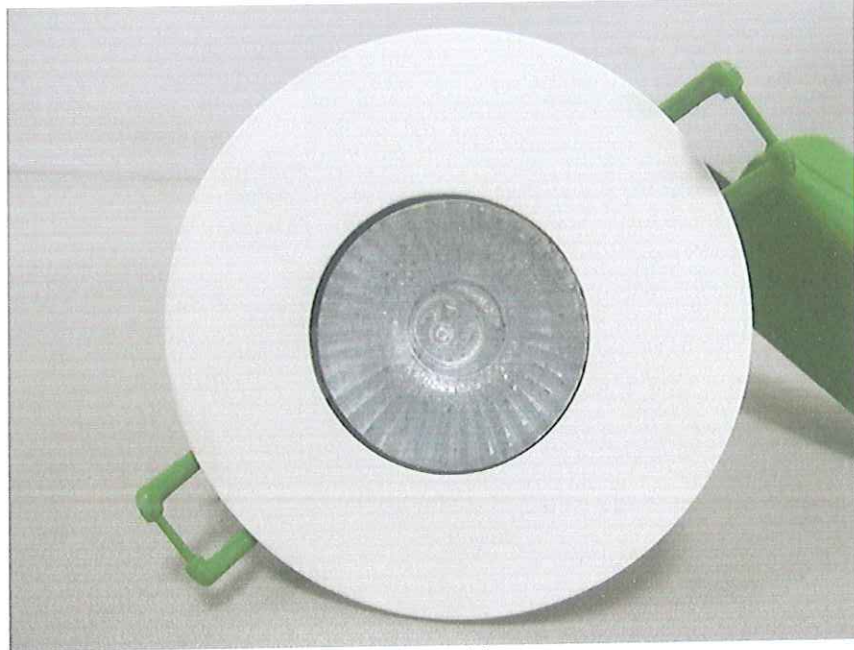
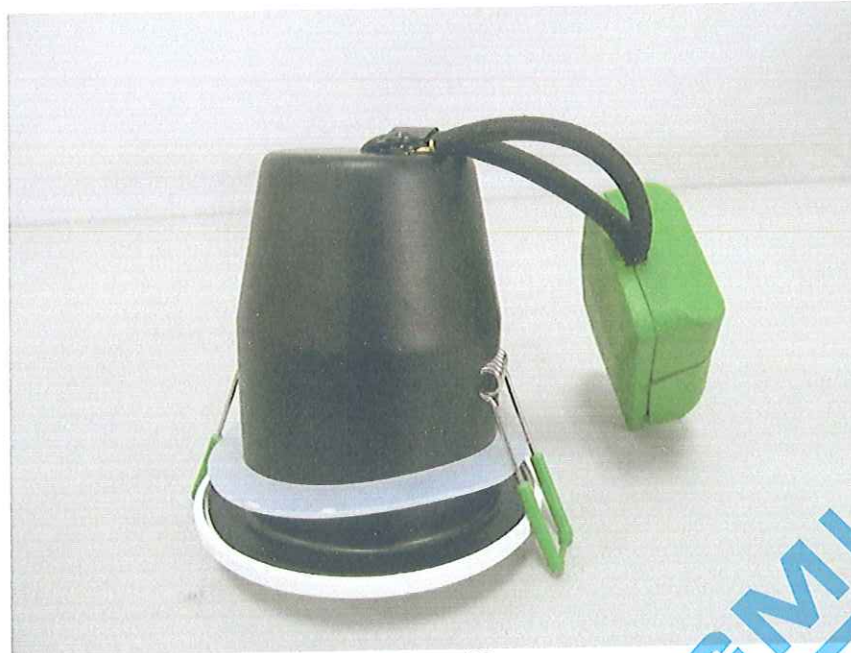
Photo 11: Front view of specimen 'F'
Photo 12: Side view of specimen 'F'

Product Name	: Fireguard Fixed Downlight
Reference	: JC010010 Fireguard Fixed Downlight
Manufacturer	: JCC Lighting
Type	: Round, tilt downlight
Overall dimensions and construction	: See figure 9
Hole size in ceiling boards	: 78 mm diameter
Materials	i: Casing: Mild Steel ii: Cover: White/Chrome/Brushed Nickel iii: Spring clip: Steel iv: Connection block: Polycarbonate Housing Approx. weight:0.21 Kg
Details of fireproof material	i: Manufacturer: JCC Lighting Products ii: Type: Mild Steel 'Can' iii: Thickness: 0.8mm

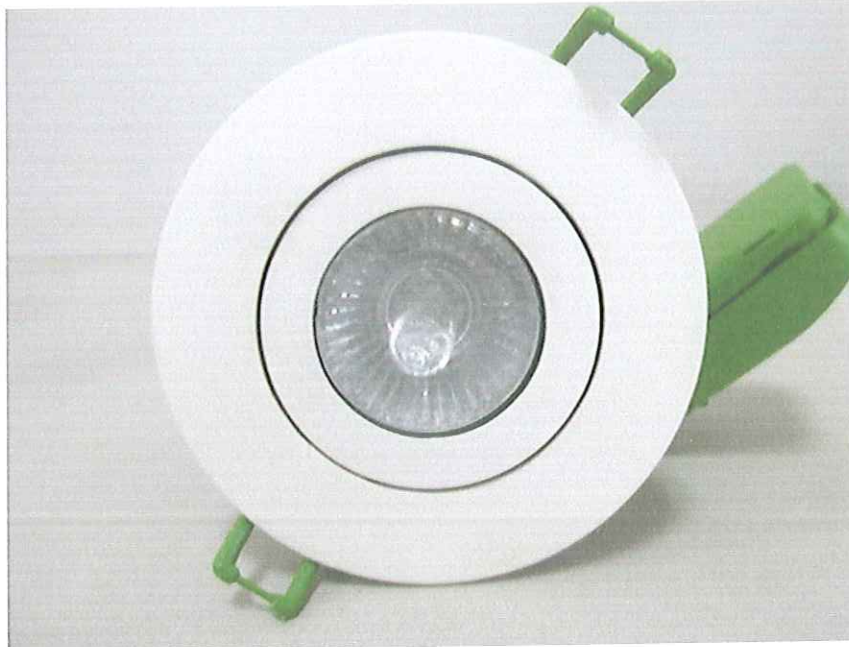
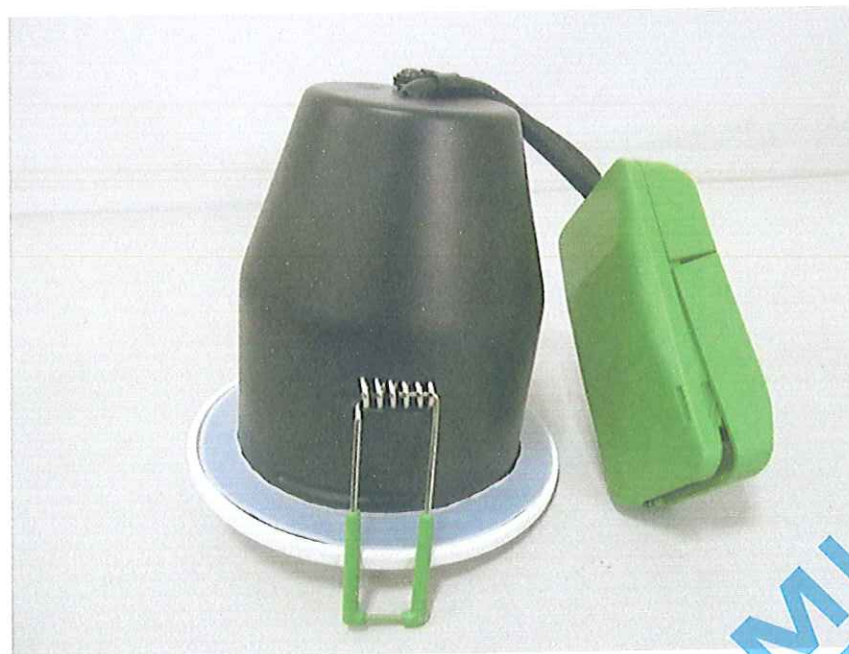
Photo 13: Front view of specimen 'G'
Photo 14: Side view of specimen 'G'

Product Name	: Fireguard Tilt Downlight
Reference	: JC010023 Fireguard Tilt Downlight
Manufacturer	: JCC Lighting
Type	: Recessed Downlight
Overall dimensions and construction	: See figure 10
Hole size in ceiling boards	: 84 mm diameter
Materials	i: Casing: Mild Steel ii: Cover: White/Chrome/Brushed Nickel iii: Spring clip: Steel iv: Connection block: Polycarbonate Housing Approx. weight: 0.26 Kg
Details of fireproof material	i: Manufacturer: JCC Lighting Products ii: Type: Mild Steel 'Can' iii: Thickness: 0.8mm

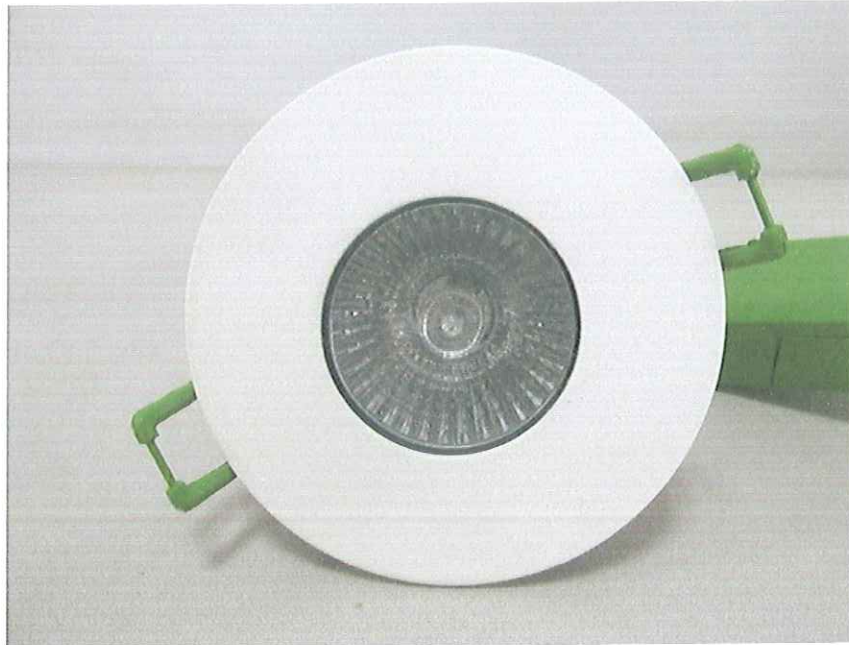
Photo 15

Photo 15: Front view of specimen 'H'

Product Name	: Fireguard IP65 Downlight
Reference	: JC010016 Fireguard IP65 Downlight
Manufacturer	: JCC Lighting
Type	: Recessed Downlight
Overall dimensions and construction	: See figure 11
Hole size in ceiling boards	: 72 mm diameter
Materials	i: Casing: Mild Steel ii: Cover: White/Chrome/Brushed Nickel iii: Spring clip: Steel iv: Connection block: Polycarbonate Housing Approx. weight: 0.23 Kg
Details of fireproof material	i: Manufacturer: JCC Lighting Products ii: Type: Mild Steel 'Can' iii: Thickness: 0.8mm

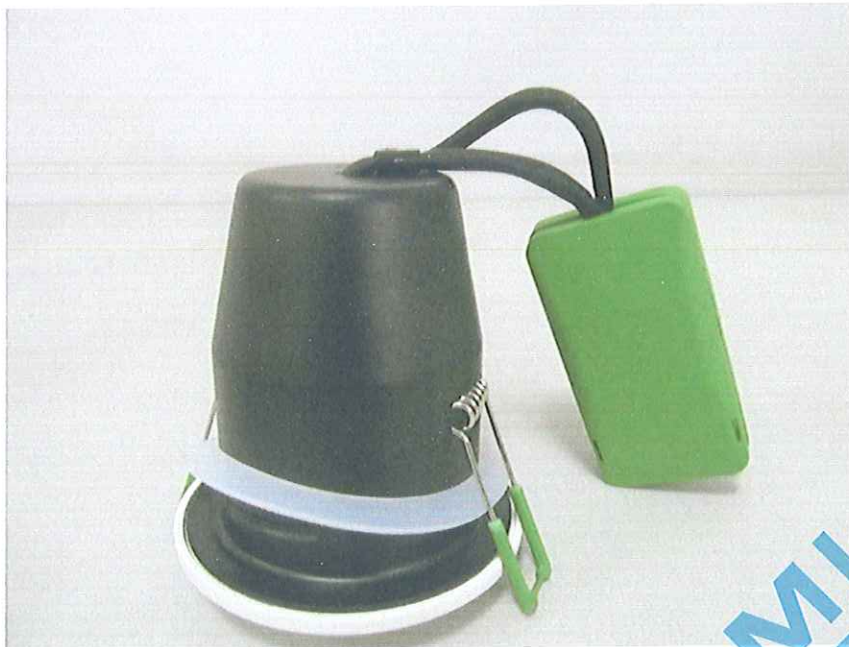
Photo 16

Photo 16: Side view of specimen 'H'

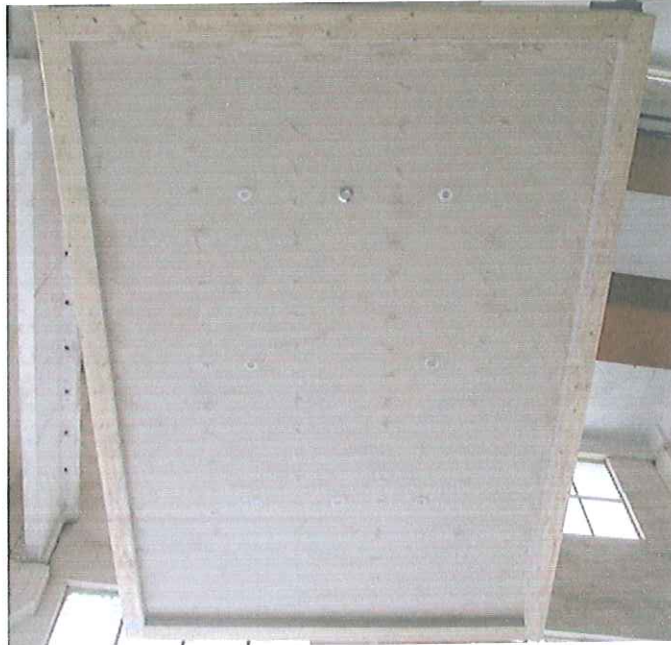
Photo 17

Photo 17: The exposed surface of the specimen before the test

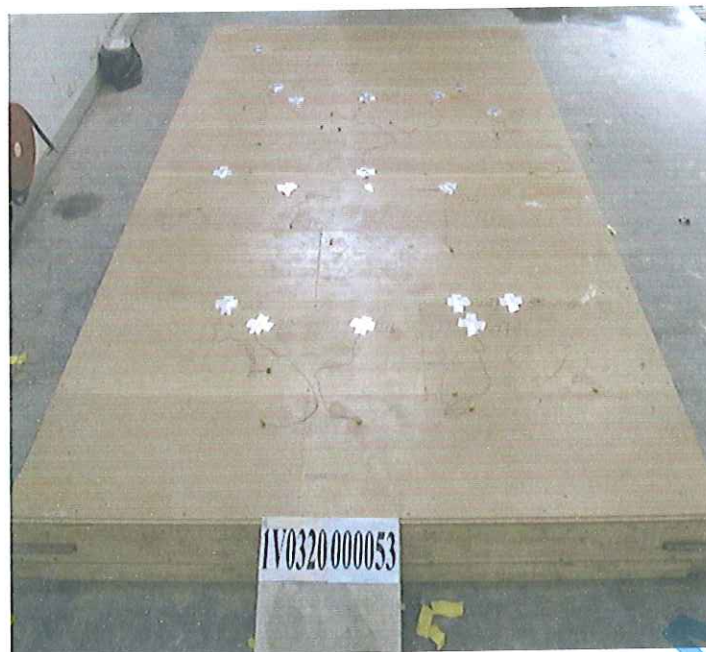
Photo 18

Photo 18: The unexposed surface of the specimen before the test.

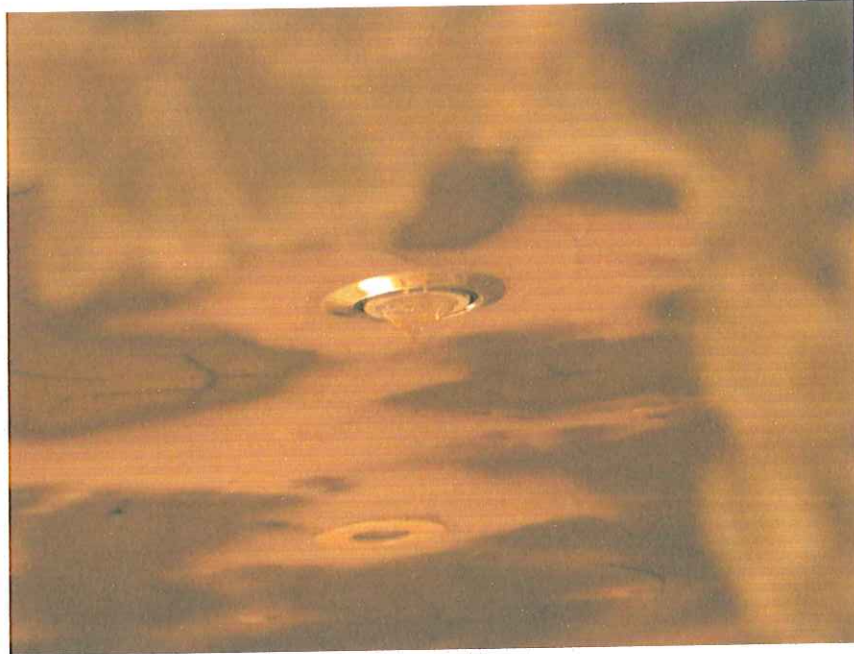
Photo 19

Photo 19: The exposed surface of the specimen after test duration of 4 minutes, showing the lens of specimen was fusing.

Time (min)	Observation (All observations are from the exposed face unless noted otherwise)
0	Test started.
4	The lens of specimen 'A' fused.
5	The lens of specimen 'B' fused.
7	The lens of specimen 'D' fused, and the bezels of specimen 'C', 'D', 'E', 'H' and 'G' turned black.
9	The bezels of specimen 'F' turned black.
10	Coating of the plasterboard ceiling fell away.
17	The bezel of specimen 'C' fell away.
23	The lamp cup of specimen 'A' fell out from the light can.
26	The lamp cups of specimen 'F' and 'G' fell out from the light can.
28	The first layer plasterboard ceiling started to sag slightly and joints began to open.
31	Test terminated at sponsor's request.

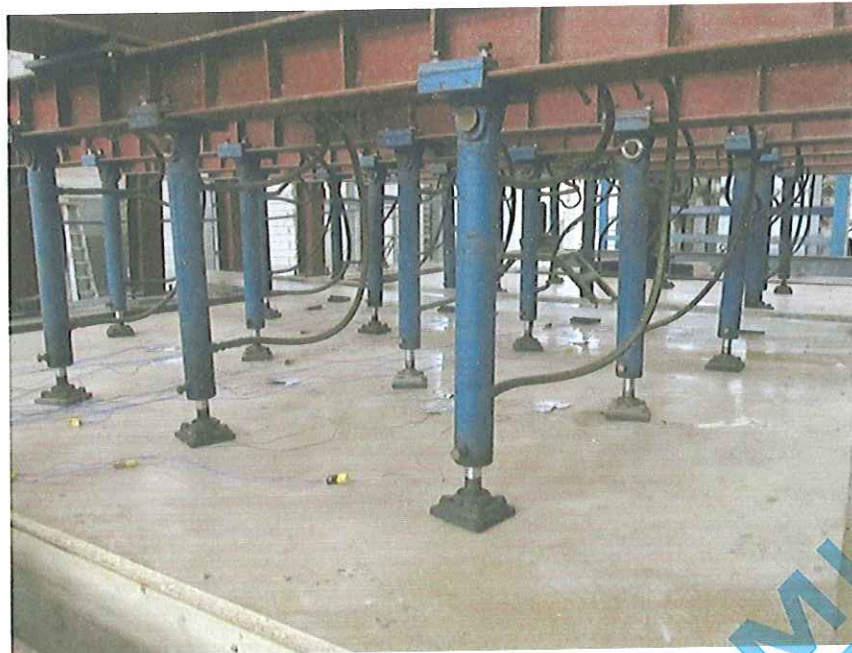
Photo 20

Photo 20: The unexposed surface of the specimen after test duration of 15 minutes.

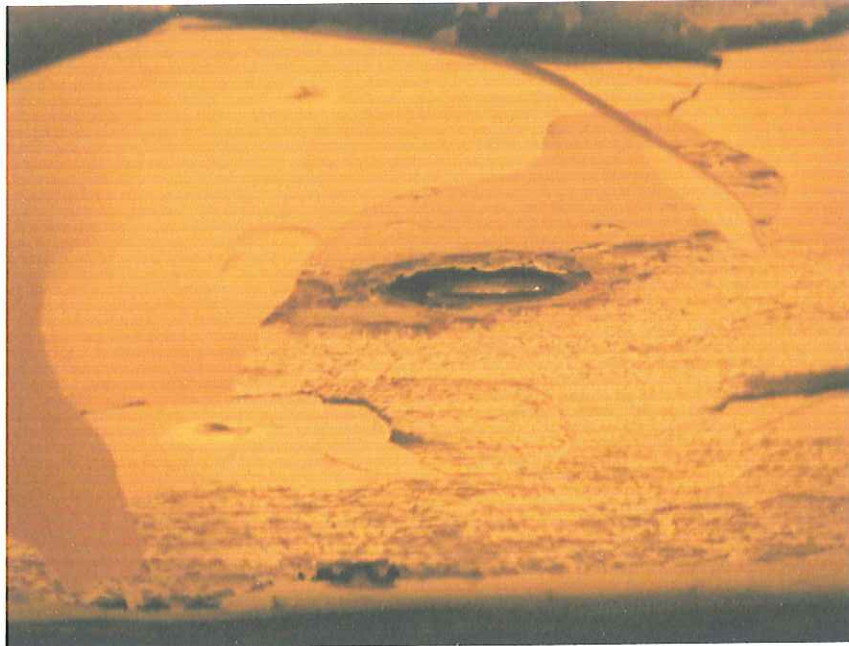
Photo 21

Photo 21: The exposed surface of the specimen after test duration of 17 minutes, showing the bezel of specimen fell away.

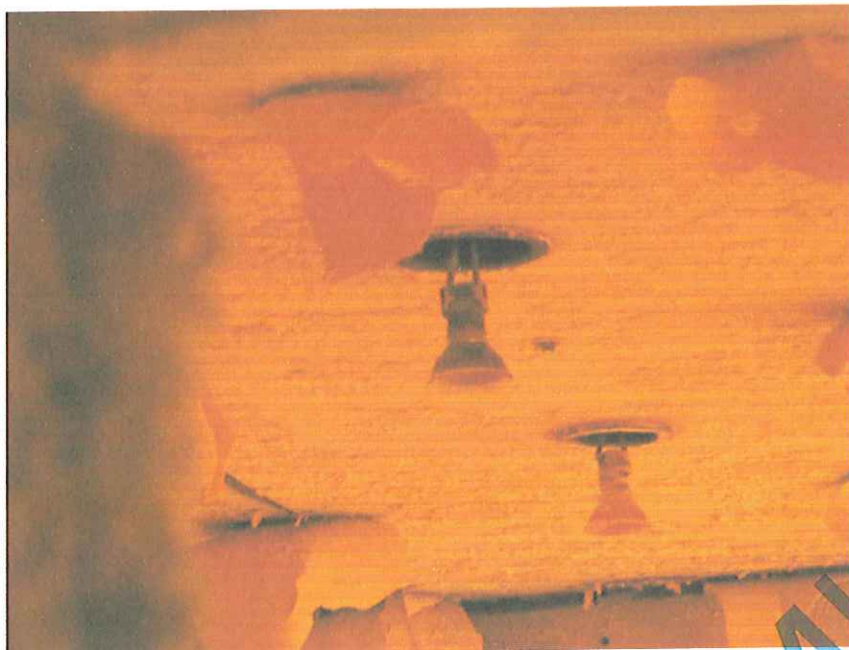
Photo 22

Photo 22: The exposed surface of the specimen after test duration of 26 minutes, showing the lamp cups of specimen fell out from the light can.

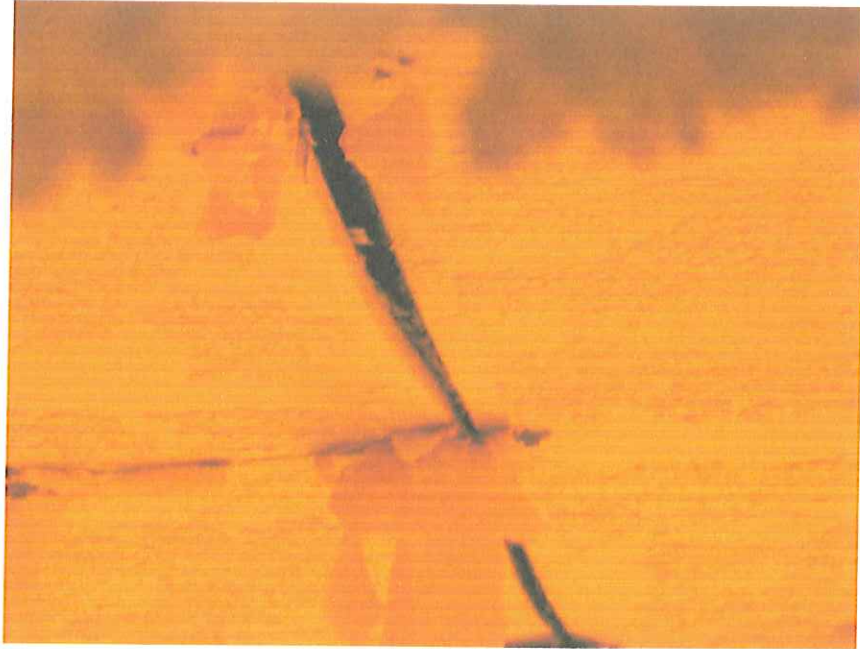
Photo 23

Photo 23: The exposed surface of the specimen after test duration of 29 minutes, the first layer plasterboard ceiling started to sag slightly and joints began to open.

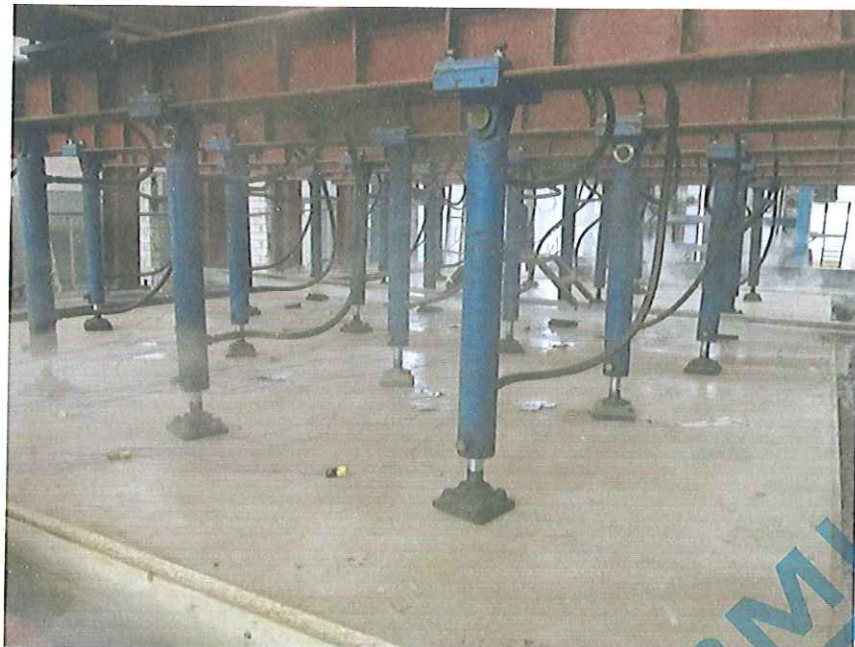
Photo 24

Photo 24: The unexposed surface of the specimen after test duration of 30 minutes.

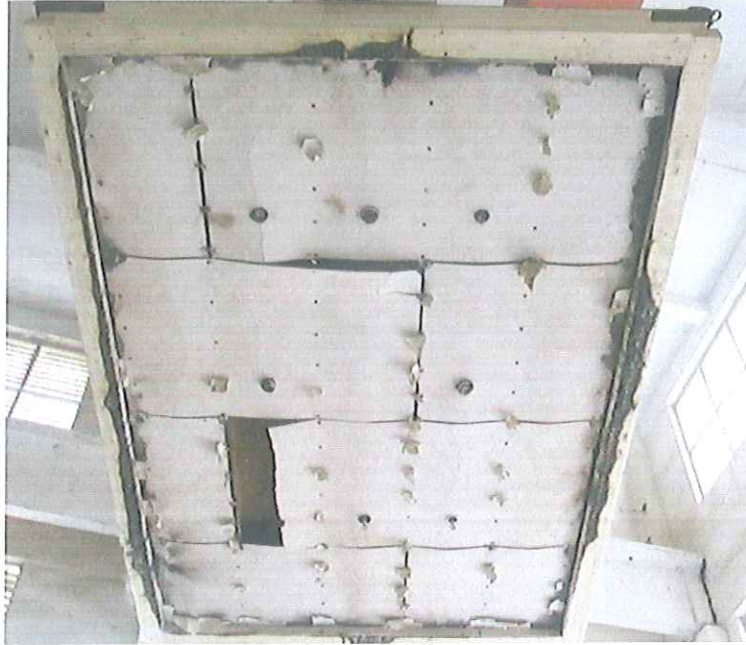
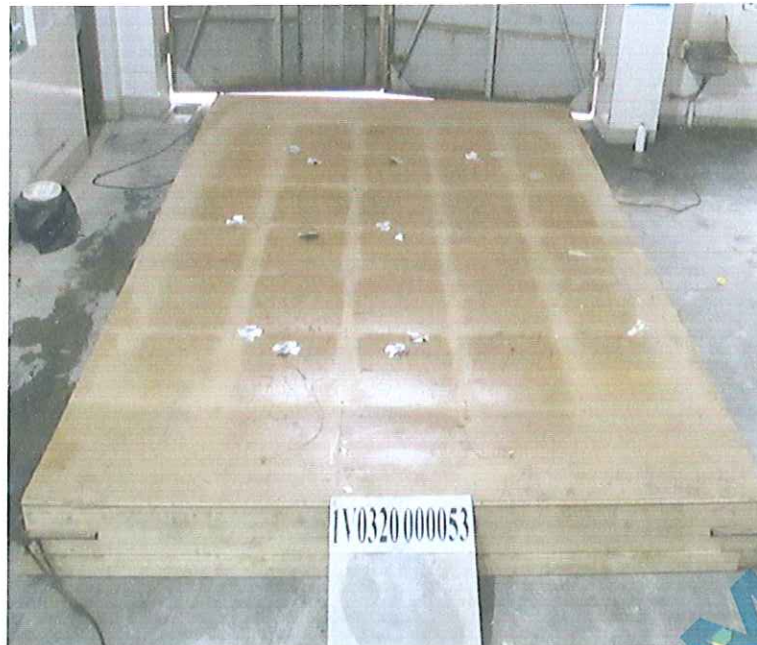
Photo 25: The exposed surface of the specimen after the test.
Photo 26: The unexposed surface of the specimen after the test.

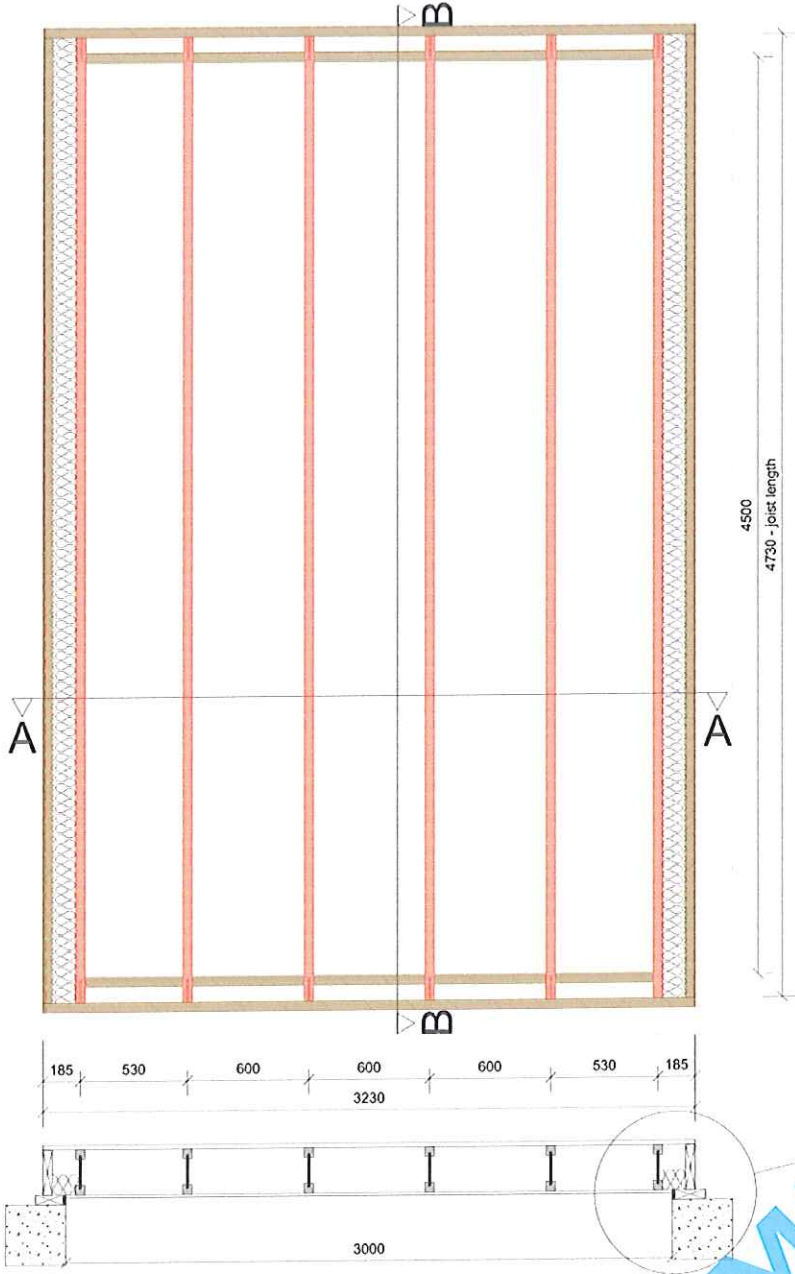
Figure 1 - Specimen Structural Drawing

Section A - A

The timber floor assembly had overall nominal dimensions of 4700 mm long by 3230 mm wide and comprised joists at 600mm centres. The depth of the each joist was 220mm. The upper surface of the floor comprised nominally 22mm thick P5 T&G Chipboard, and screwed fixed to the top chord of the joists. The floor assembly was protected on its underside by a direct fixed ceiling, formed from a single layer of 15mm thick Type A BG wallboard, the ceiling was screw fixed to the bottom chord of the floor joists.

<u>Item</u>	<u>Description</u>
1. Floor I-Joists	
Material	: 2 rectangular timber flanges and OSB web
Size	: 220mm High; Timber flanges: 47mmx47mm
Centres:	: 600 mm
2.Floorboards	
Material	: P5 T&G Chipboard
Thickness	: 22mm
Fixing method	: All board joints staggered with respect to adjacent layer and screw fixed to all joists
3.Ceiling boards	
Material	: 1 layer, Type A BG wallboard
Thickness	: 15mm
Fixing method	: All board fixed to joists with Drywall screws at max.230mm c/c. The joints between the boards were filled with joint filler with was also used to cover the heads of the screws. The perimeter joints between the floor construction and the supporting construction were filled with intumescent sealant.

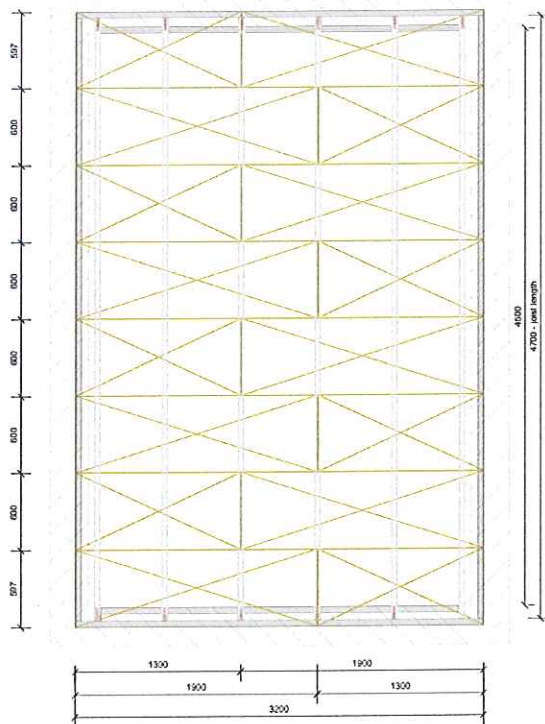
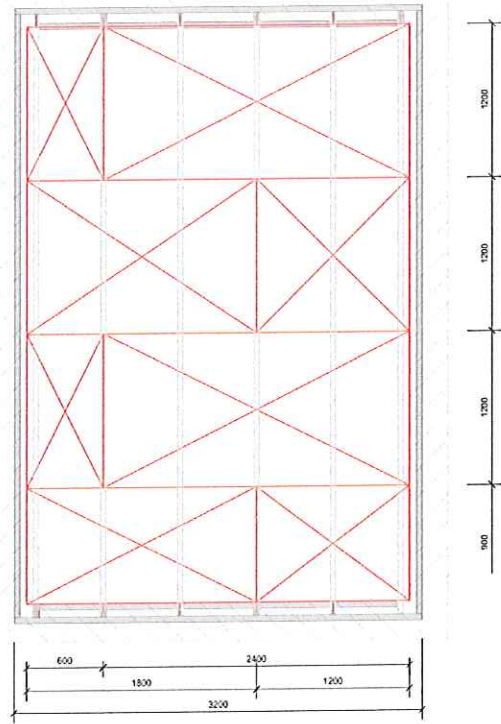
Figure 2 - Specimen Structural Drawing

Chipboard glued between tongue and groove, and to joists with D4 adhesive and fixed with 2.8Ø x 51mm long nails through tongues at max 600mm c/c generally, and at max. 300mm at perimeter.

Chipboard Layout

Plasterboard fixed to joists with 3.5Ø x 38mm Drywall screws at max. 230mm c/c. All joints filled only (no tape) using Gyproc joint filler and screw heads covered with filler.

Plasterboard Layout

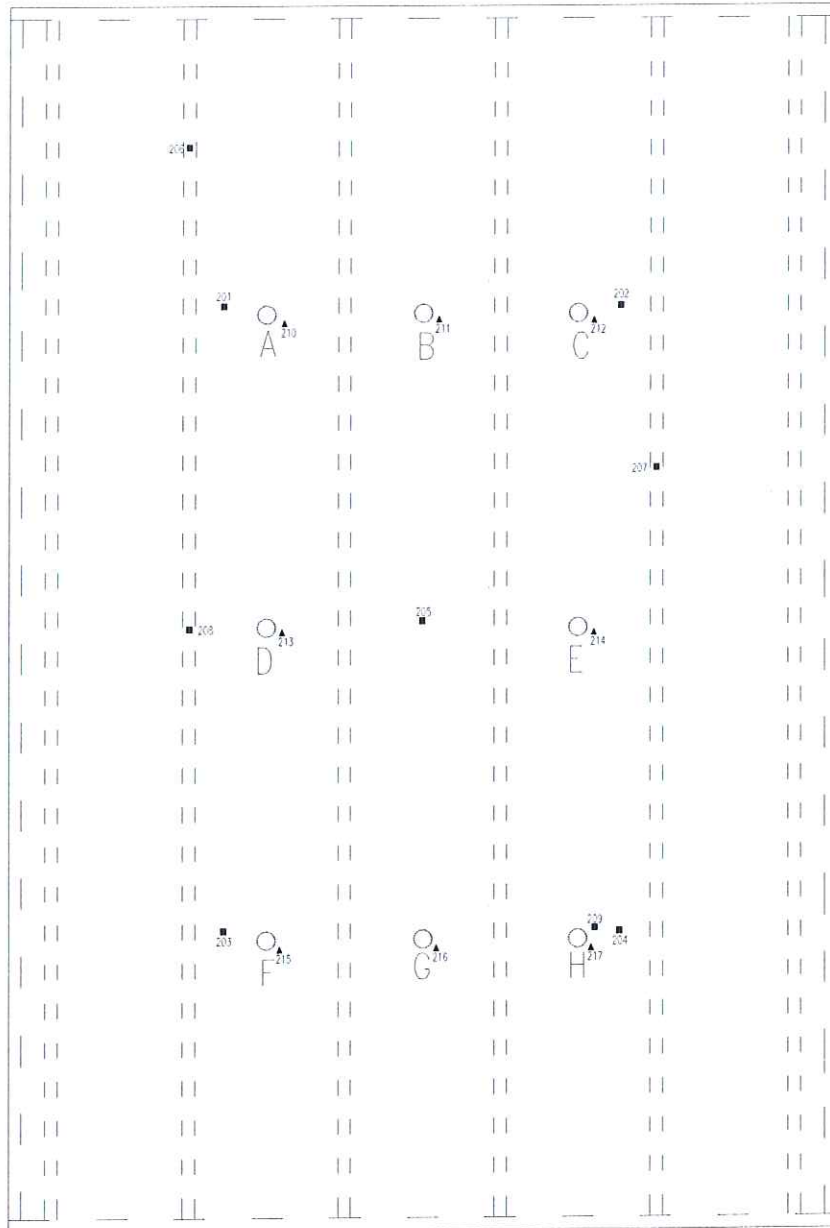
Figure 3 - Positions for Thermocouples Plan

Positions of thermocouples

- surface mounted thermocouples on upper surface of floorboards
- ▲ mineral insulated (MI) thermocouples at mid-cavity, adjacent to each downlight

GENERAL PLAN
Down light specimens 'A' to 'H'

Thermocouples were provided to monitor the unexposed surface of the floor assembly and the output of all instrumentation was recorded at no less than one minute intervals. The locations and reference numbers of the various unexposed surface and internal thermocouples are shown in Figure 3.
