FLOOR ASSEMBLY FIRE TEST REPORT

Sponsor: JCC LIGHTING PRODUCTS

Test Method: BS 476-21:1987, BS 476-20:1987

Test Report No. V03-20000293(E)

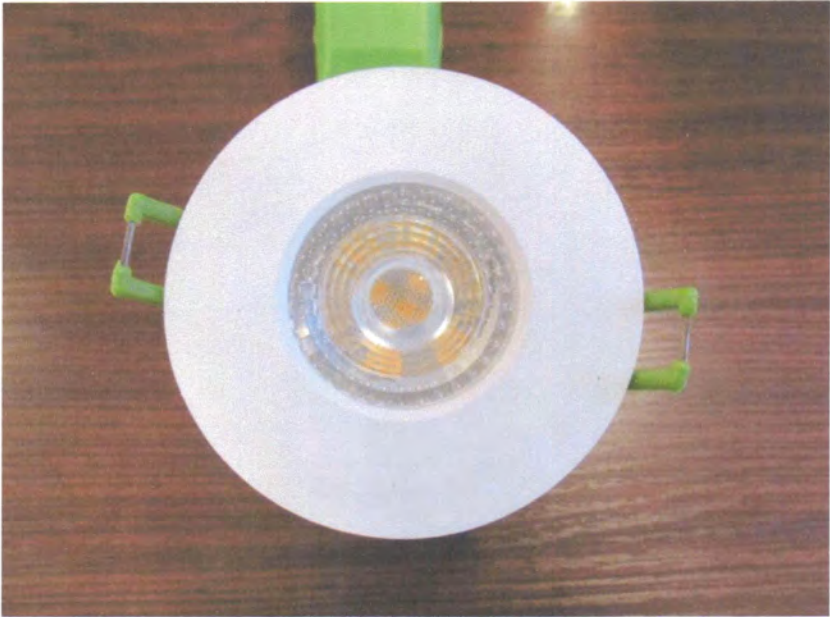
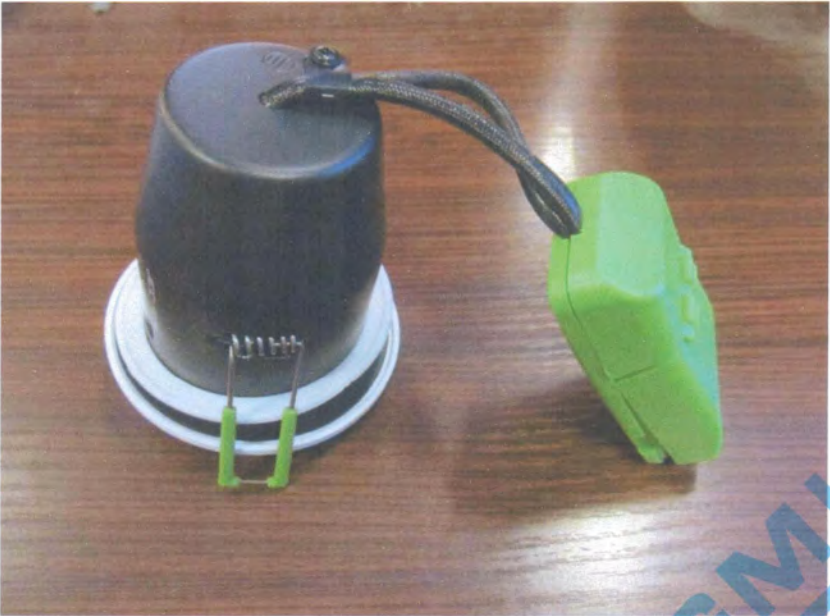
Photo 1: Front view of specimen 'A'
Photo 2: Side view of specimen 'A'

Product Name : Fire Guard
Type No. : JC010010 WH / CH / BN / BLK
Manufacturer : JCC Lighting
Reference : JC010010 Fireguard Fixed Downlight
Type : Recessed Downlight
Overall dimensions and construction : 94mm (H) x 87mm (⌀) , See figure 4
Hole size in ceiling boards : 72mm ⌀
Materials :
i: Casing: Mild Steel
ii: Cover: White/Chrome/Brushed Nickel
iii: Spring clip: Steel
iv: Connection block: Polycarbonate Housing
Approx. weight: 0.202 Kg
Details of fireproof material :
i: Manufacturer: JCC lighting Products
ii: Type: Mild Steel 'Can'
iii: Thickness: 0.8mm

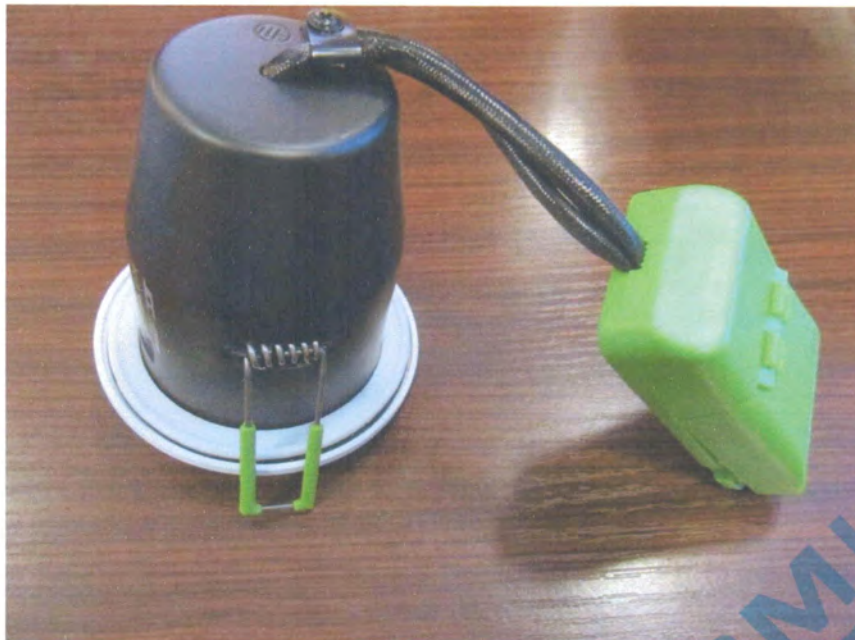
Photo 3: Front view of specimen 'B'

Photo 4: Side view of specimen 'B'

Product Name	: Fire Guard
Type No.	: JC010010 WH / CH / BN / BLK
Manufacturer	: JCC Lighting
Reference	: JC010010 Fireguard Fixed Downlight
Type	: Recessed Downlight
Overall dimensions and construction	: 94mm (H) x 87mm (∅) , See figure 5
Hole size in ceiling boards	: 72mm ∅
Materials	i: Casing: Mild Steel ii: Cover: White/Chrome/Brushed Nickel iii: Spring clip: Steel iv: Connection block: Polycarbonate Housing Approx. weight: 0.202 Kg
Details of fireproof material	i: Manufacturer: JCC lighting Products ii: Type: Mild Steel 'Can' iii: Thickness: 0.8mm

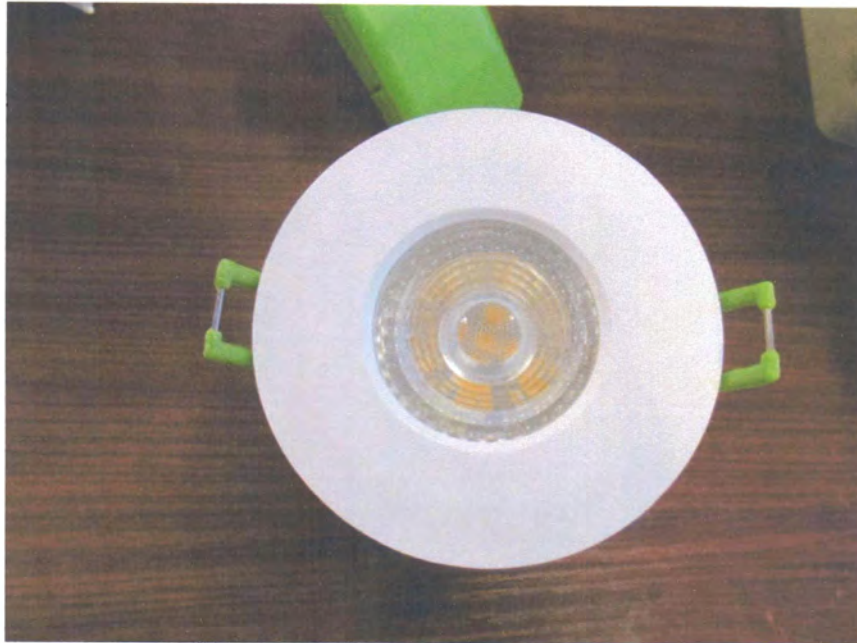
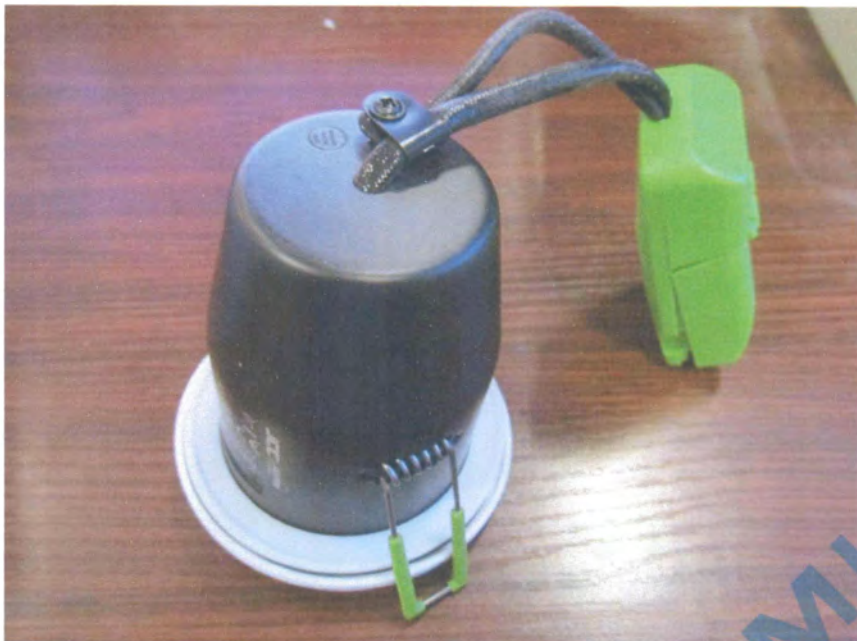
Photo 5: Front view of specimen 'C'

Photo 6: Side view of specimen 'C'

Product Name	: Fire Guard
Type No.	: JC010016 WH / CH / BN / BLK
Manufacturer	: JCC Lighting
Reference	: JC010016 Fireguard IP65 Downlight
Type	: Recessed Downlight
Overall dimensions and construction	: 94mm (H) x 87mm (∅) , See figure 6
Hole size in ceiling boards	: 72mm ∅
Materials	i: Casing: Mild Steel ii: Cover: White/Chrome/Brushed Nickel iii: Spring clip: Steel iv: Connection block: Polycarbonate Housing Approx. weight: 0.217 Kg
Details of fireproof material	i: Manufacturer: JCC lighting Products ii: Type: Mild Steel 'Can'

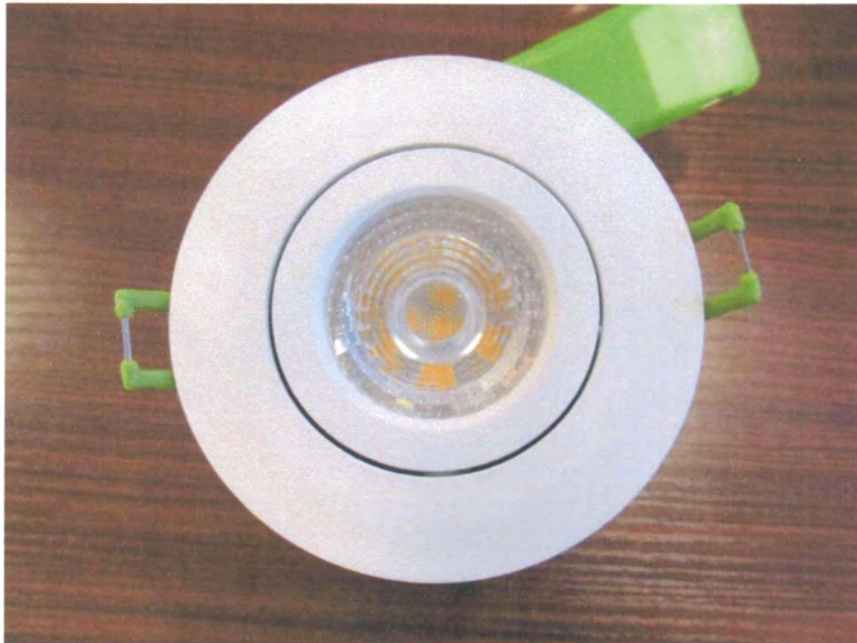
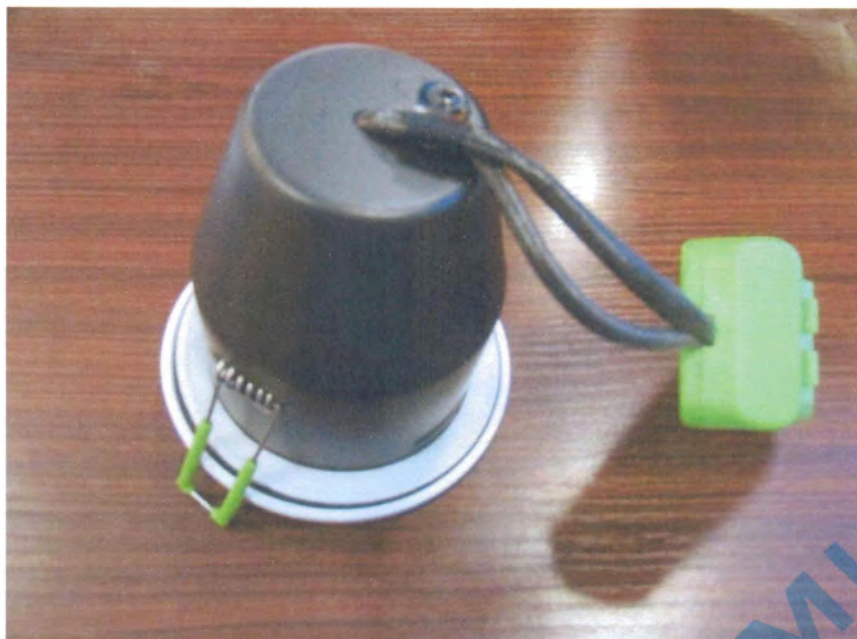
Photo 7: Front view of specimen 'D'

Photo 8: Side view of specimen 'D'

Product Name : Fire Guard
Type No. : JC010023 WH / CH / BN / BLK
Manufacturer : JCC Lighting
Reference : JC010023 Fireguard Tilt Downlight
Type : Recessed Downlight
Overall dimensions and construction : 101mm (H) x 100mm (∅) , See figure 7
Hole size in ceiling boards : 84mm ∅
Materials :
i: Casing: Mild Steel
ii: Cover: White/Chrome/Brushed Nickel
iii: Spring clip: Steel
iv: Connection block: Polycarbonate Housing
Approx. weight: 0.261 Kg
Details of fireproof material :
i: Manufacturer: JCC lighting Products
ii: Type: Mild Steel 'Can'
iii: Thickness: 0.8mm

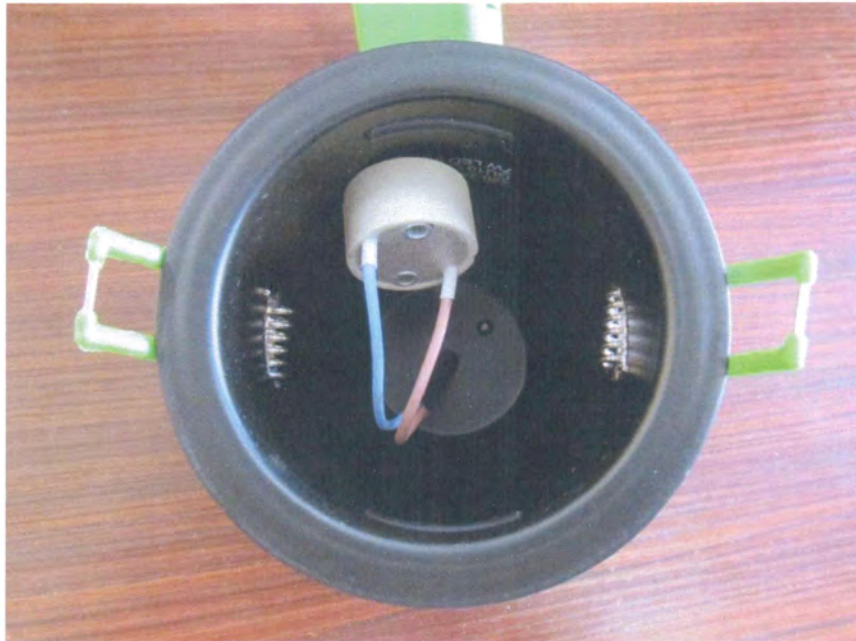
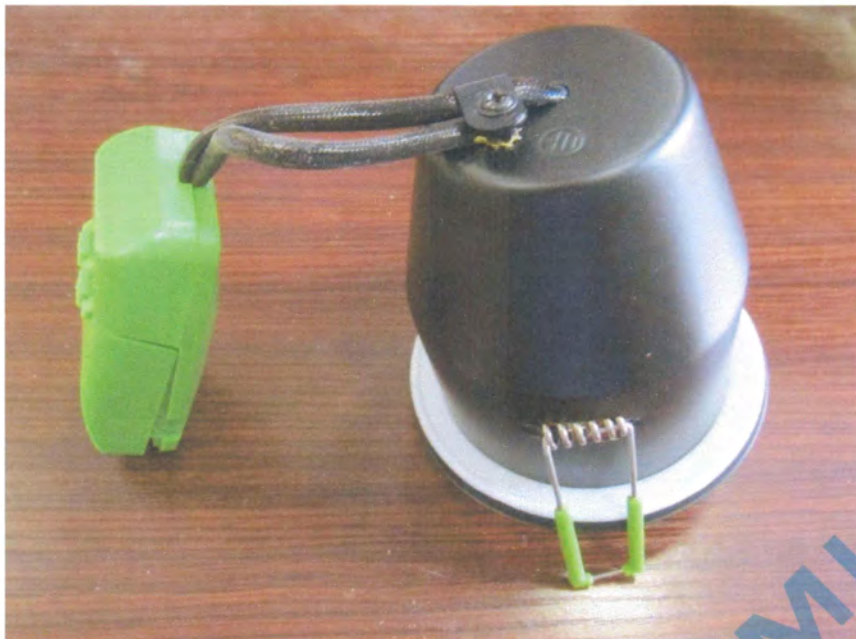
Photo 19: Front view of specimen 'E'

Photo 10: Side view of specimen 'E'

Product Name : Fire Guard
Type No. : JC010023/NB
Manufacturer : JCC Lighting
Reference : JC010023NB Fireguard Tilt Downlight without bezel
Type : Recessed Downlight
Overall dimensions and construction : 98mm (H) x 94mm (∅) , See figure 8
Hole size in ceiling boards : 84mm ∅
Materials :
i: Casing: Mild Steel
ii: Spring clip: Steel
iii: Connection block: Polycarbonate Housing
Approx. weight: 0.194 Kg
Details of fireproof material :
i: Manufacturer: JCC lighting Products

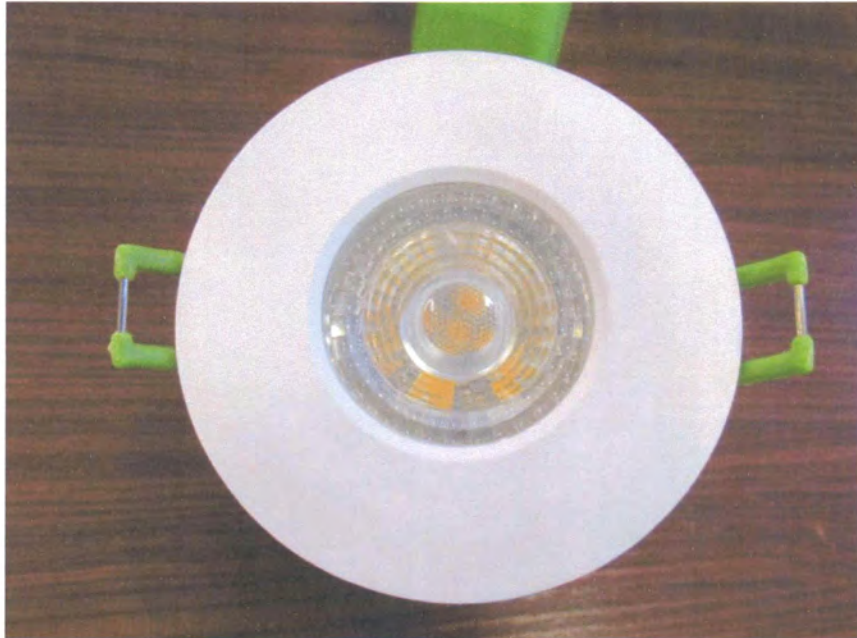
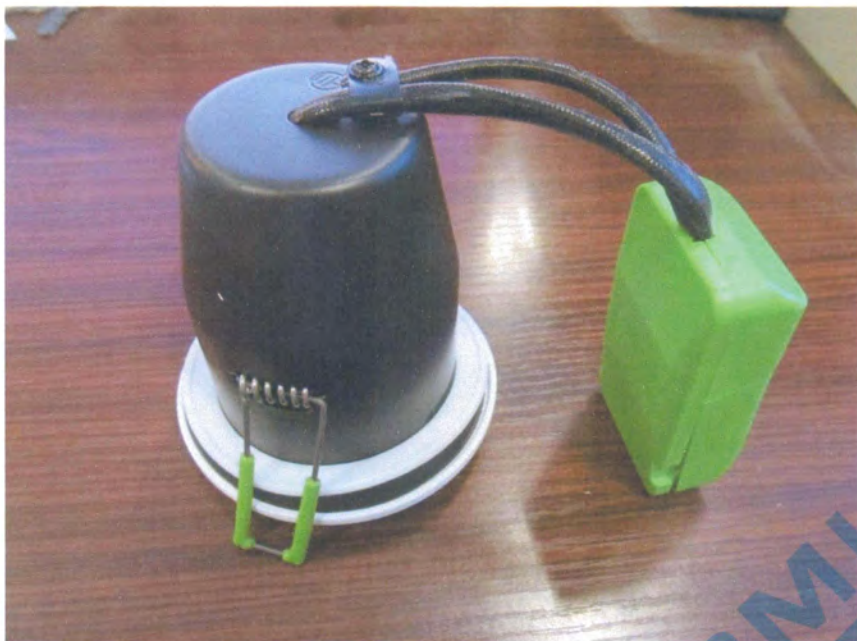
Photo 11: Front view of specimen 'F'
Photo 12: Side view of specimen 'F'

Product Name	: Fire Guard
Type No.	: JC010016 WH / CH / BN / BLK
Manufacturer	: JCC Lighting
Reference	: JC010016 Fireguard IP65 Downlight
Type	: Recessed Downlight
Overall dimensions and construction	: 94mm (H) x 87mm (∅) , See figure 9
Hole size in ceiling boards	: 72mm ∅
Materials	i: Casing: Mild Steel ii: Cover: White/Chrome/Brushed Nickel iii: Spring clip: Steel iv: Connection block: Polycarbonate Housing Approx. weight: 0.217 Kg
Details of fireproof material	i: Manufacturer: JCC lighting Products ii: Type: Mild Steel 'Can' iii: Thickness: 0.8mm

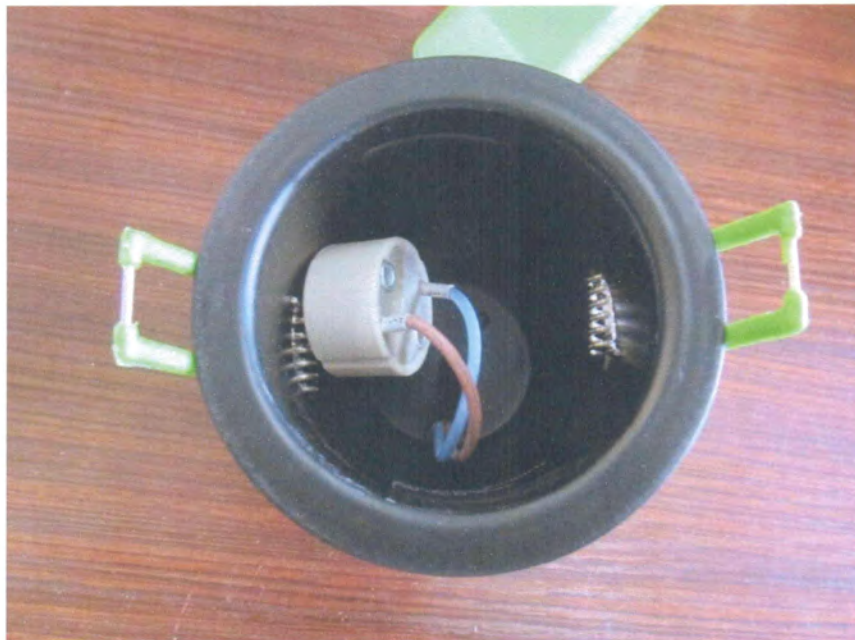
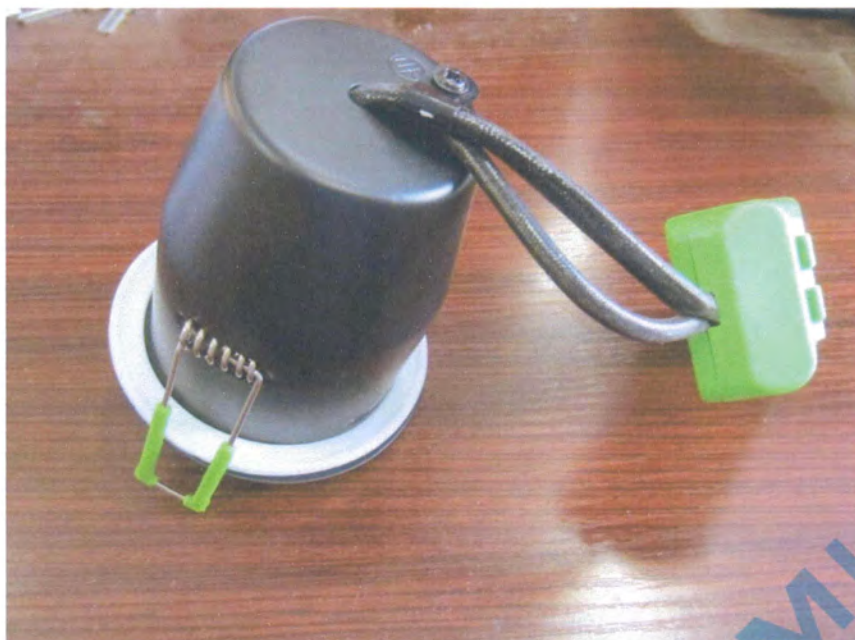
Photo 13: Front view of specimen 'G'

Photo 14: Side view of specimen 'G'

Product Name	: Fire Guard
Type No.	: JC010010/NB
Manufacturer	: JCC Lighting
Reference	: JC010010NB Fireguard Fixed Downlight without bezel
Type	: Recessed Downlight
Overall dimensions and construction	: 92mm (H) x 81mm (∅) , See figure 10
Hole size in ceiling boards	: 72mm ∅
Materials	i: Casing: Mild Steel ii: Cover: White/Chrome/Brushed Nickel iii: Spring clip: Steel iv: Connection block: Polycarbonate Housing

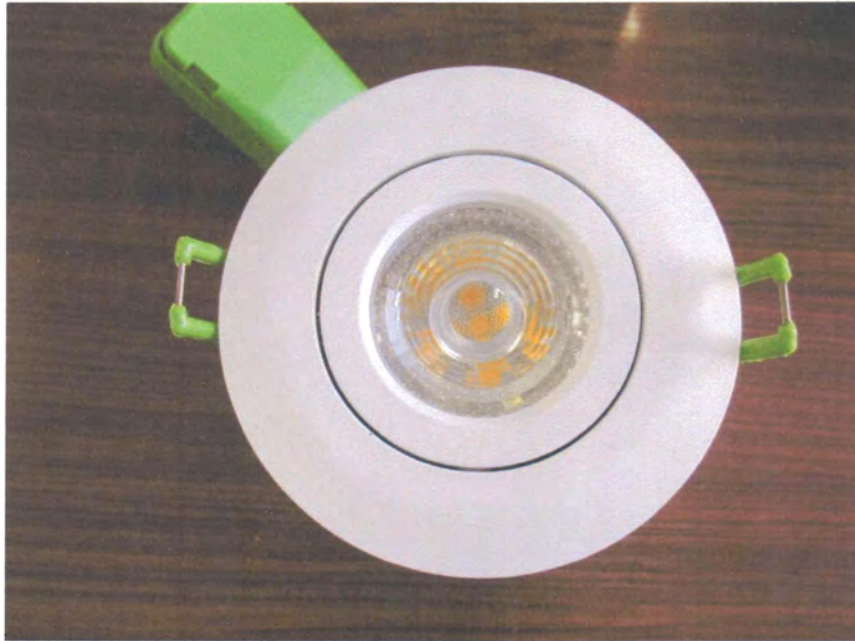
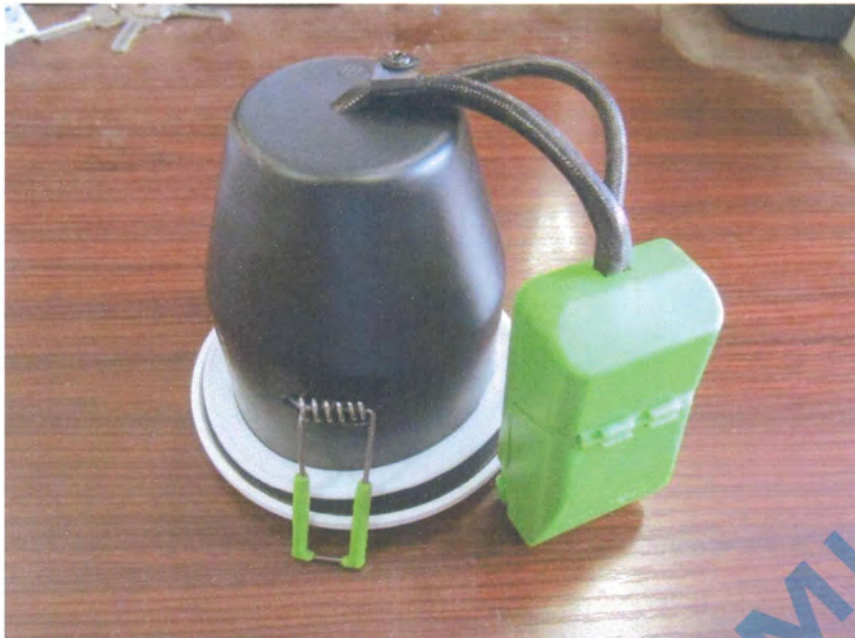
Photo 15: Front view of specimen 'H'

Photo 16: Side view of specimen 'H'

Product Name : Fire Guard
Type No. : JC010023 WH / CH / BN / BLK
Manufacturer : JCC Lighting
Reference : JC010023 Fireguard Tilt Downlight
Type : Recessed Downlight
Overall dimensions and construction : 101mm (H) x 100mm (∅) , See figure 11
Hole size in ceiling boards : 84mm ∅
Materials
i: Casing: Mild Steel
ii: Cover: White/Chrome/Brushed Nickel
iii: Spring clip: Steel
iv: Connection block: Polycarbonate Housing
Approx. weight: 0.261 Kg
Details of fireproof material
i: Manufacturer: JCC lighting Products
ii: Type: Mild Steel 'Can'
iii: Thickness: 0.8mm

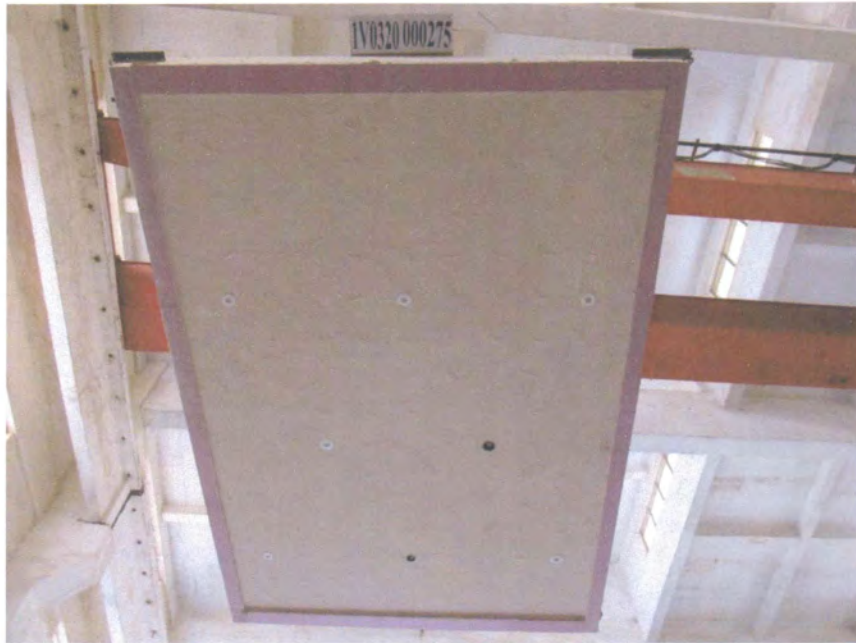
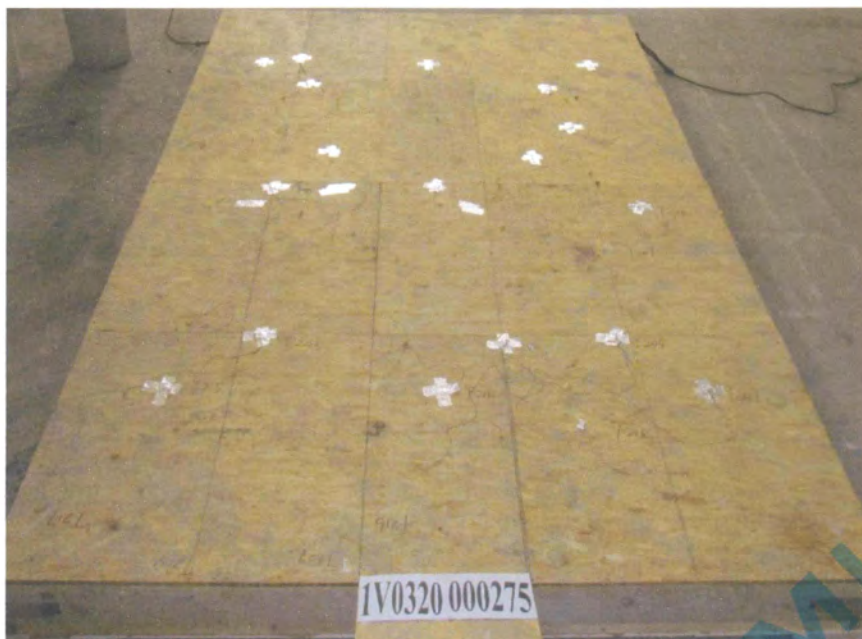
Photo 17: The exposed surface of the specimen before the test
Photo 18: The unexposed surface of the specimen before the test.

Thermocouples were provided to monitor the unexposed surface of the floor assembly and the output of all instrumentation was recorded at no less than one minute intervals. The locations and reference numbers of the various unexposed surface and internal thermocouples are shown in Photo 18.

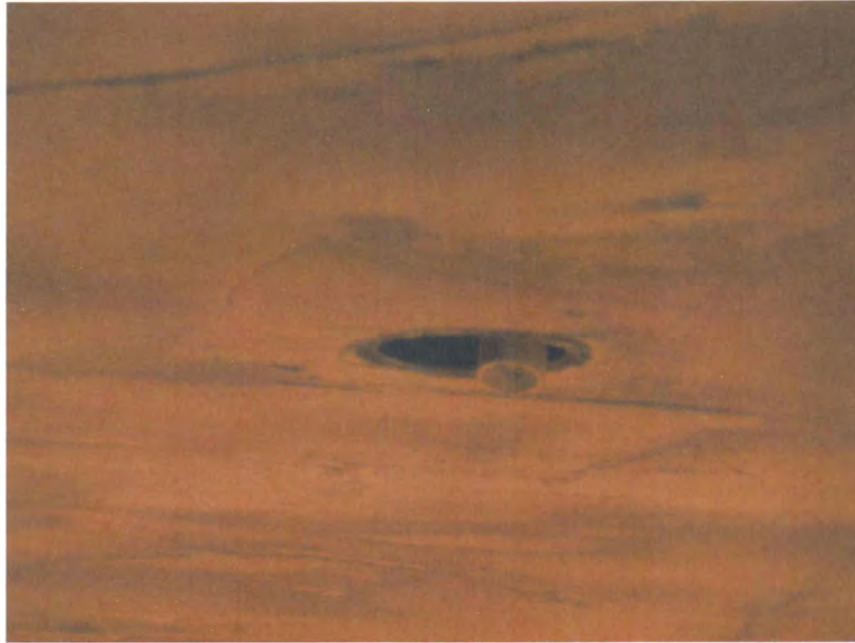
Photo 19

Photo 19: The exposed surface of the specimen after test duration of 4 minutes, showing the lamb cup of specimen 'F' fell out from the light can.

Time (min)	Observation (All observations are from the exposed face unless noted otherwise)
0	Test started.
4	The lamb cup of the specimen 'F' fell out from the light can.
5	The lens of most specimen fused already.
9	The lamb cup of the specimen 'B' fell out from the light can.
12	The lamb cup of the specimen 'C' fell out from the light can.
15	Coating of the plasterboard ceiling fell away.
16	The lamb cup of the specimen 'H' fell out from the light can.
22	The lamb cup of the specimen 'G' fell out from the light can.
29	Smoke released from perimeter of the specimen.
47	The first layer plasterboard ceiling started to sag slightly and joints began to open.
52	Part of first layer plasterboard ceiling fell into the furnace.
60	White smoke released from the joints of floorboards at the unexposed surface of the specimen.
68	Most of the first layer of plasterboard ceiling fell away.
70	The second layer plasterboard ceiling started to sag and joints began to open.

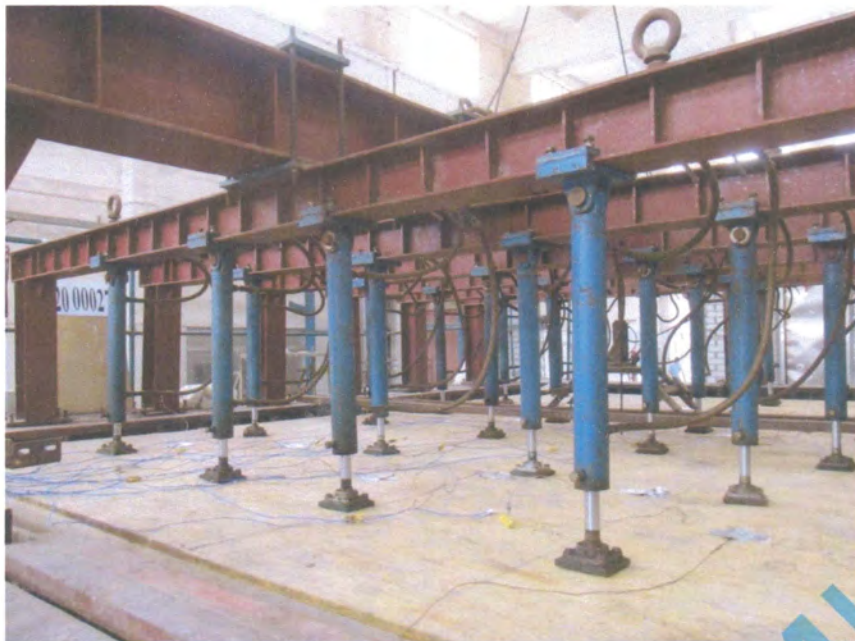
Photo 20

Photo 20: The unexposed surface of the specimen after test duration of 15 minutes.

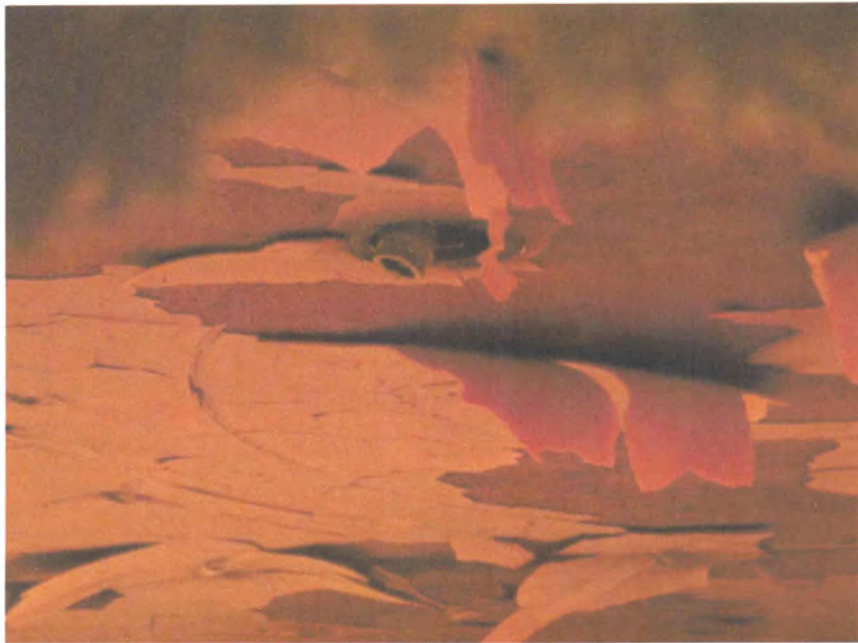
Photo 21

Photo 21: The exposed surface of the specimen after test duration of 16 minutes, showing the lamb cup of specimen 'H' fell out from the light can.

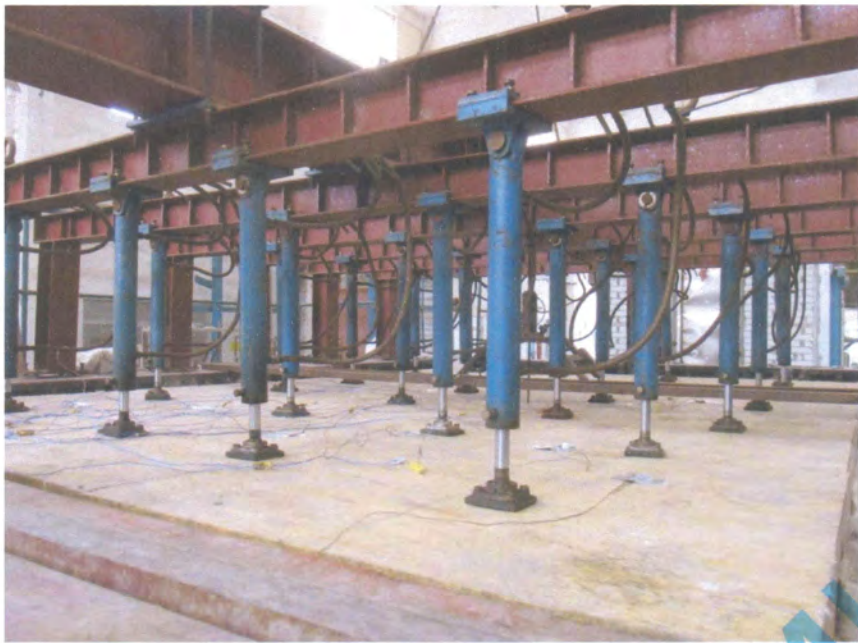
Photo 22

Photo 22: The unexposed surface of the specimen after test duration of 30 minutes.

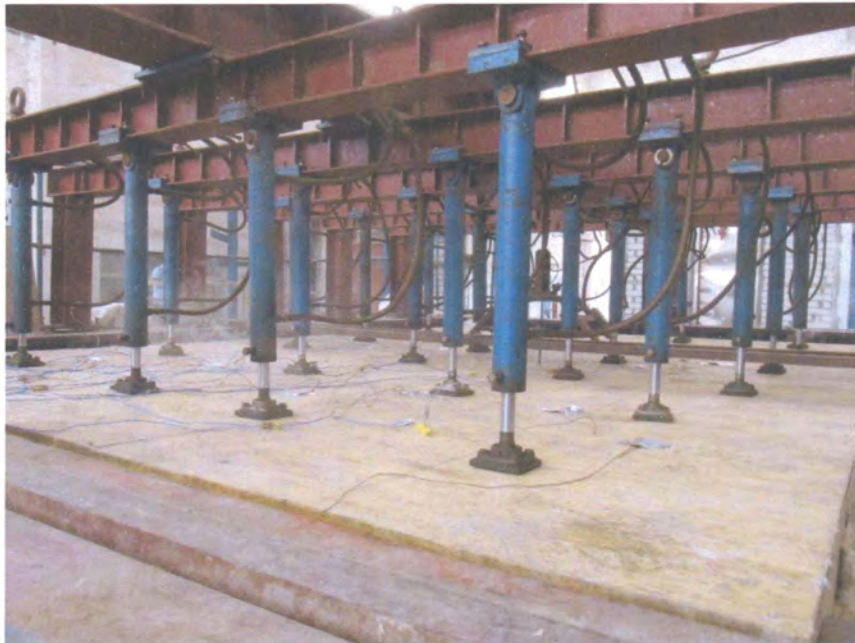
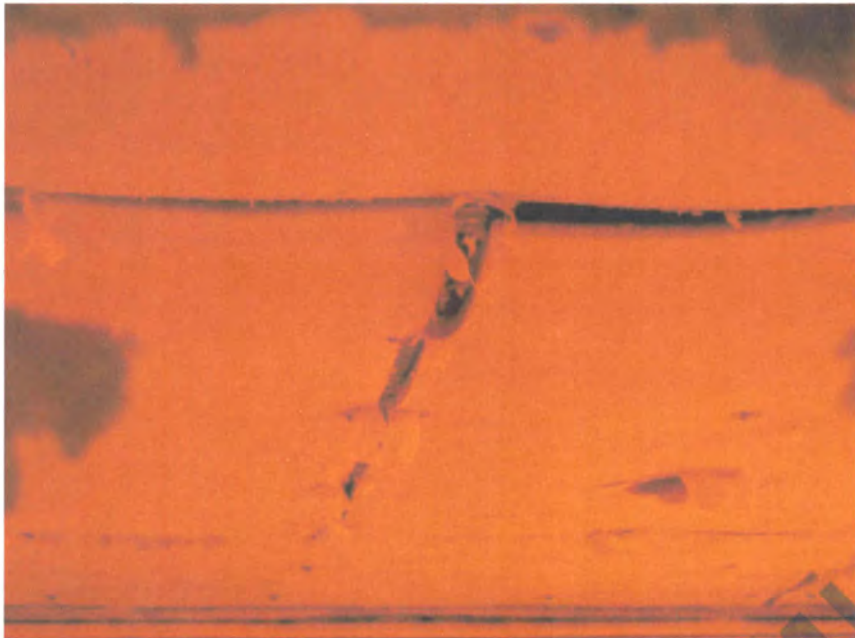
Photo 23: The unexposed surface of the specimen after test duration of 45 minutes.
Photo 24: The exposed surface of the specimen after test duration of 47 minutes, showing the first layer plasterboard ceiling started to sag slightly and joints began to open.

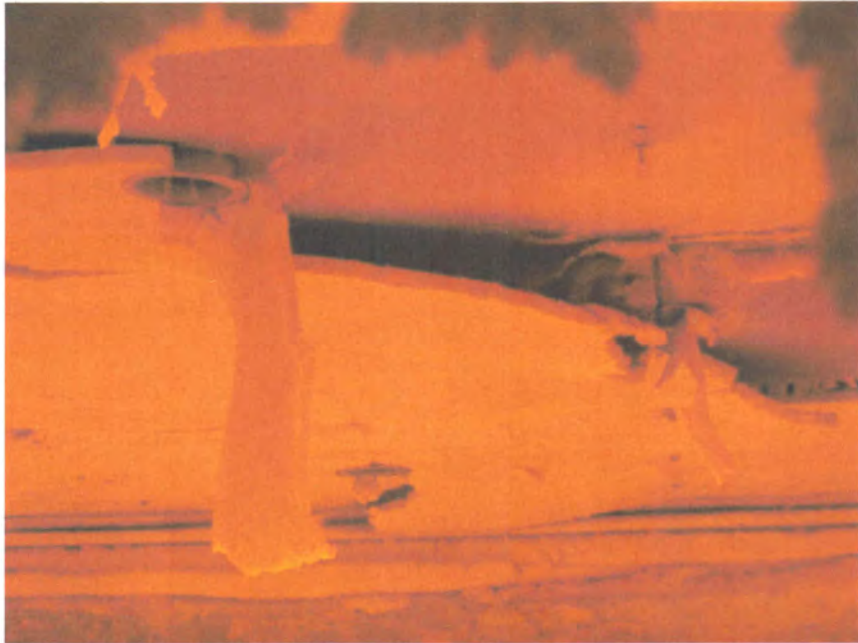
Photo 25

Photo 25: The exposed surface of the specimen after test duration of 52 minutes, showing part of first layer plasterboard ceiling fell into furnace already.

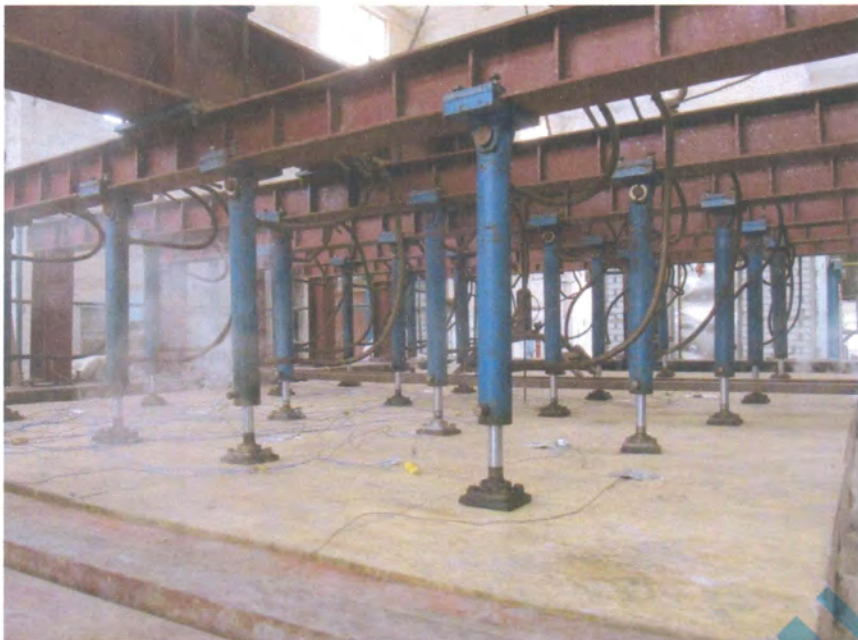
Photo 26

Photo 26: The unexposed surface of the specimen after test duration of 60 minutes.

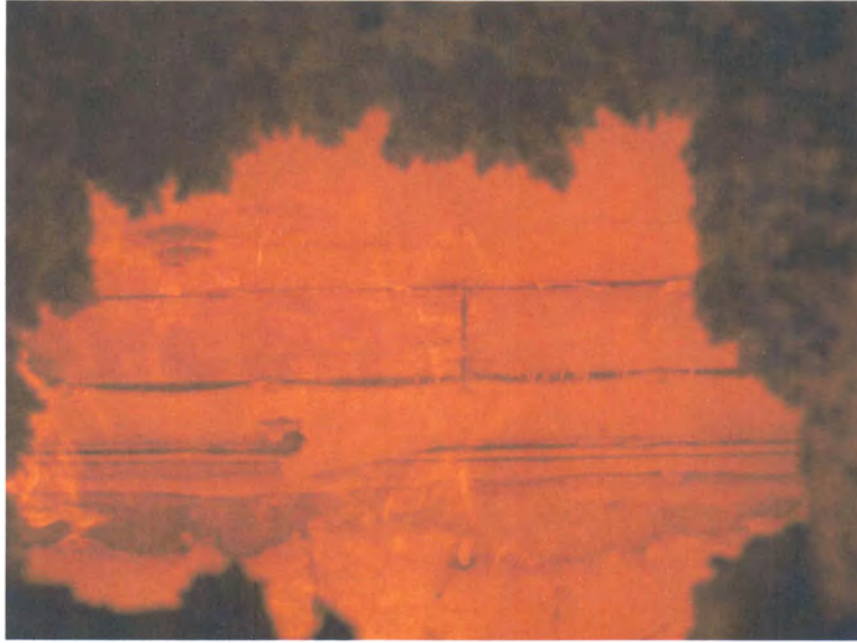
Photo 27

Photo 27: The exposed surface of the specimen after test duration of 68 minutes, showing most of the first layer plasterboard ceiling fell into furnace.

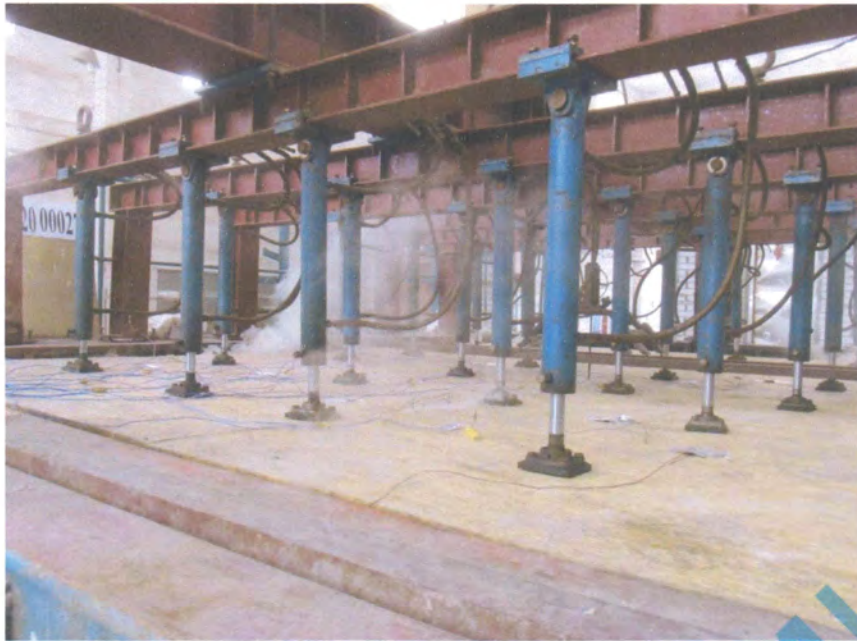
Photo 28

Photo 28: The unexposed surface of the specimen after test duration of 75 minutes.

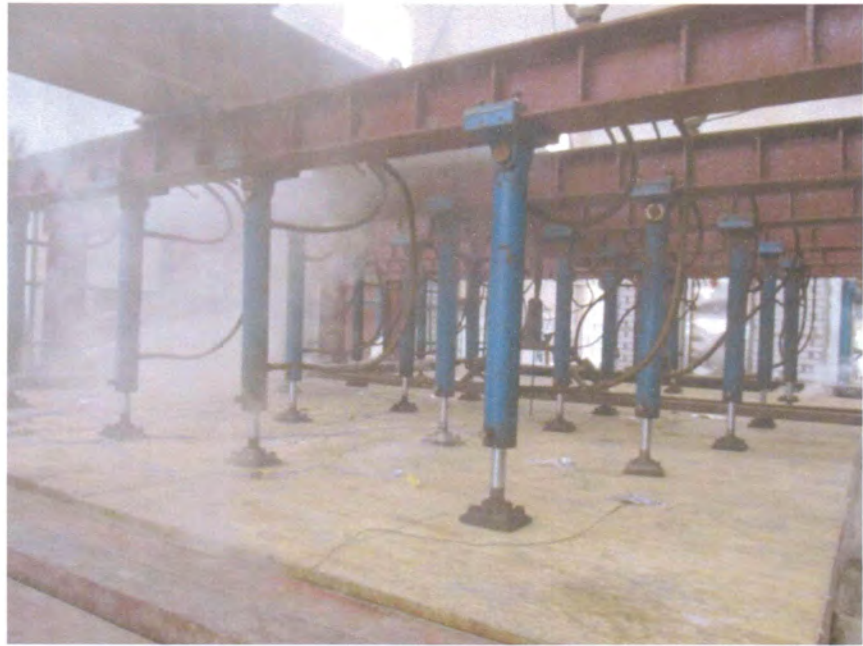
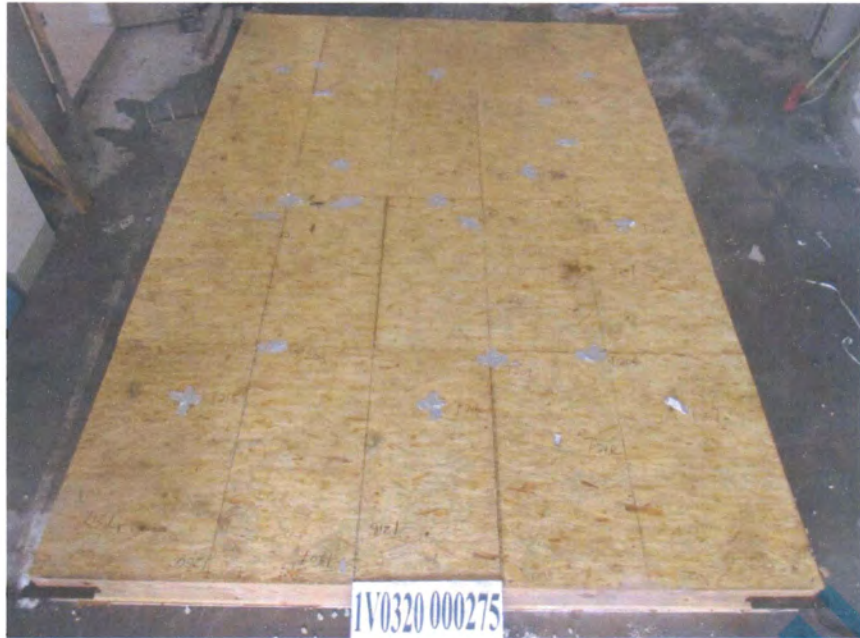
Photo 29: The unexposed surface of the specimen after test duration of 90 minutes.
Photo 30: The unexposed surface of the specimen after the test.

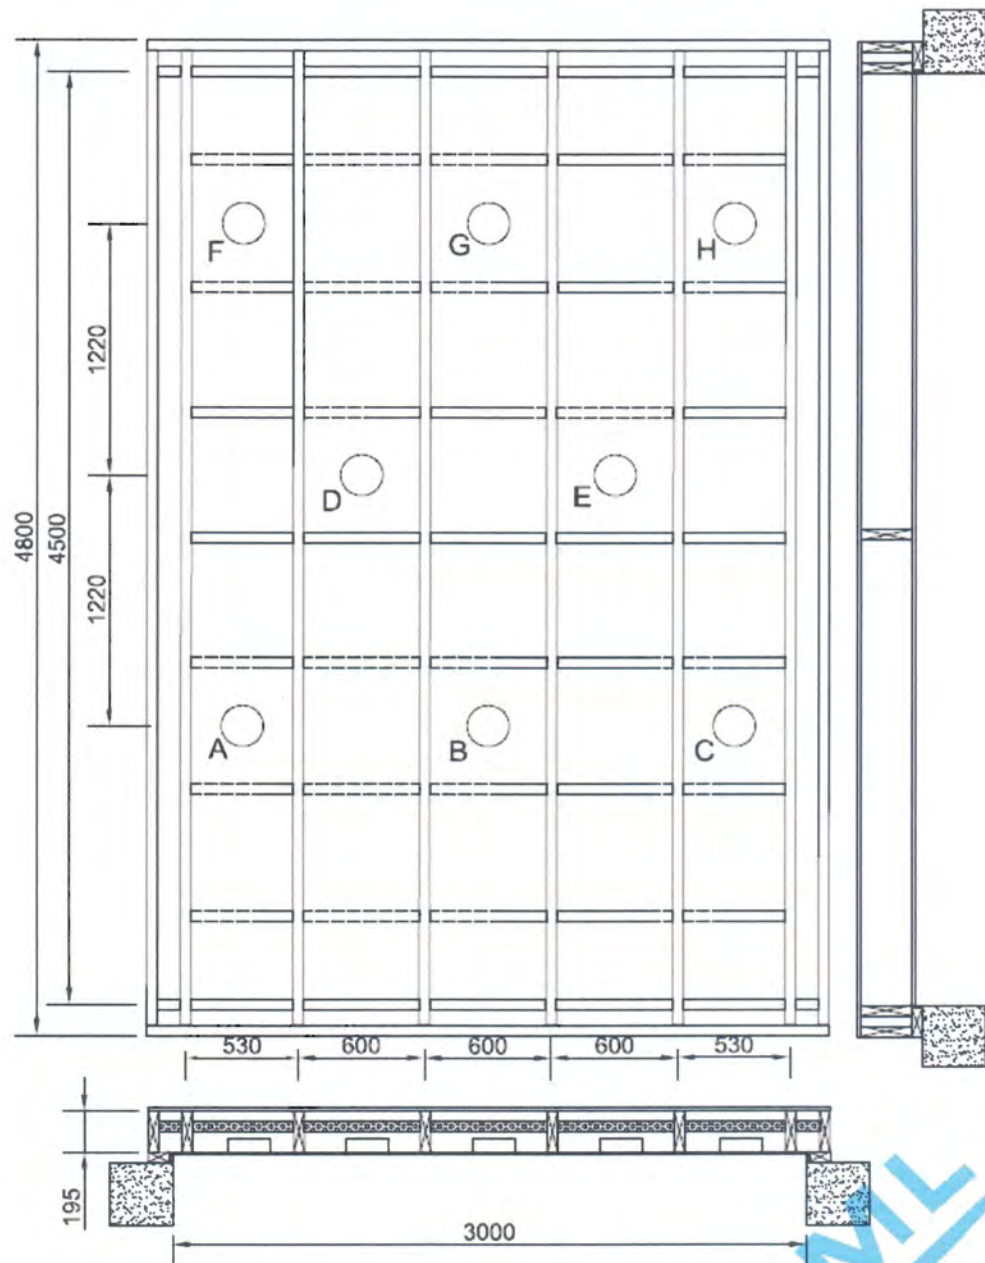
Figure 1 - Specimen Structural Drawing

Timber Joist Layout

The timber floor assembly had overall nominal dimensions of 4800 mm long by 3230 mm wide and comprised joists at 600mm centres. The depth of the solid timber joist was 195mm. The upper surface of the floor comprised nominally 18mm thick OSB board, and screwed fixed to the upside of the floor joists. The floor assembly was protected on its underside by a direct fixed ceiling, formed from two layers of 15mm thick fire shield plaster boards, the ceiling was screw fixed to the underside of the floor joists.

<u>Item</u>	<u>Description</u>
1. Floor Joists	
Material	: Solid Timber Joist, softwood
Size	: 195mm deep, 45mm thick
Centres:	: 600 mm
2.Floorboards	
Material	: OSB board
Thickness	: 18mm
Fixing method	: All board joints staggered with respect to adjacent layer and screw fixed to all joists
3.Ceiling boards	
Material	: Fire shield Gypsum plasterboard
Thickness	: 2 layer, 15mm thick
Fixing method	: All board fixed to joists with Drywall screws at max.230mm c/c. The joints between the boards were filled with joint filler with was also used to cover the heads of the screws.
4.Rockwool	
Manufacturer	: ROCKWOOL
Thickness	: 50mm

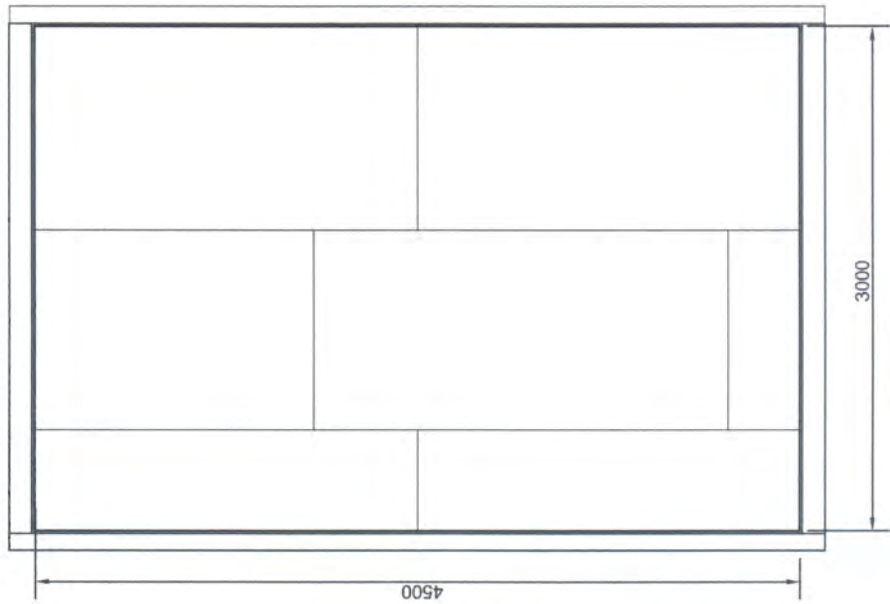
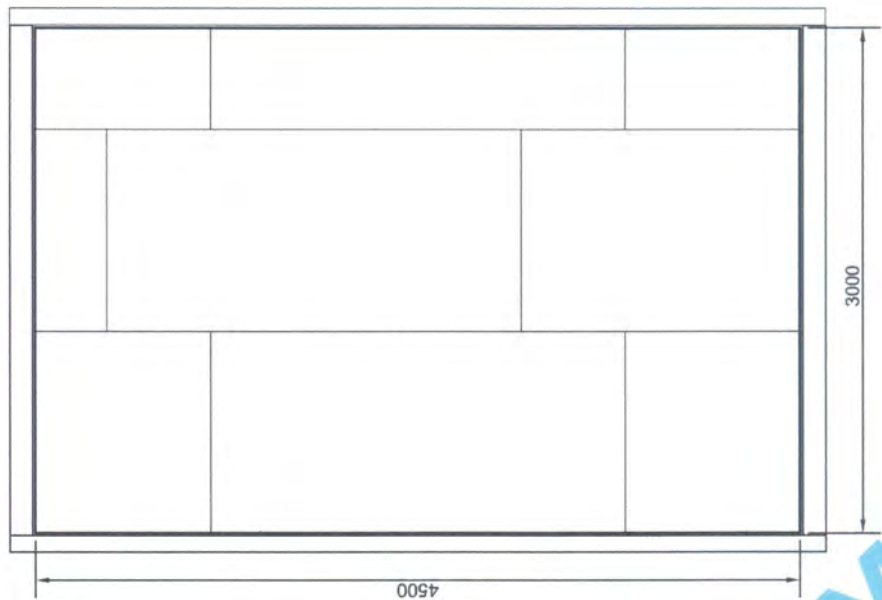
Figure 2 - Specimen Structural Drawing

2st Layer
Plasterboard Layout

1st Layer
Plasterboard Layout

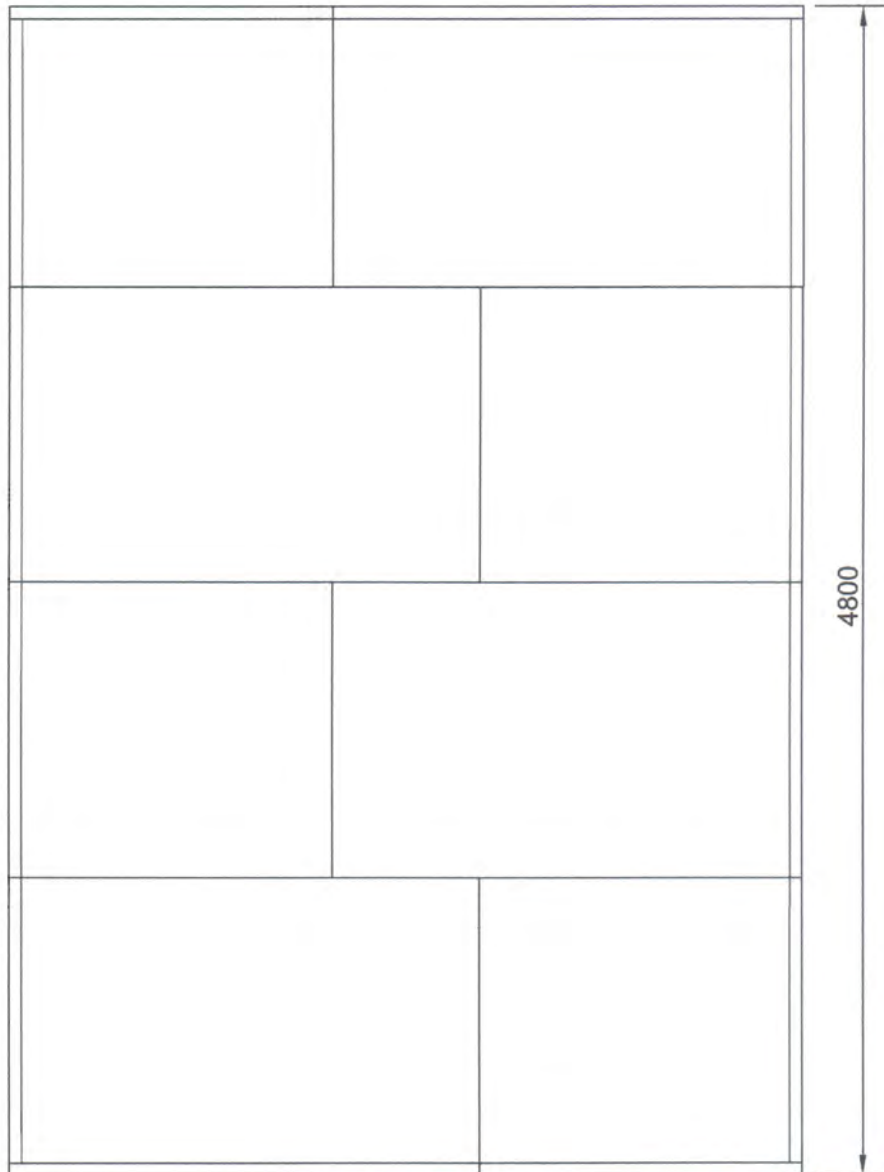
Figure 3 - Specimen Structural Drawing

Chipboard Layout

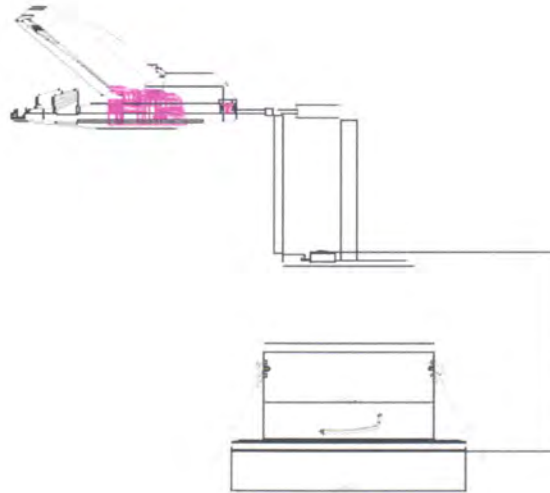
Figure 4 – Details of specimen 'A'

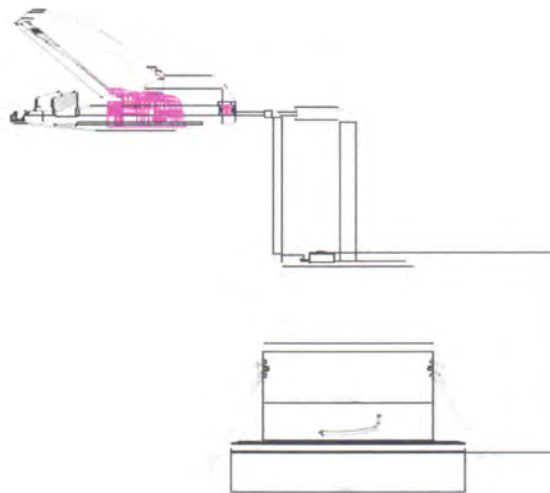
Figure 5 –Details of specimen 'B'

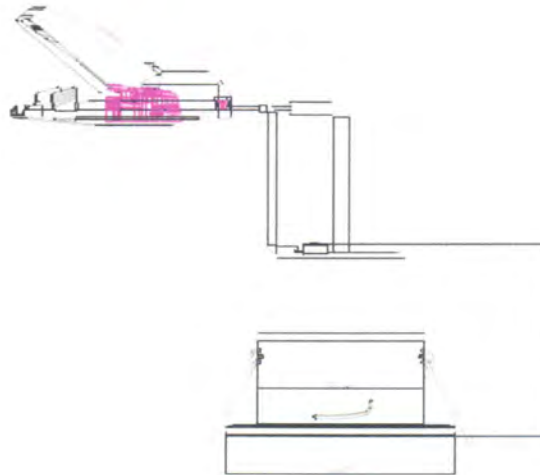
Figure 6 –Details of specimen 'C'

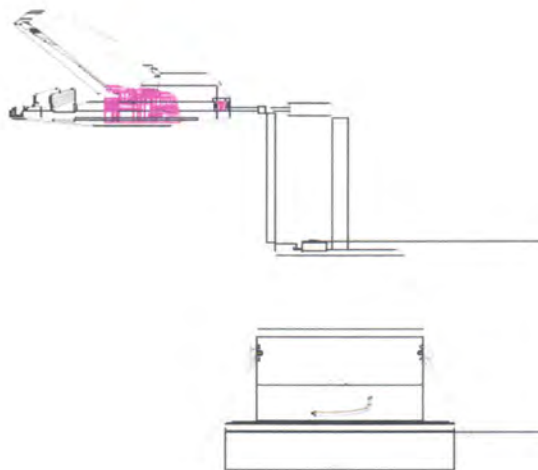
Figure 7 –Details of specimen 'D'
