FLOOR ASSEMBLY FIRE TEST REPORT

Sponsor: JCC LIGHTING PRODUCTS

Test Method: BS 476-21:1987, BS 476-20:1987

Test Report No. V03-20000293(E)

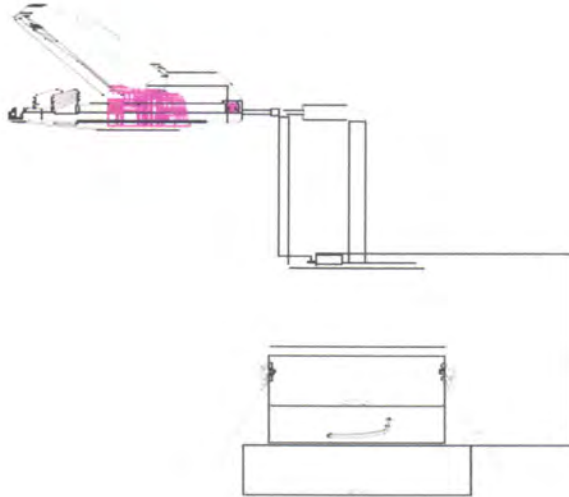
Figure 8 –Details of specimen 'E'

Product Name : Fire Guard
Type No. : JC010023/NB
Manufacturer : JCC Lighting
Reference : JC010023NB Fireguard Tilt Downlight without bezel
Type : Recessed Downlight
Overall dimensions and construction : 98mm (H) x 94mm (∅) , See figure 8
Hole size in ceiling boards : 84mm ∅
Materials :
i: Casing: Mild Steel
ii: Spring clip: Steel
iii: Connection block: Polycarbonate Housing
Approx. weight: 0.194 Kg
Details of fireproof material :
i: Manufacturer: JCC lighting Products

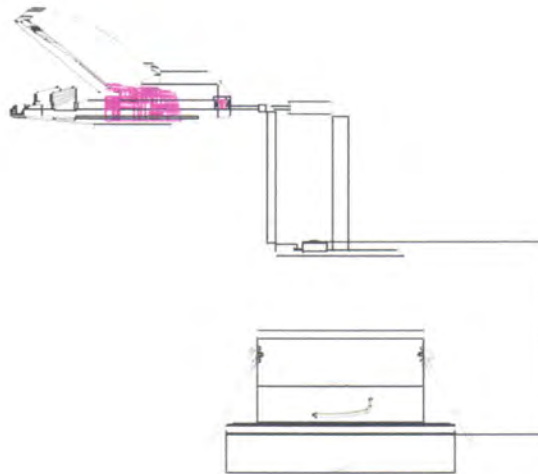
Figure 9 –Details of specimen 'F'

Product Name	: Fire Guard
Type No.	: JC010016 WH / CH / BN / BLK
Manufacturer	: JCC Lighting
Reference	: JC010016 Fireguard IP65 Downlight
Type	: Recessed Downlight
Overall dimensions and construction	: 94mm (H) x 87mm (∅) , See figure 9
Hole size in ceiling boards	: 72mm ∅
Materials	i: Casing: Mild Steel ii: Cover: White/Chrome/Brushed Nickel iii: Spring clip: Steel iv: Connection block: Polycarbonate Housing Approx. weight: 0.217 Kg
Details of fireproof material	i: Manufacturer: JCC lighting Products ii: Type: Mild Steel 'Can' iii: Thickness: 0.8mm

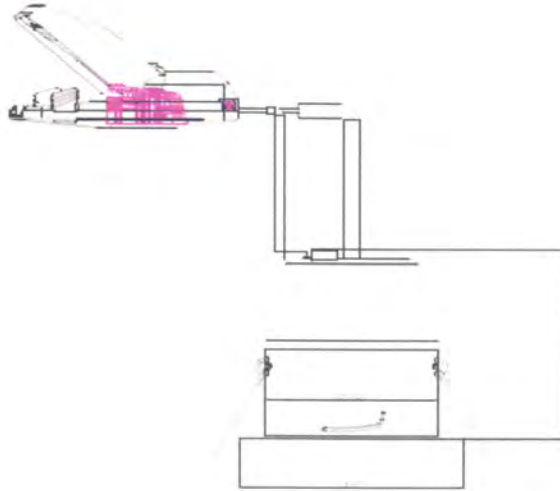
Figure 10 –Details of specimen 'G'

Product Name	: Fire Guard
Type No.	: JC010010/NB
Manufacturer	: JCC Lighting
Reference	: JC010010NB Fireguard Fixed Downlight without bezel
Type	: Recessed Downlight
Overall dimensions and construction	: 92mm (H) x 81mm (∅) , See figure 10
Hole size in ceiling boards	: 72mm ∅
Materials	i: Casing: Mild Steel ii: Cover: White/Chrome/Brushed Nickel iii: Spring clip: Steel iv: Connection block: Polycarbonate Housing

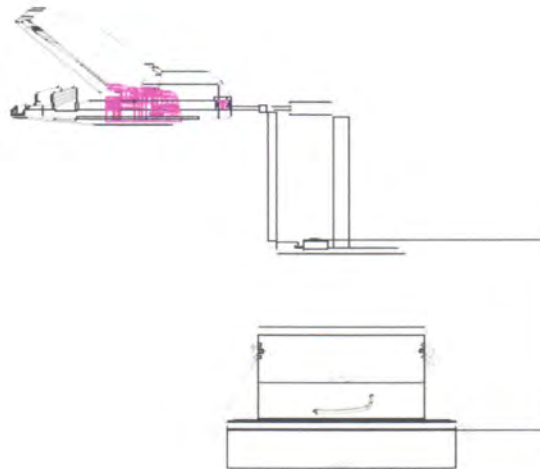
Figure 11 –Details of specimen 'H'

Product Name : Fire Guard
Type No. : JC010023 WH / CH / BN / BLK
Manufacturer : JCC Lighting
Reference : JC010023 Fireguard Tilt Downlight
Type : Recessed Downlight
Overall dimensions and construction : 101mm (H) x 100mm (∅) , See figure 11
Hole size in ceiling boards : 84mm ∅
Materials
i: Casing: Mild Steel
ii: Cover: White/Chrome/Brushed Nickel
iii: Spring clip: Steel
iv: Connection block: Polycarbonate Housing
Approx. weight: 0.261 Kg
Details of fireproof material
i: Manufacturer: JCC lighting Products
ii: Type: Mild Steel 'Can'
iii: Thickness: 0.8mm

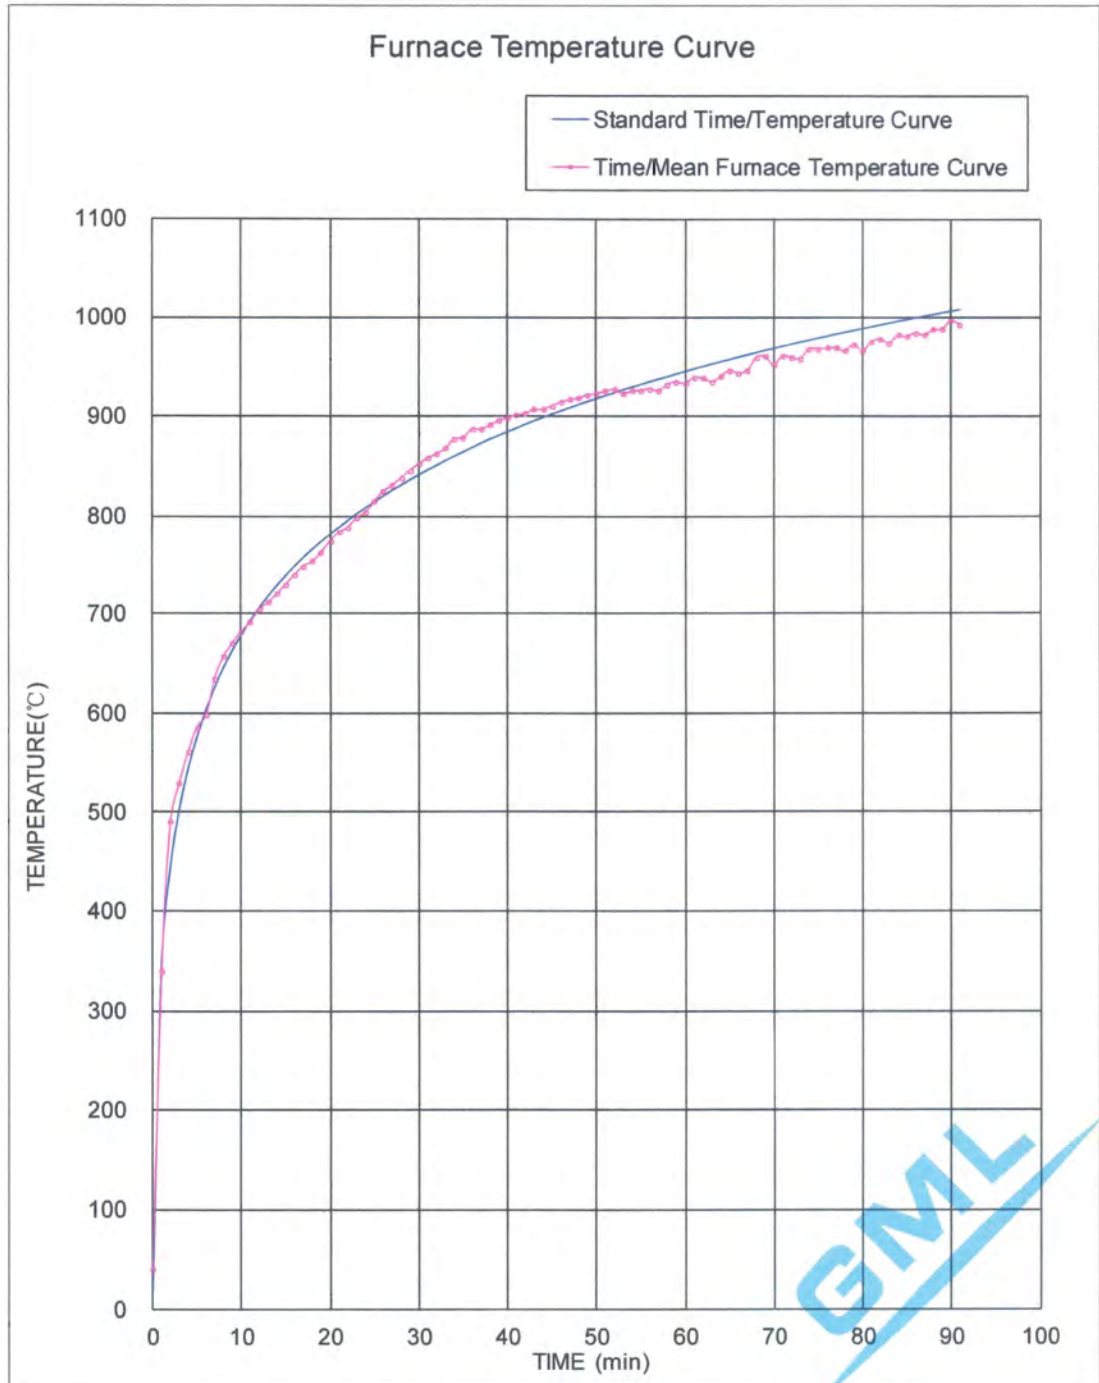
Figure 12 - Furnace Temperature Curve

The furnace temperature was measured by means of nine thermocouples distributed evenly in the furnace, with their measuring junctions 100 mm ± 10 mm from the exposed surface of the specimen. The furnace was controlled so that the mean of the nine thermocouple readings followed as closely as possible the time/temperature relationship specified in Clause 3.1 of BS 476-20:1987.

The mean furnace temperature records are shown in Appendix 2, and the actual time-temperature curve of furnace in relation to the specified time-temperature curve is shown in Figure 12.

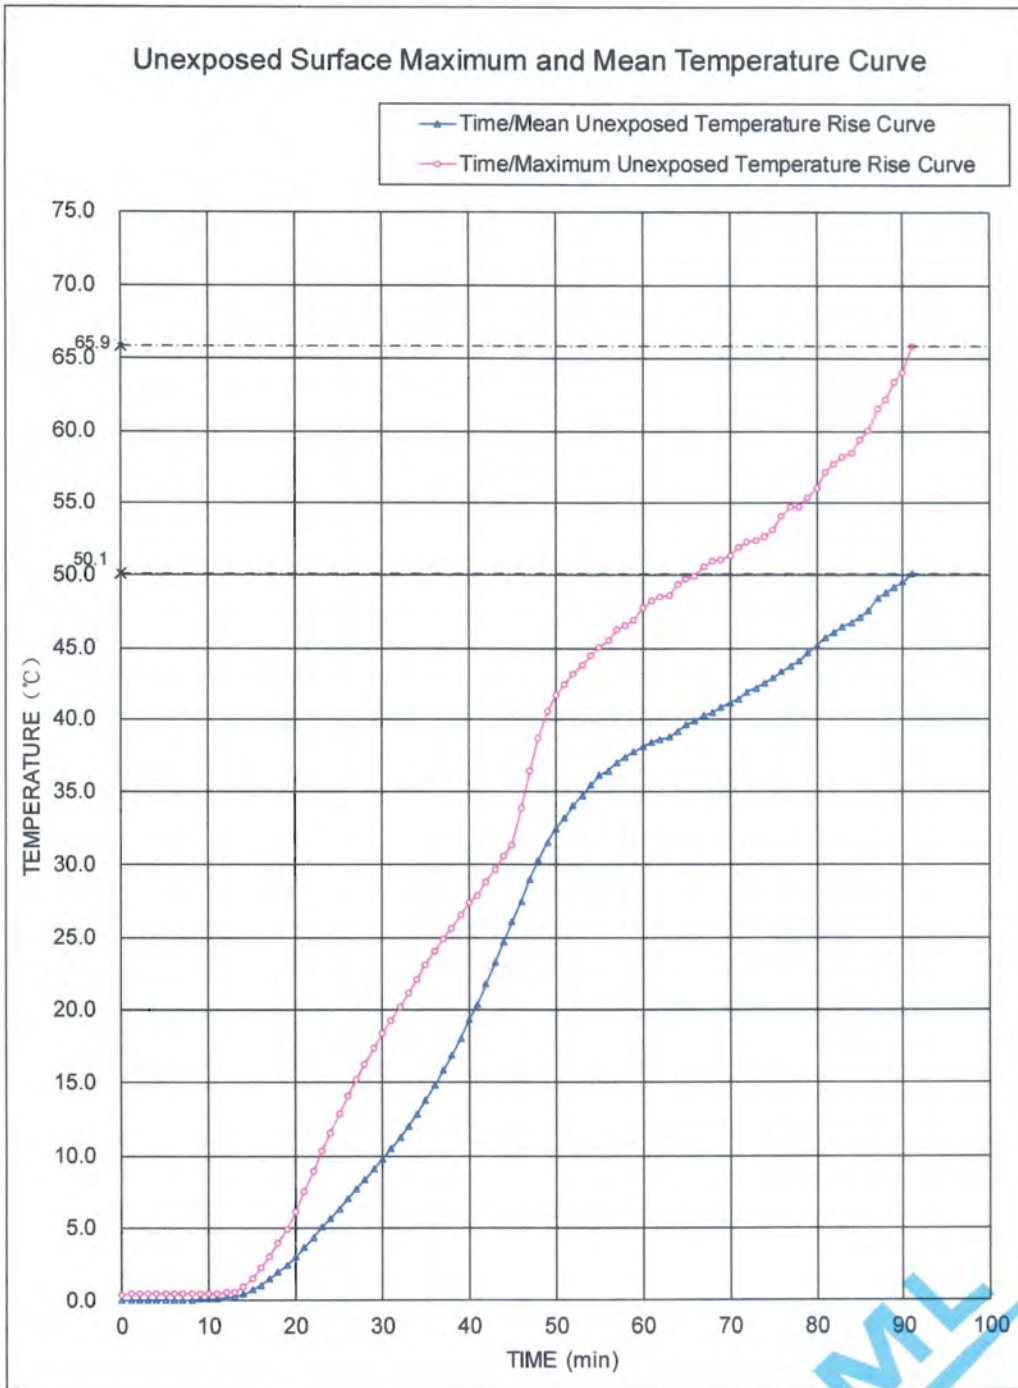
Figure 13 - Unexposed Face Mean and Maximum Temperature Curve

The unexposed surface temperature records are shown in Appendix 3, and the individual temperatures recorded adjacent to the spotlight fittings at mid-height of the cavity are shown in Appendix 4. The unexposed surface maximum and mean temperature curve are shown in Figure 13.

At the heating period of 91 minutes, the mean temperature rise of the unexposed face was 50.1°C, the maximum temperature rise of the unexposed face was 65.9°C. The insulation requirement was satisfied.

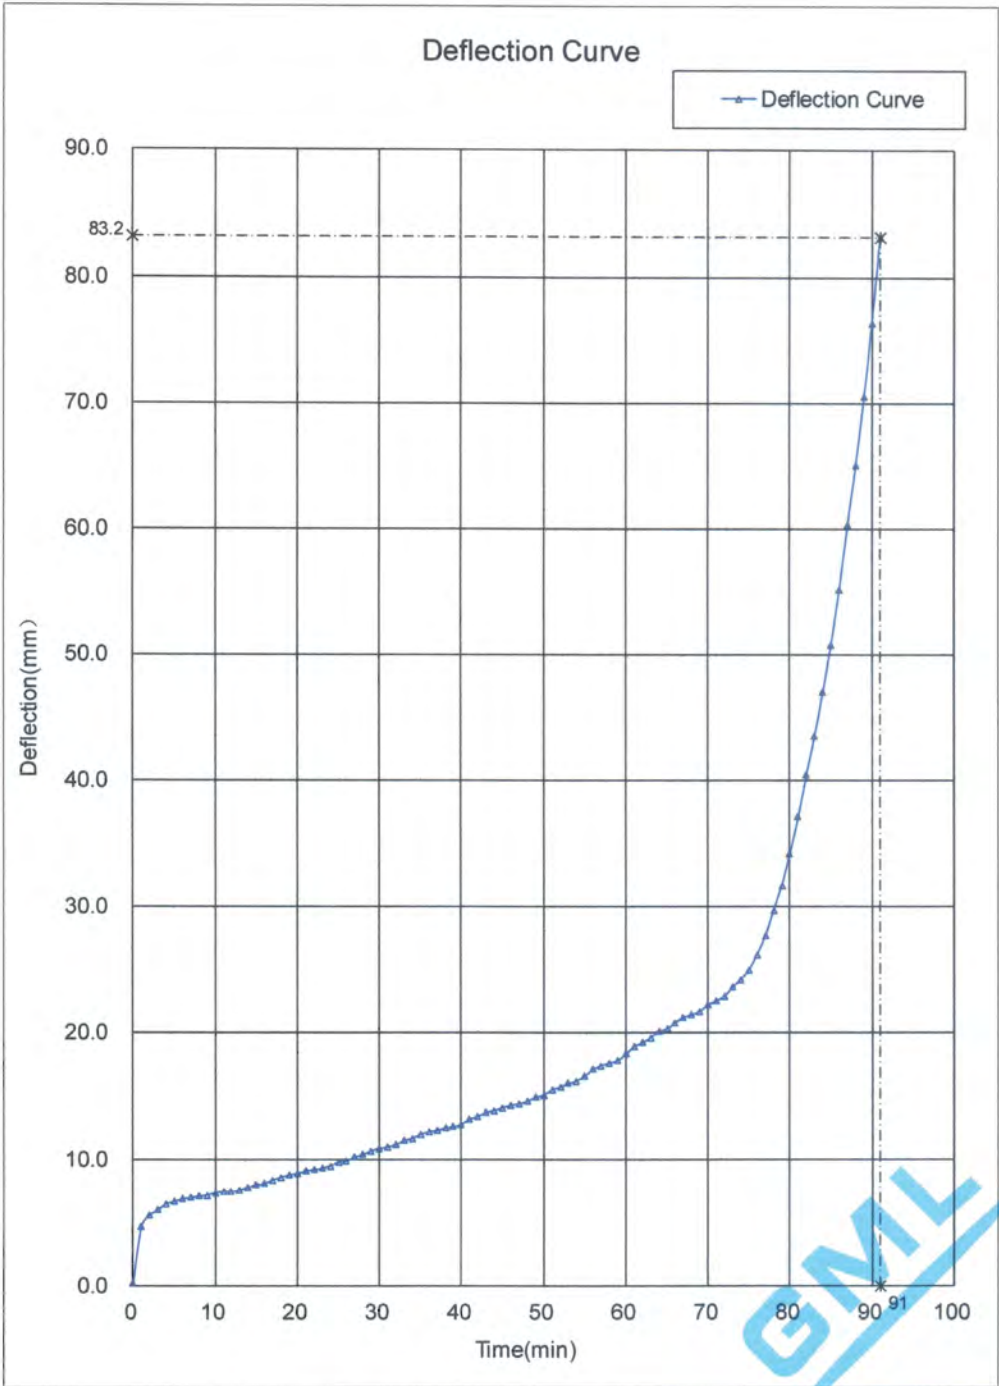
Figure 14 - Deflection Curve

The vertical deflection at the centre of the floor assembly was continuously measured during the test, and the data records are given in Appendix 5. The deflection curve is shown in Figure 14.

At the heating period of 91 minutes, the maximum deflection was 83.2mm; the rate of deflection was 6.8 mm/min. The loadbearing capacity was satisfied.
