FLOOR ASSEMBLY **FIRE TEST REPORT**

JCC LIGHTING PRODUCTS

BS 476-21:1987, BS 476-20:1987

Test Report No.: V03-20000056(E)

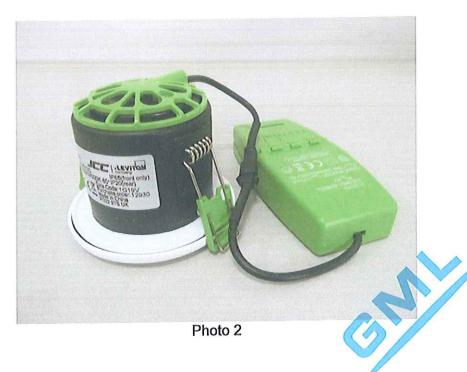
Photo 1: Front view of specimen 'A' Photo 2: Side view of specimen 'A'

Details of the specimen structure are shown in Figure 1 to 11. The photographs of the Downlights are shown in Photo 1 to 16.

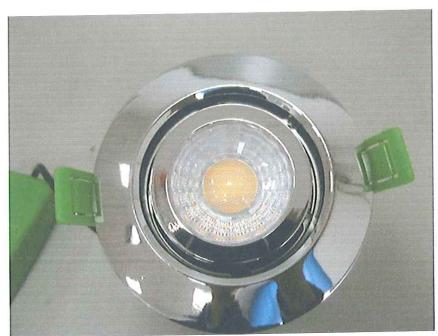
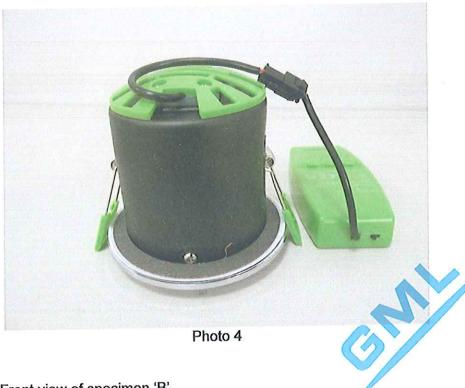
Photo 3

Photo 3: Front view of specimen 'B' Photo 4: Side view of specimen 'B'

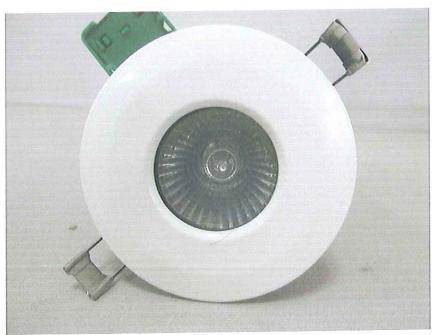
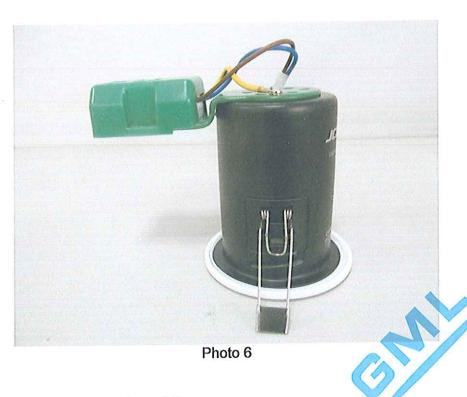
Photo 5

Photo 5: Front view of specimen 'C' Photo 6: Side view of specimen 'C'

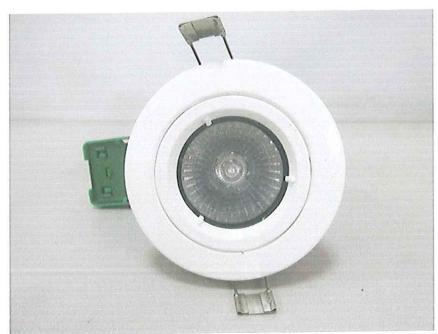
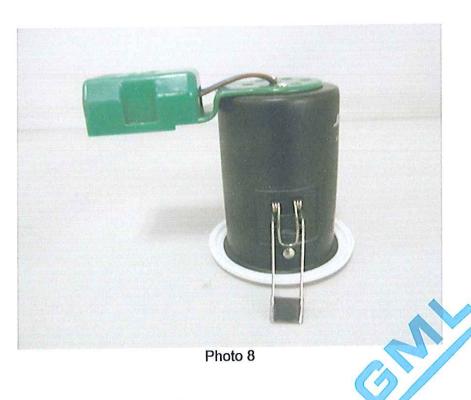
Photo 7

Photo 7: Front view of specimen 'D' Photo 8: Side view of specimen 'D'

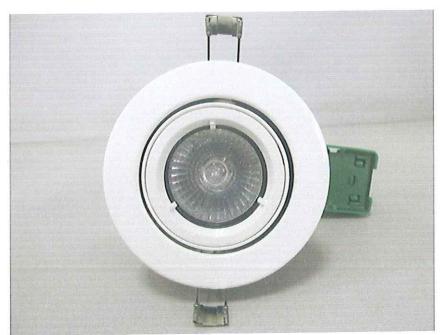
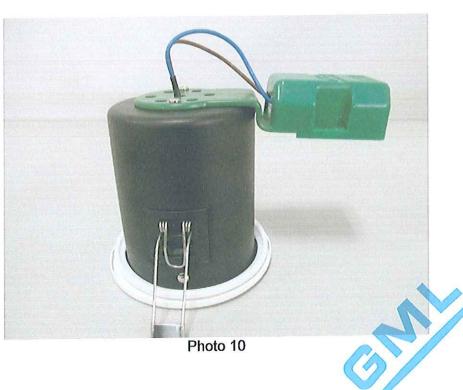
Photo 9

Photo 9: Front view of specimen 'E' Photo 10: Side view of specimen 'E'

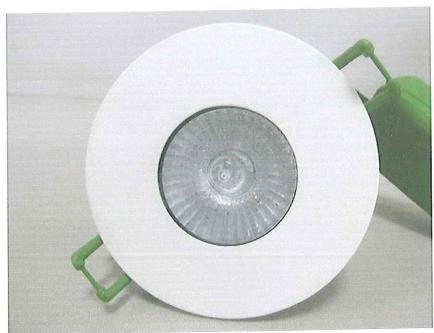
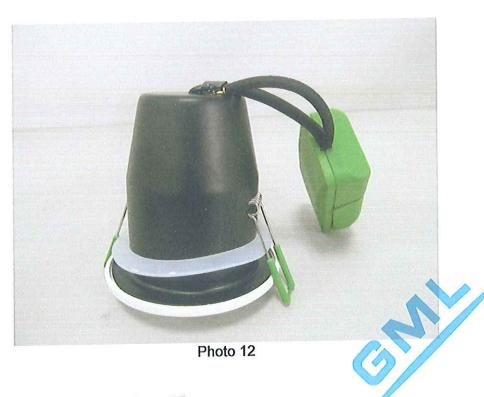
Photo 11

Photo 11: Front view of specimen 'F' Photo 12: Side view of specimen 'F'

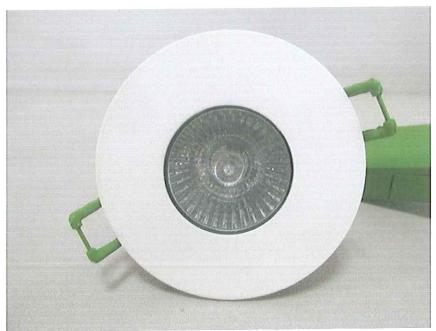
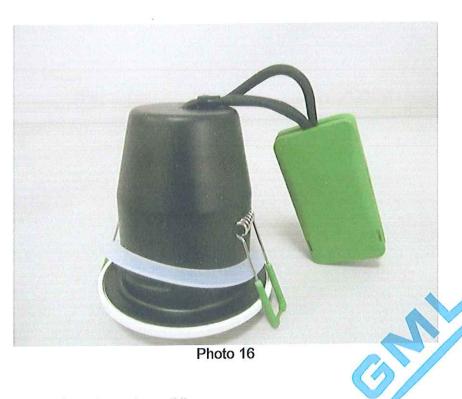
Photo 15

Photo 15: Front view of specimen 'H' Photo 16: Side view of specimen 'H'

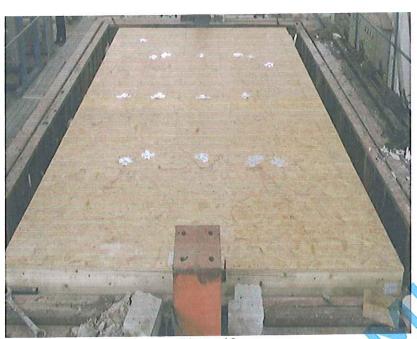
Photo 18

Photo 18: The unexposed surface of the specimen before the test.

Photographs of the test are shown in Photos 17 to 28. A summary of the observations made on the general behavior of the specimen is given in Appendix 1.

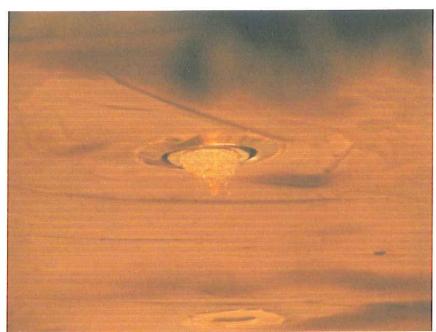
Photo 19

Photo 19: The exposed surface of the specimen after test duration of 4 minutes, showing the lens of specimen was fusing.

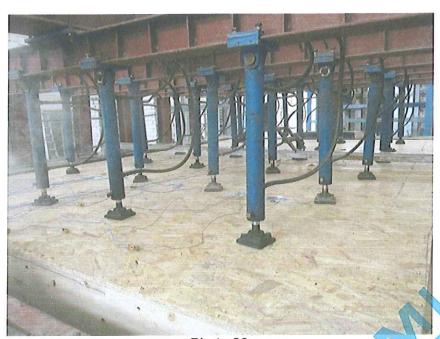
Photo 20

Photo 20: The unexposed surface of the specimen after test duration of 15 minutes.

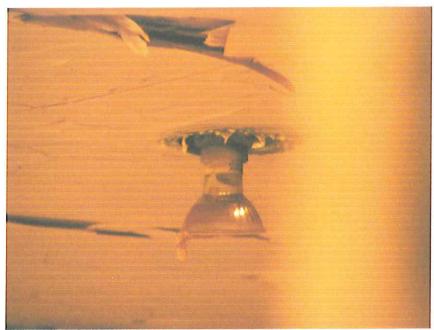
Photo 21

Photo 21: The exposed surface of the specimen after test duration of 15 minutes, showing the lamp cups of specimen fell out from the light can.

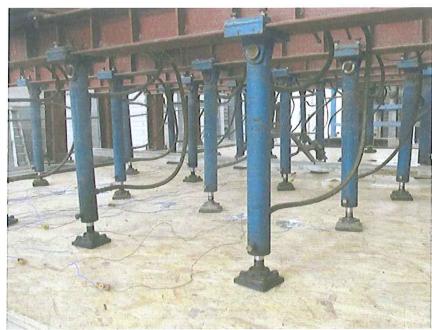
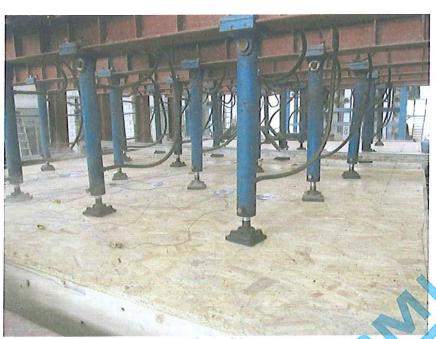
Photo 23: The unexposed surface of the specimen after test duration of 30 minutes. Photo 24: The unexposed surface of the specimen after test duration of 45 minutes.

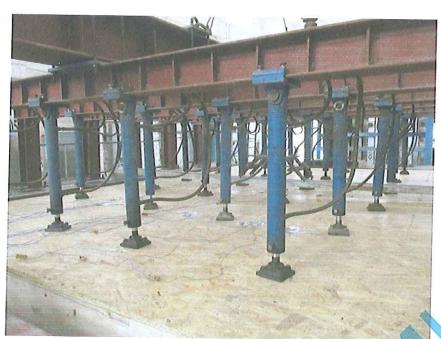
Photo 25: The exposed surface of the specimen after test duration of 55 minutes, the first layer plasterboard ceiling started to sag slightly and joints began to open. Photo 26: The unexposed surface of the specimen after test duration of 60 minutes.

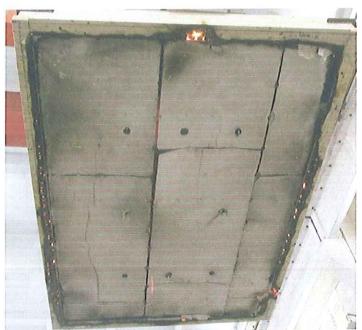
Photo 27

Photo 27: The exposed surface of the specimen after the test.

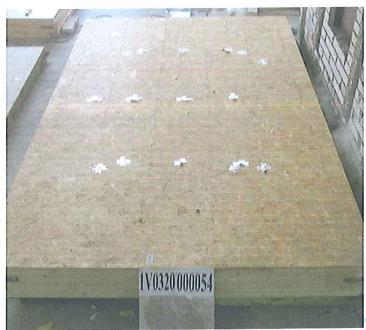
Photo 28

Photo 28: The unexposed surface of the specimen after the test.
