TEST REPORT

No. : XMIN2208008557CM

Sample Name : LED FIRE RATED DOWNLIGHT

To determine the fire resistance of a timber floor assembly protected by a plasterboard ceiling designed to provide 30 minutes fire resistance, incorporating 12 LED FIRE RATED DOWNLIGHT fittings, when tested in accordance with BS EN 1365-2: 2014, "Fire resistance tests for loadbearing elements Part 2: Floors and roofs".

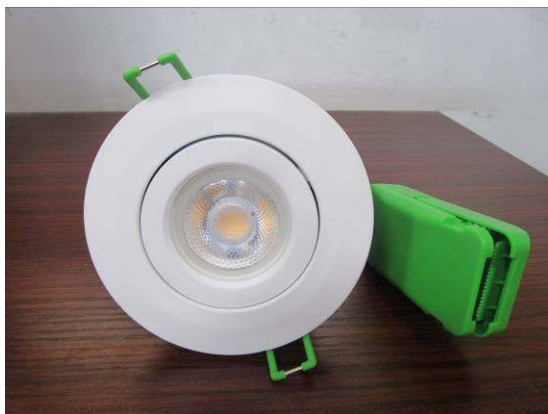
Photo 1: Front view of specimen 'A'

Product Name : Fireguard Next Generation
 Reference : JC010023 WH/CH/BN/BLK Fireguard Tilt Downlight
 Manufacturer : JCC Lighting Products
 Type : Fireguard Recessed Downlight
 Overall dimensions and construction : 101mm (H) x 100mm (Φ), See figure 3
 Hole size in ceiling boards : 84mm Φ
 Materials :
 i: Casing: Mild Steel
 ii: Cover: Aluminum
 iii: Spring clip: Steel
 iv: Connection Block: Polycarbonate Housing
 Approx. weight: 0.261 Kg

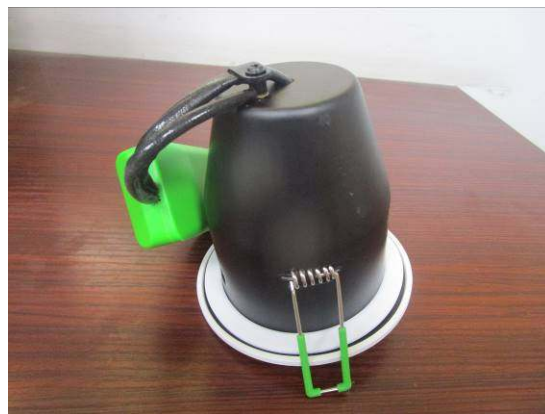
Photo 2: Side view of specimen 'A'

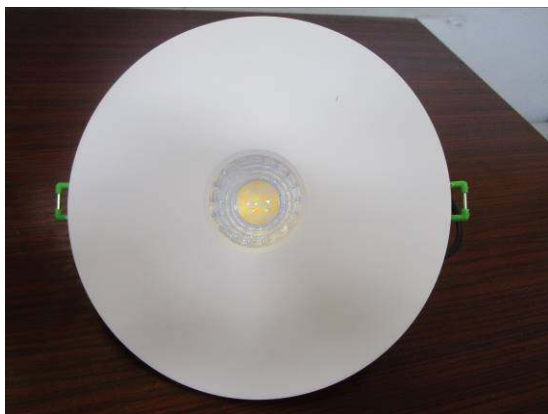
Photo 3: Front view of specimen 'B'

Product Name : V50
 Reference : V50 Slim Converter 72-165mm
 Manufacturer : JCC Lighting products
 Type : JC1017
 Overall dimensions and construction : 63mm H x 170mm W, See figure 4
 Hole size in ceiling boards : 150mm
 Materials :
 i: Casing: Mild Steel (can)
 ii: Cover: Aluminum (bezel)
 iii: Spring clip: Sprung Steel
 iv: Connection Block: Polycarbonate (housing)
 Approx. weight: 0.30 Kg

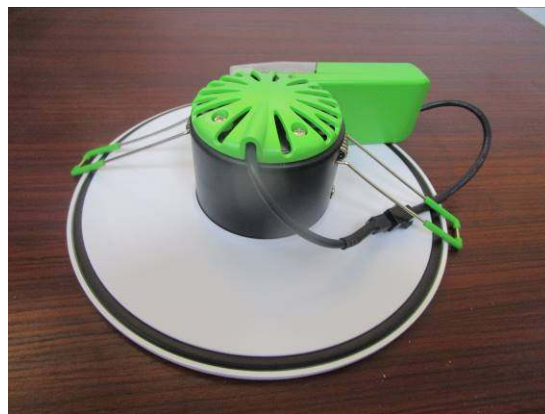
Photo 4: Side view of specimen 'B'

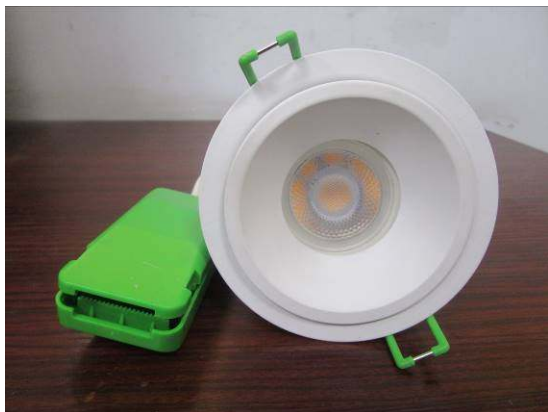
Photo 5: Front view of specimen 'C'

Product Name : Fireguard Next Generation
 Reference : JC010035 WH/CH/BN/BLK Fireguard Downlight
 Manufacturer : JCC Lighting Products
 Type : Fireguard IP65 Recessed Downlight
 Overall dimensions and construction : 98mm (H) x 94mm (Φ), See figure 5
 Hole size in ceiling boards : 80mm Φ
 Materials :
 i: Casing: Mild Steel
 ii: Cover: Aluminum
 iii: Spring clip: Steel
 iv: Connection Block: Polycarbonate Housing
 Approx. weight: 0.261 Kg

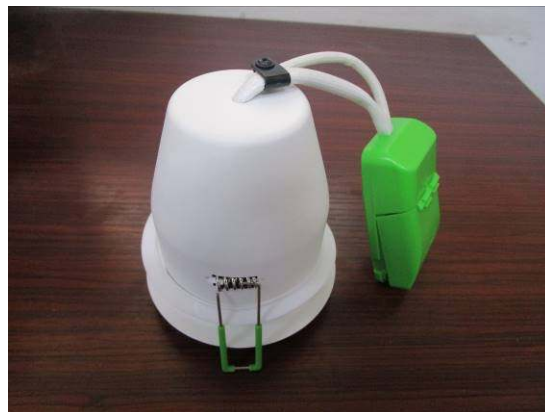
Photo 6: Side view of specimen 'C'

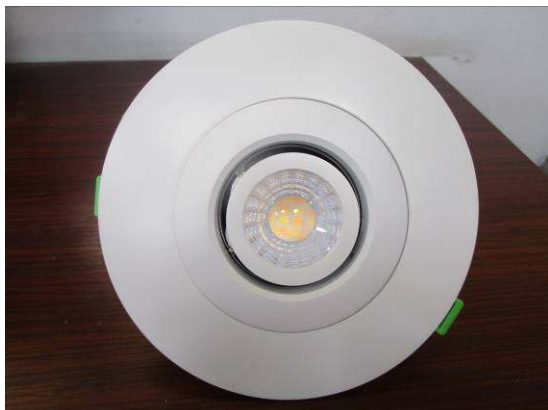
Photo 7: Front view of specimen 'D'

Product Name : V50
 Reference : V50 Converter plate for use with JC1002
 Manufacturer : JCC Lighting Products
 Type : JC1002 with JC1004
 Overall dimensions and construction : 46mm H x 170mm W, See figure 6
 Hole size in ceiling boards : 140mm
 Materials :
 i: Casing: Mild Steel (can)
 ii: Cover: Aluminum (bezel)

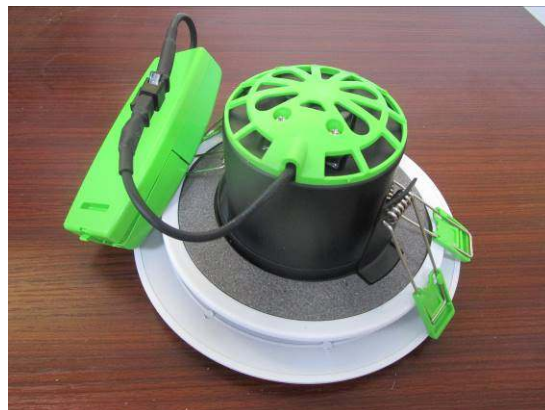
Photo 8: Side view of specimen 'D'

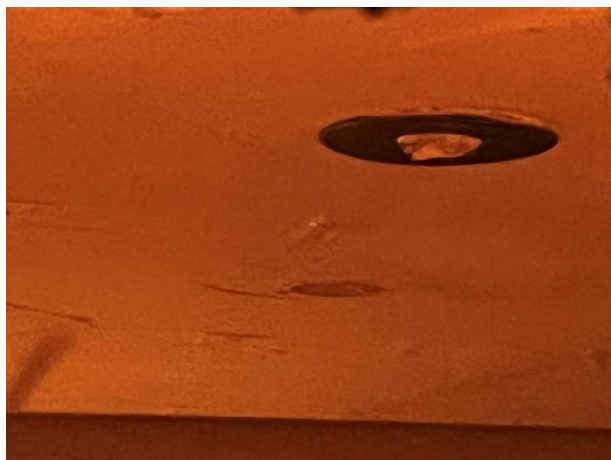
Photo 27: The exposed surface of the specimen after test duration of 3 minutes, showing the lens of specimen was fusing.

Time (min)	Observation (All observations are from the exposed face unless noted otherwise)
0	Test started.
3	Some lens of specimen was fusing.
9	Coating of the plasterboard ceiling fell away.
16	Large areas of coating of the plasterboard ceiling fell away.
28	The plasterboard ceiling started to sag slightly and joints began to open.
30	Test terminated at sponsor's request.

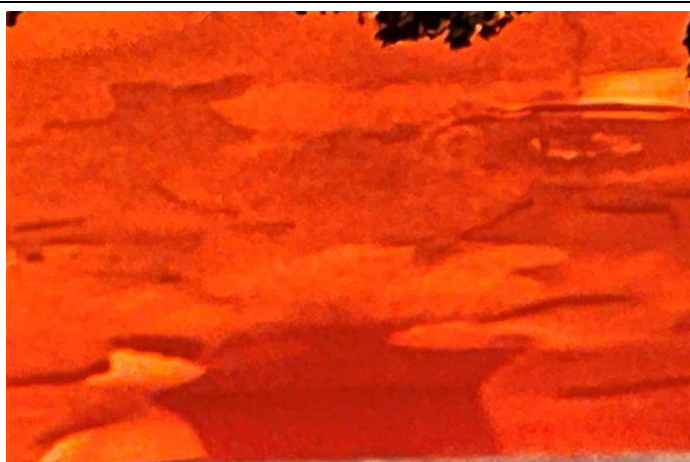
Photo 29: The exposed surface of the specimen after test duration of 16 minutes, large areas of coating of the plasterboard ceiling fell away.

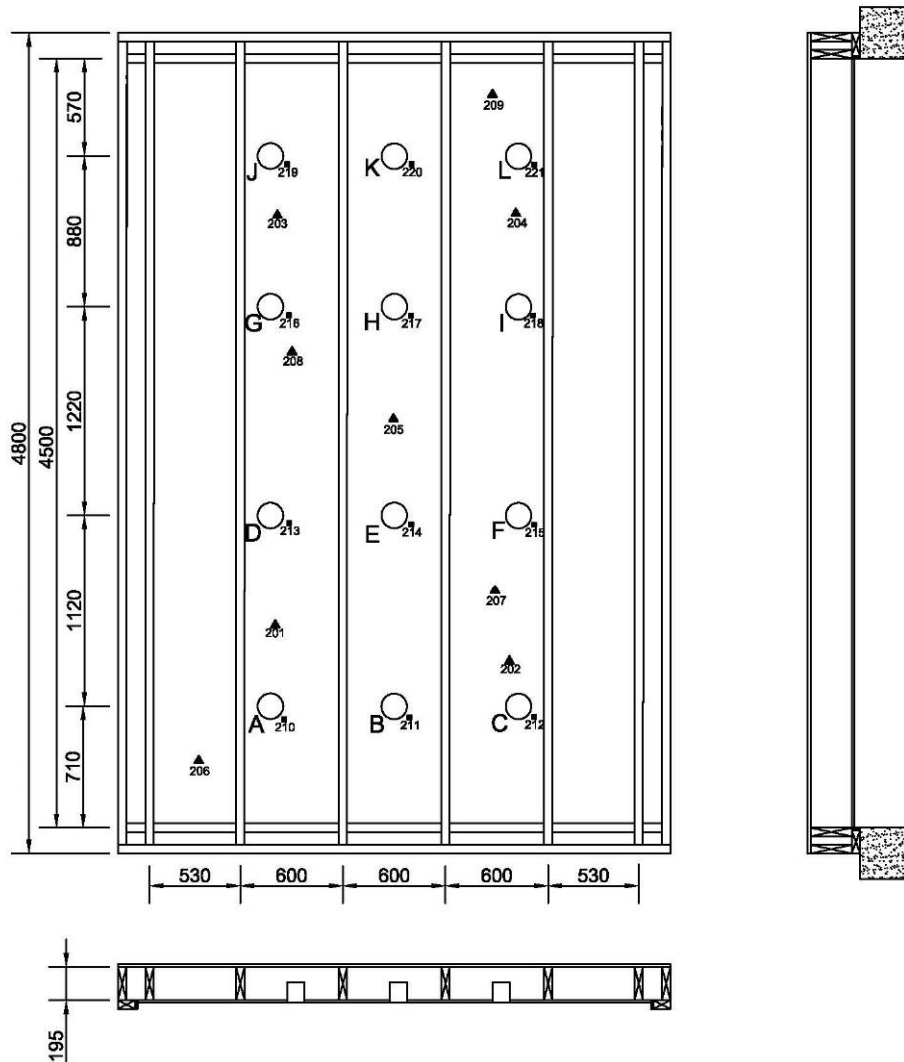
Joists Layout

Figure 1 - Specimen General Plan

The timber floor assembly had overall nominal dimensions of 4800 mm long by 3230 mm wide and comprised solid wood joists at 600mm centres. The depth of the solid wood joist was 195mm. The upper surface of the floor comprised nominally 22mm thick T&G chipboard and screwed fixed to the upside of the floor joists. The floor assembly was protected on its underside by a direct fixed ceiling, formed from one layer of 15mm thick Standard Gypsum Boards, the ceiling was screw fixed to the underside of the floor joists.

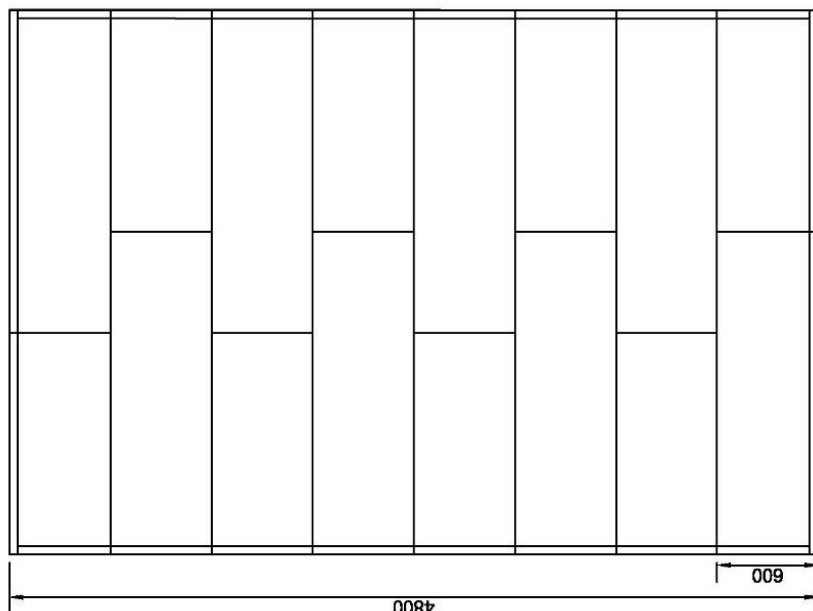
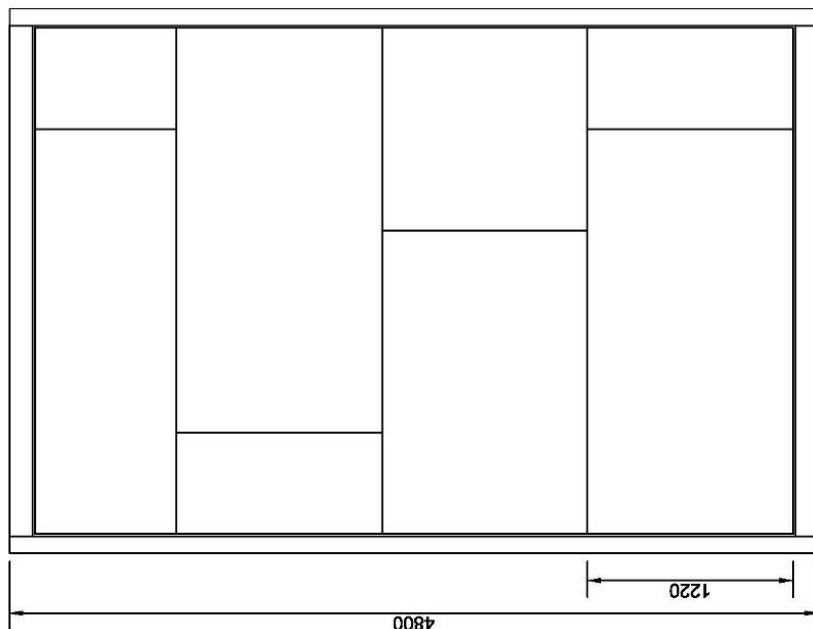
Chipboard Layout

Plasterboard Layout

Figure 2 - Specimen Structural Drawing

<u>Item</u>	<u>Description</u>
1. Floor Joists	
Material	: Solid Timber Joist, softwood
Size	: 195mm deep; 45mm thick
Centres:	: 600mm
2. Floorboards	
Material	: Egger T&G chipboard
Thickness	: 1 No. layer, 22mm thick
Fixing method	: All board screw fixed to all joists using drywall steel screws, at 200 mm centers along joists and 150 mm centers along perimeter of floor.
3. Ceiling boards	
Material	: Knauf Standard Gypsum Board
Thickness	: 1 No. layer, 15mm thick
Fixing method	: All board fixed to joists with Drywall screws at max.230mm c/c. The joints between the boards were filled with joint filler with was also used to cover the heads of the screws.
4. End Joists	
Material	: Glulam
Size	: 195mm high x 50mm thick
Fixing method	: Fitted across the ends of the joists and through screwed to each joist.

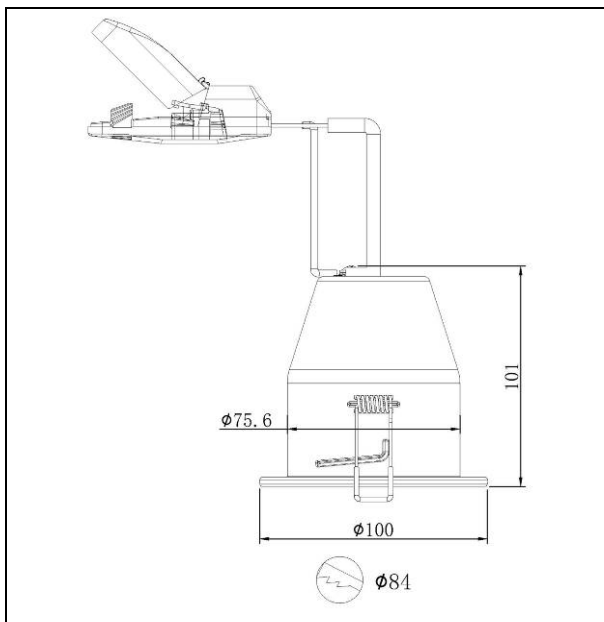
Figure 3 – Details of specimen 'A'

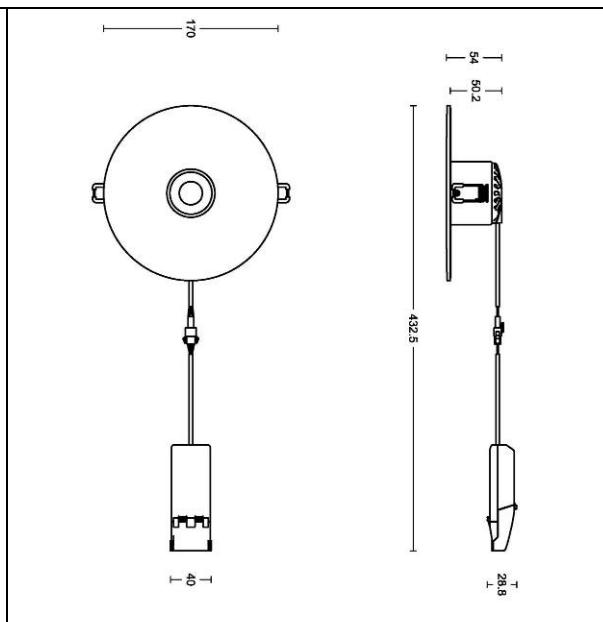
Figure 4 – Details of specimen 'B'

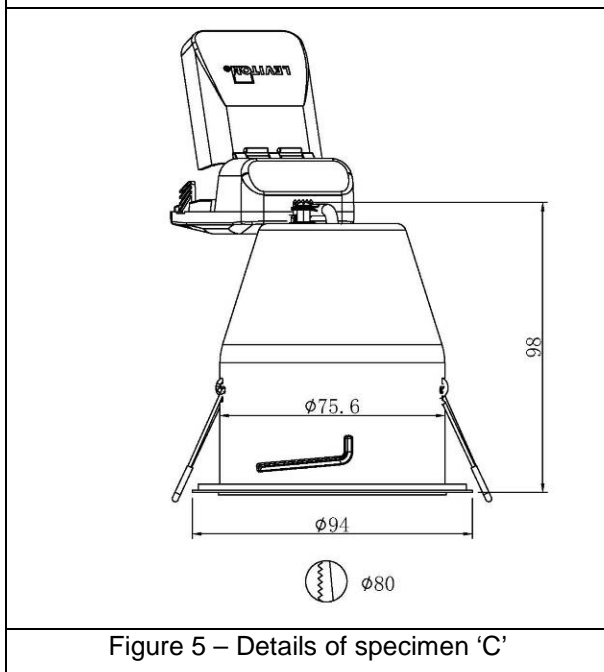
Figure 5 – Details of specimen 'C'

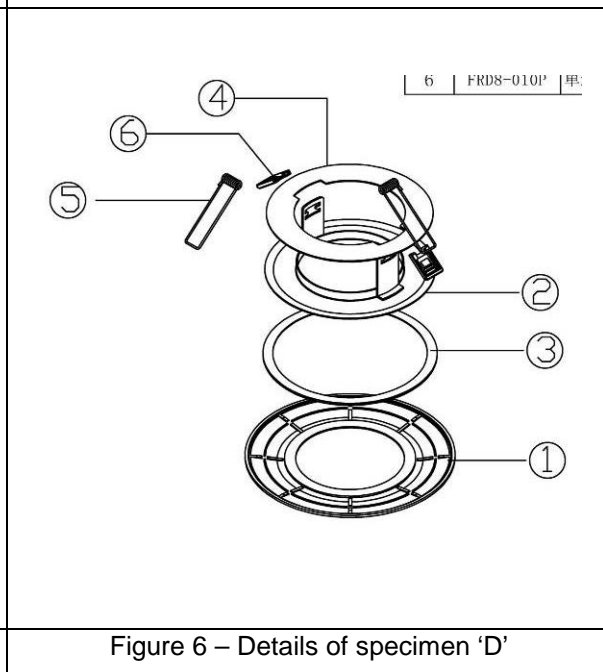
Figure 6 – Details of specimen 'D'

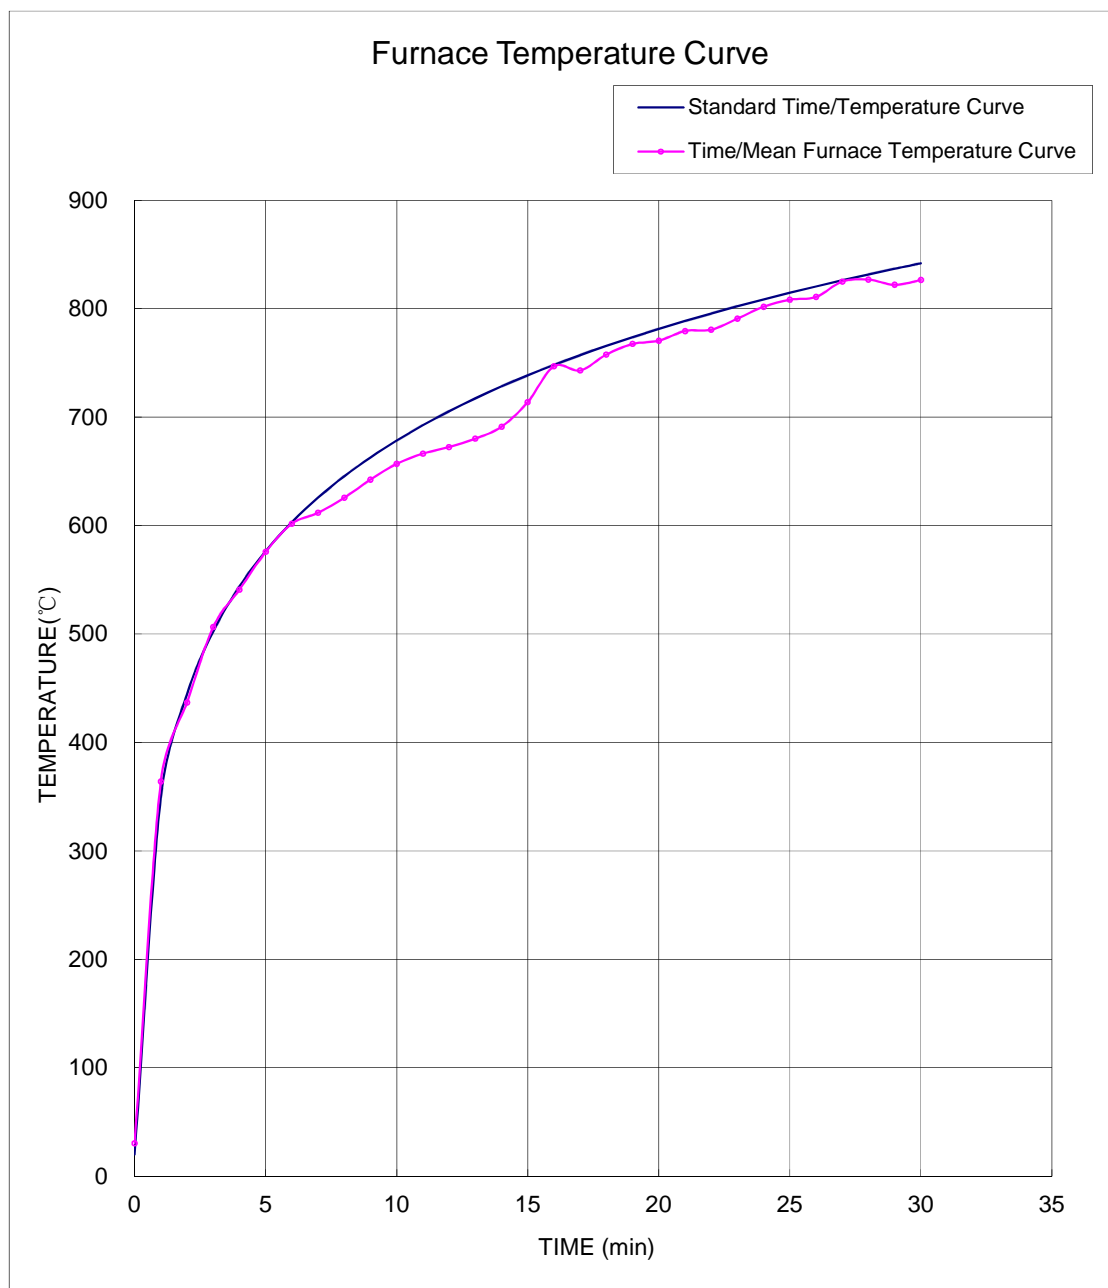
Figure 15 - Furnace Temperature Curve

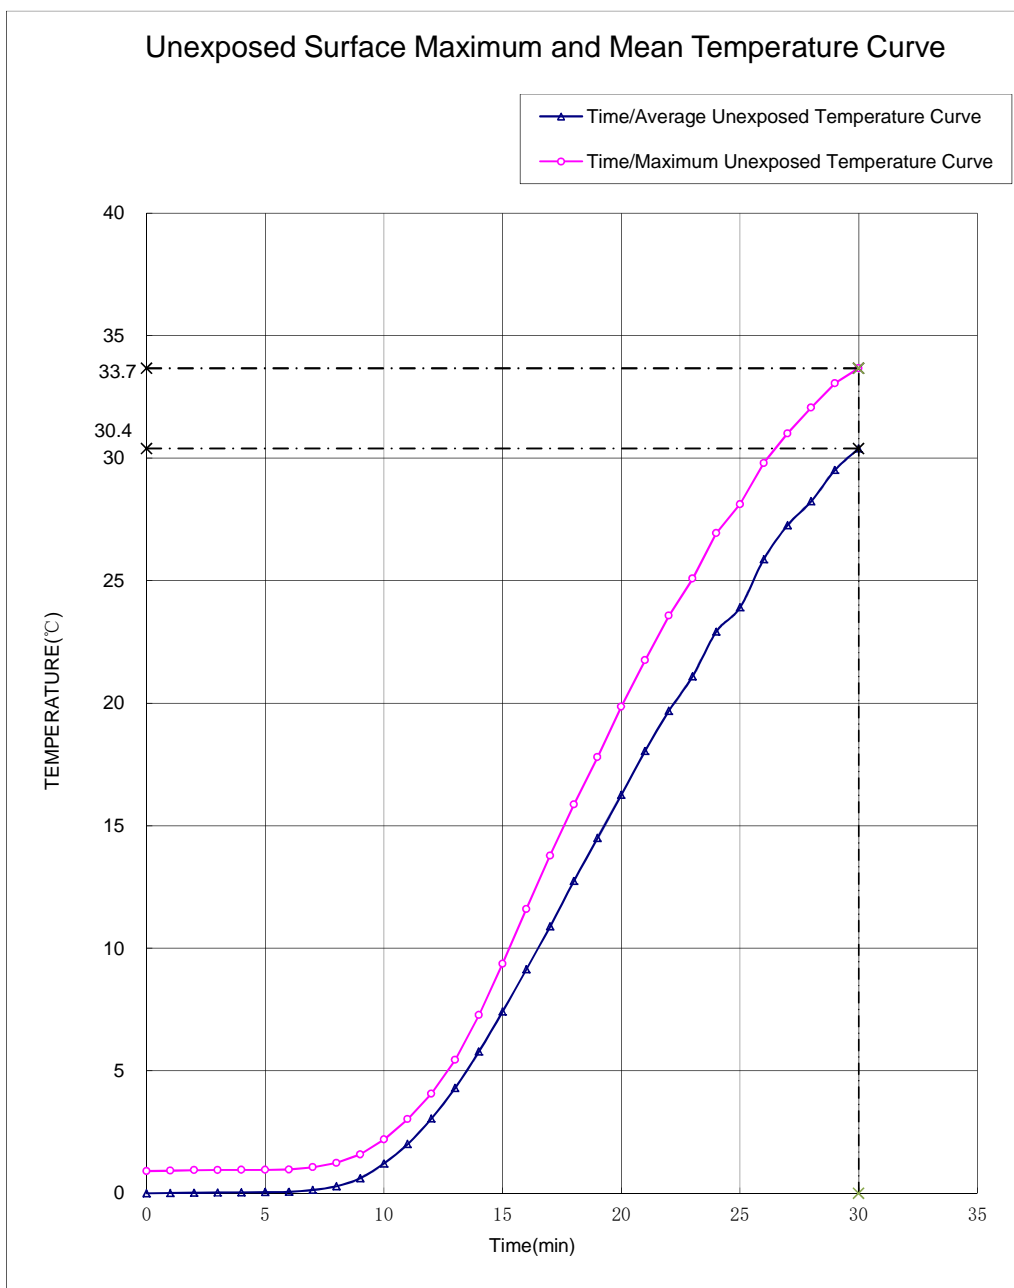
Figure 16 - Unexposed Face Mean and Maximum Temperature Curve

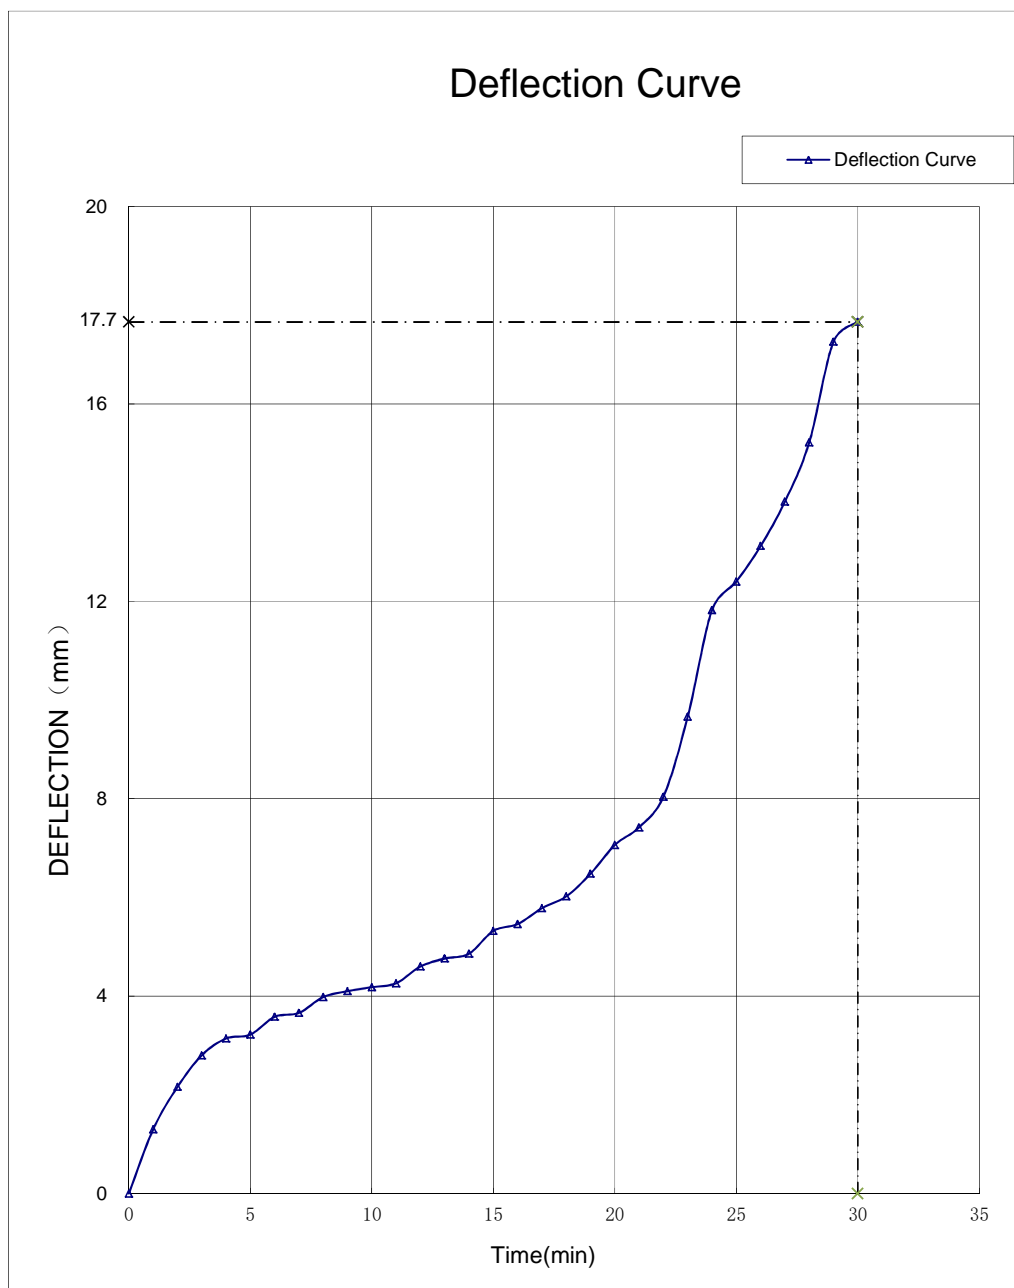
Figure 17 - Deflection Curve
